# All Pro Home Inspections

INSPECTION REPORT	9
STRUCTURE, FOUNDATION, CRAWL SPACE	13
EXTERIOR	18
ATTIC AREAS & ROOF FRAMING	24
ELECTRICAL SYSTEMS	25
PLUMBING	28
HEATING SYSTEMS	30
GARAGE - CARPORT	32
LAUNDRY	34
WATER HEATERS	35
BATHROOMS	36
INTERIOR ROOMS	40
KITCHEN	42

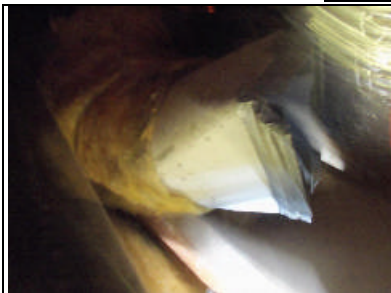
Picture shows one of the abandoned heat registers in the attic.

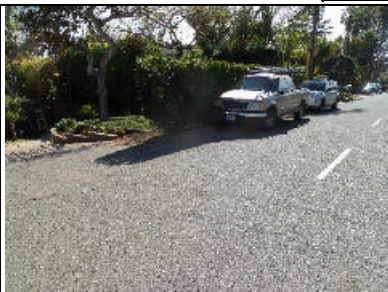
[FE] One potential complication for the drainage on this property is the possibility of water running down off the city street. Evaluating the extent of this risk is beyond the scope of this inspection. You should ask the sellers in writing what experience they have had with this issue in the past. Also, neighbors can be a good source of information. It seems clear that at least some water will run off the street and down the driveway. This will complicate the issues with adequacy of the drains and the general slope and elevation of the driveway in front of the garage door.

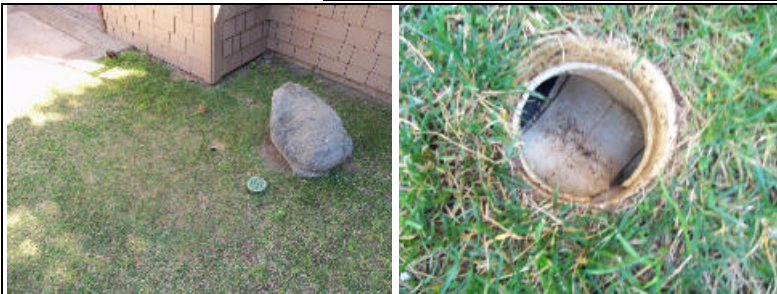
The first two pictures show how high the soil is in the area off the front right corner of the garage and how shallow the drain line was installed.

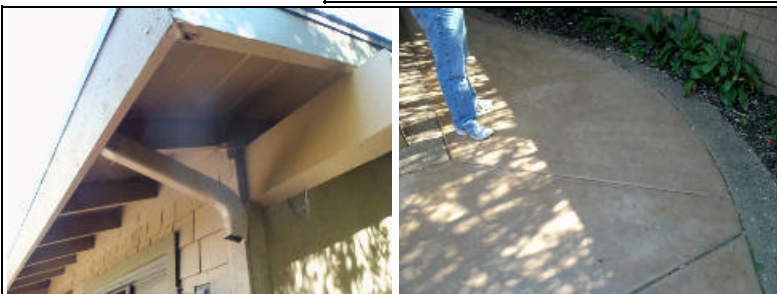
### 3.3 RIGHT SIDE

**[CR]** I highly recommend installing more drain inlets than the system currently has. Every planting area next to the house or any low or shallow areas around the yard that can trap or hold water should each have a drain. I don't see any way for the area on the right side of the kitchen wing to drain and suspect that this area will just pond. It needs a drain but that would require cutting and patching concrete and landscaping. Water runs off the roof where the downspout is missing, across the patio and is trapped against the fence with no way to run in either direction.

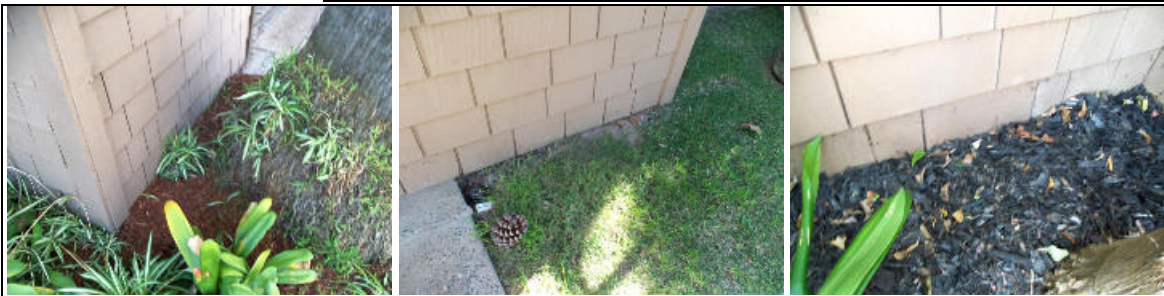
These pictures are just examples and there are other areas.

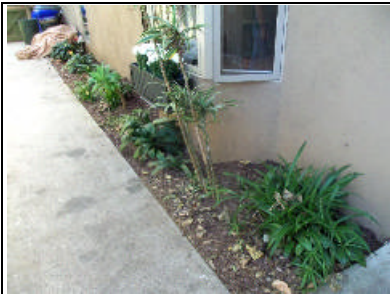
### 3.8 LEFT SIDE

[FE] [CR] This picture is along the left side of the house. There is no rain gutter and water runs off the roof and is trapped in this narrow planter against the house with no good way to escape. The soil is too high. The sidewalk is too high. Installing rain gutters is definitely recommended as part of the solution. Filling the area with concrete can help but it is critical that the concrete slopes away from the house without ponding. Also, any concrete is supposed to be a minimum of tow inches below the interior slab level. Since the concrete is so high, this will not be possible for at least part of this side yard. See note in following section about the water intrusion due to the concrete being too high.

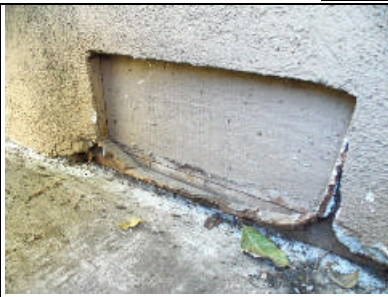
[CR] Stucco repair is needed by a stucco contractor who can match the stucco and make sure the weatherproof membrane or building paper is in good condition to ensure that moisture in the stucco will not leak into the wall cavity. The stucco contractor should check the entire exterior of the building and be responsible for patching wherever needed. This picture shows where the vent on the left side of the original garage was covered to extend the master bedroom closets. Moisture is definitely leaking into the wall cavity in this area. Also see notes in next section about the concrete sidewalk level being too high and forcing water into the wall.

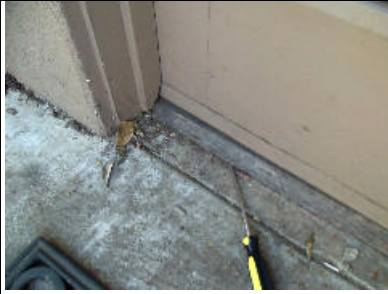
## 4.2 EXTERIOR DOOR

**[FE] [CR]** The exterior door to the master bedroom does not have a properly installed sill and this will increase the potential for water leaking onto the framing at the base of the door and this will increase the potential for rot in the framing or subfloor at the base of the door. Have a specialty door installation contractor evaluate the door sill further and correct as needed. The sill needs to slope all the way to the outside edge of the slab to provide a path for water that flows down the face of the door. Anything less than a distinct slope from the outside face to the door to the outside edge of the slab below the sill is only asking for trouble. The sill needs to extend past and over the slab. The door sill needs to be replaced by a door contractor. To properly seal the sill and integrate it into the door frame may require removing the entire door frame and replacing it. See Sidewalk note below for problem with the height of the exterior sidewalk.

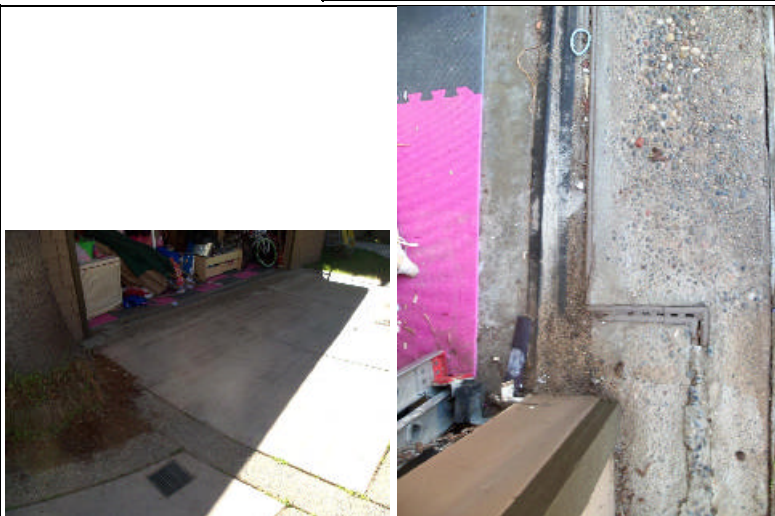
### 4.3 DRIVEWAY:

**[CR]** The driveway sloped toward the garage and there can be risk that water could run into the garage on a heavy rain. Ask the sellers if this has ever happened. The driveway should be a little lower than the garage but it isn't. It should slope away from the garage door but it doesn't. The slope into the drain in the picture is weak. The tiny channel drain at the front of the door is probably worthless. The rubber gasket glued down at the base of the door appears to be doing a good job and is a relatively novel way of deal with this. I am not sure how well it will work in a heavy rain or how long it will last but it should be monitored. It is hard to guess how much water could come down the driveway towards the garage door. It is unfortunate that the concrete and drainage contractors did such a poor job and it may be necessary to cut and replace this section to correct the drainage issues. See Grading and Drainage notes also.

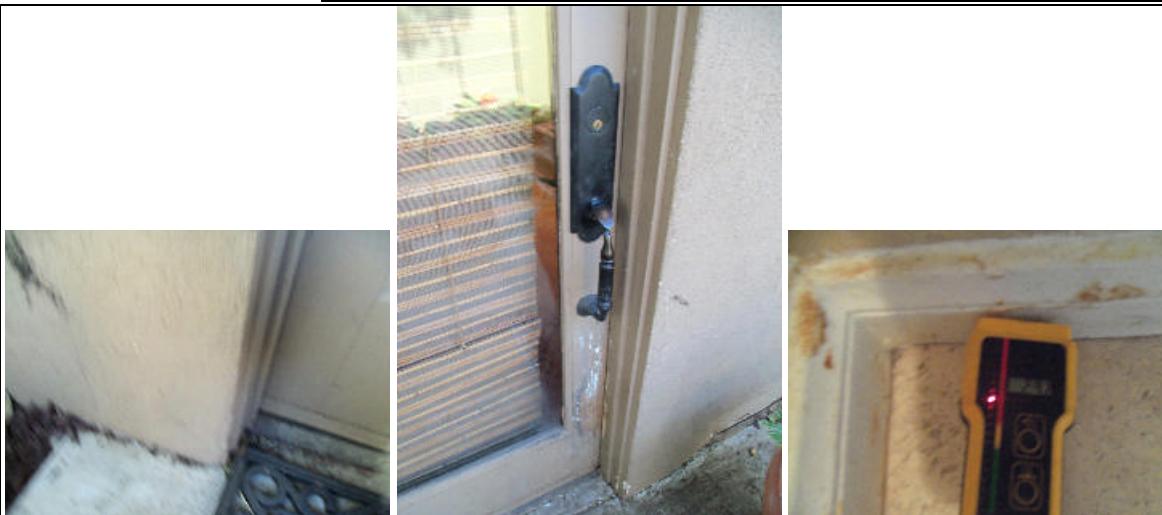
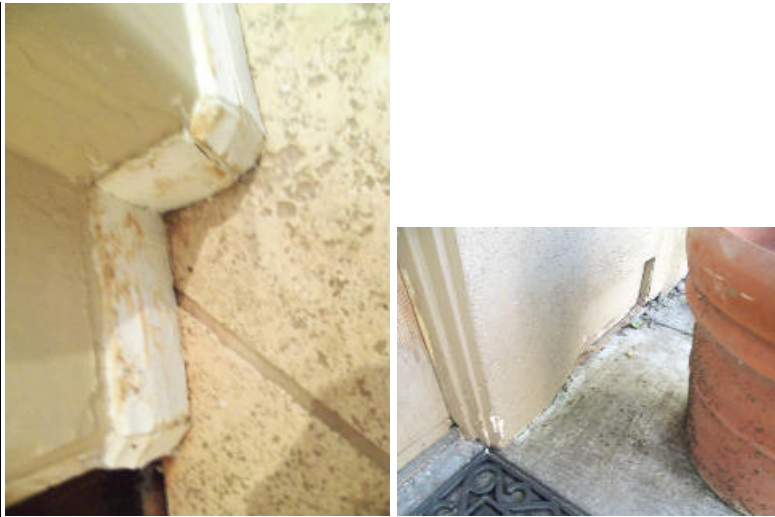
**[Defect]** The finish height of the sidewalk or patio is higher than the wood framing that supports the outside wall. Current standards specify that the finish elevation of any flatwork on the outside needs to be two inches below the level of any framing lumber to minimize the risks of moisture intrusion into the wood wall cavity and potential rot. It is hard to determine just how much risk this will create. It may not be cost effective to correct because the only solution may be to bust out the concrete and lower it. I have seen this defect manifest into a substantial problem depending on certain risk factors. When the exterior flooring level is higher than the wood at the base of the wall than any moisture that gets onto the wood will become trapped because the moisture will not have a way to escape to the exterior. This will greatly increase the likelihood of rot now and in the future. This risk increases with time. Waterproofing membranes originally installed will deteriorate over time and even the best will eventually leak if regularly exposed to water. **In this case I feel that the potential for water intrusion onto the wood framing and the risk of rot or other water damage is very high over time.** The longer that this condition has been ongoing and the longer it is allowed to continue the more risk.

The first two pictures show the concrete that is too high on the outside of the door. The next two show the water damage on the inside with one showing the moisture meter with a moderately high moisture reading. In the second picture you can also see that there is some damage to the door from dogs.

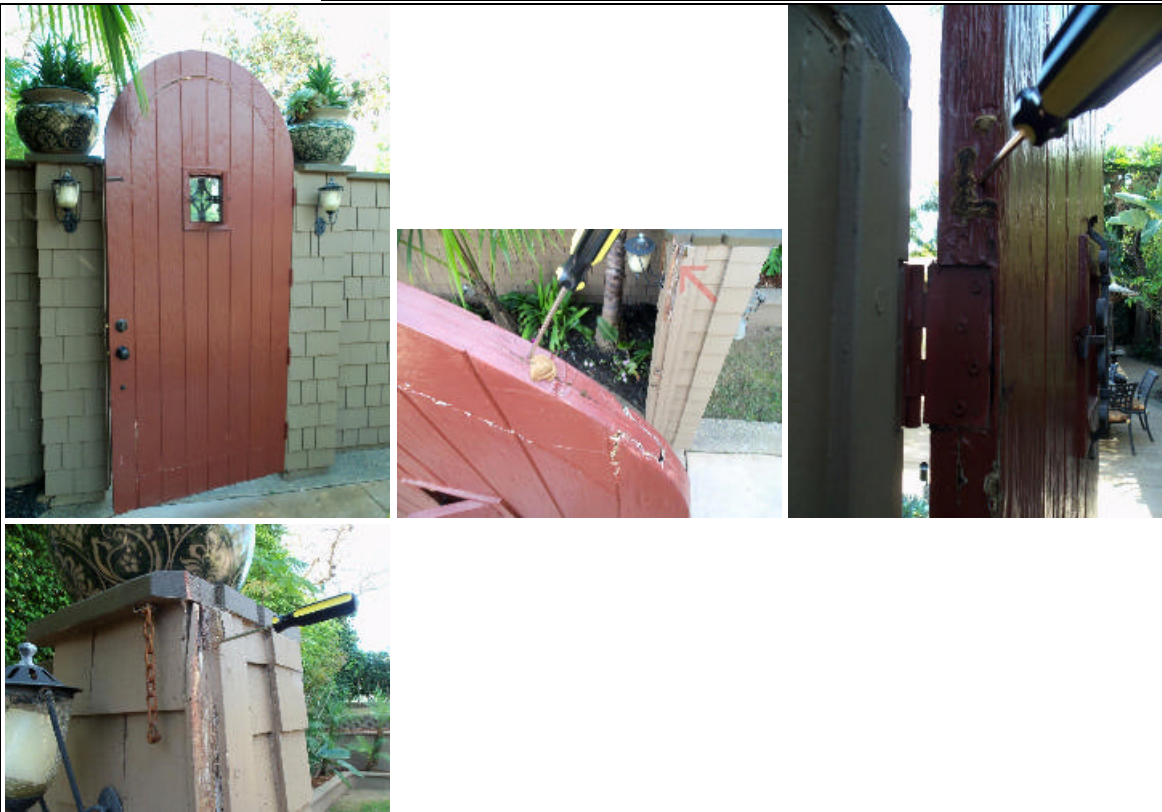
#### 4.5 ENTRY GATE

[FE] [CR] The entry gate needs further evaluation and repair. Both the door and the frame have damage. See the termite report for any potential rot or termite activity. Under California law, they are responsible for any rot or termite activity or damage. This is a custom made door and won't be easy to repair and could need to be replaced if the damage is extensive.

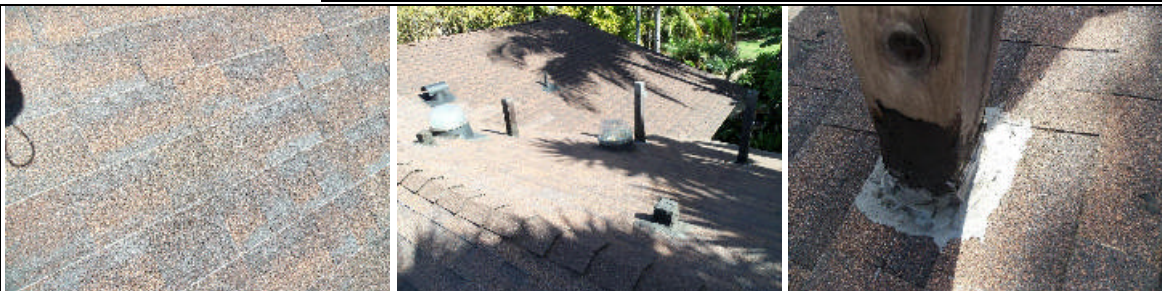
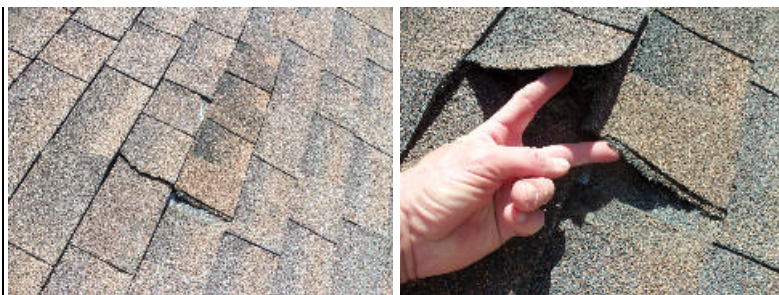
[CR] There are damaged shingles over the entry side of the kitchen wing that were very poorly patched and likely to leak. This needs to be corrected by a roofing contractor. Forth and fifth pictures.

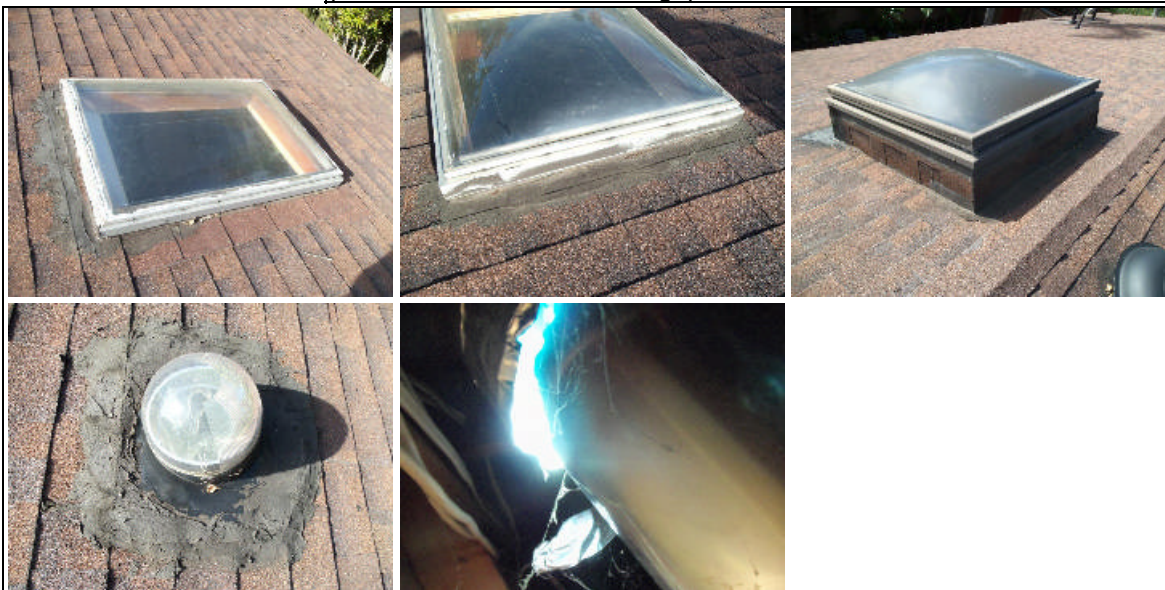
### 5.5 SKYLIGHTS:

[FE] [CR] The skylight(s) were installed in a substandard manner, which will increase there potential for leaks. You can either accept this increased risk or have them done properly. None of the skylights have proper flashings for a composition shingle roof. At least one of them has clear evidence of leaking. All of them have been patched which is usually an indication of attempts to solve past leaks. The frames are not secure. I am also not comfortable with the installation of the solar tubes. I noted that some of the seams for the tubes inside the attic were not sealed and have gaps which shows poor workmanship. Last picture shows one of those gaps in the tube in the attic.

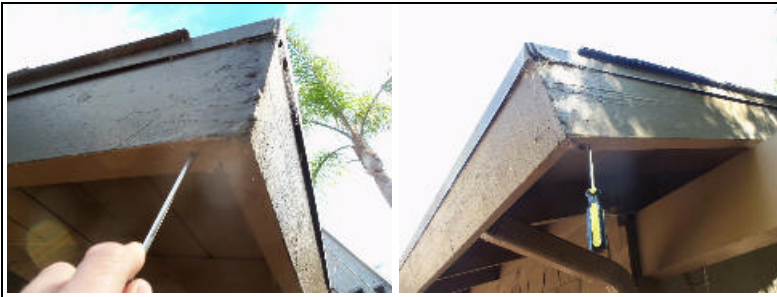
### 5.6 EDGE OF ROOF:

The wood at the edge of the roof is particularly vulnerable to rot and water damage where it becomes wet after every drizzle. You need to see the termite report for any areas of rot and the repairs that are to be made. Rot is there responsibility under California law and I try not to step on their toes, but I would not input this note unless I noted deterioration and suspected some rot in the wood.

[CR] The ends of beams or rafters that stick out past the end of the roof are very vulnerable to deterioration and possible rot if they are not flashed or protected in some way. I recommend putting a sheet metal cap on top of the beams where they are exposed that will protect against rot. I see too much damage caused to these exposed ends that could be prevented by this simple prevention. I have been making this recommendation for many years and now the 2008 code cycle explicitly requires this protection for any permits submitted after January of 2008.

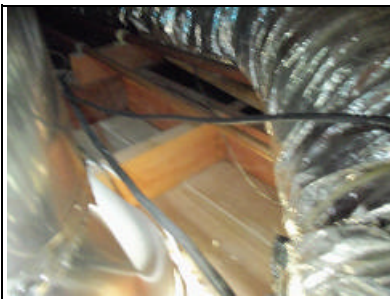
Picture shows lack of insulation.

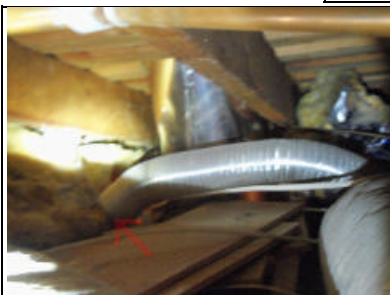
## 6.2 EXHAUST VENTS:

[CR] A bath vent fan is exhausting into the attic. They should extend to the exterior in order to minimize moisture being added to the attic. This can be very important in a cold climate where condensation is more of a problem, but doesn't cause as much of a problem in a mild climate like ours. However, correction is still recommended. Picture shows the bath duct terminating inside the attic.

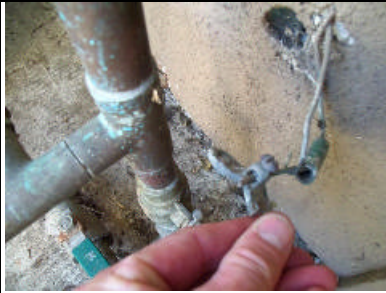
[SC] The ground wire clamp was loose and needs to be tightened on the hose bib on the left side of the house.

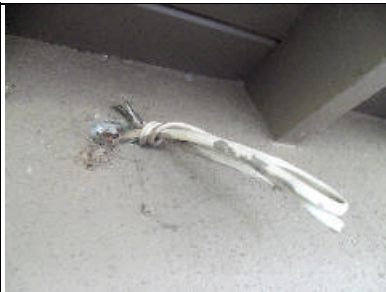
[SC] There is an exposed wire sticking out of the exterior wall above the side door into the master bedroom. This was likely stubbed out for a light that still needs to be installed.

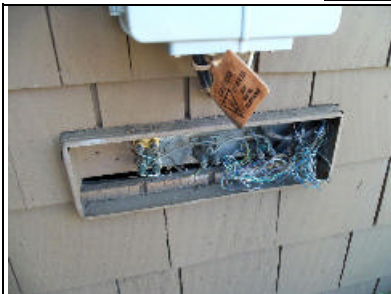
[CR] The cover panel for the telephone or cable connections is missing and needs to be replaced or installed.

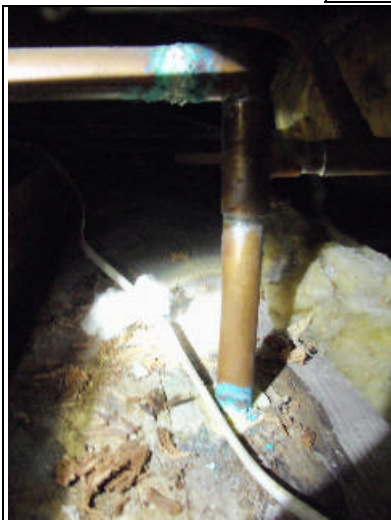
[FE] There are sections of the copper water line that have evidence of corrosion and further evaluation and any necessary repair is recommended by a plumbing contractor. This picture is taken in the attic to the left of the heater.

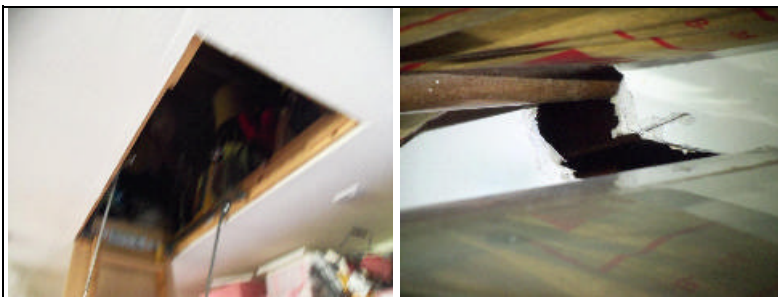
[SC] The attic access opening is a violation of the fire wall requirement for separation between a garage and any attic that is open to the area over the living areas. (first picture) There are no approved access doors or openings that meet this requirement except very expensive ones that I only see on commercial properties. The access opening should be closed off permanently. An alternative could be to create a fire wall separation in the attic over the walls of the garage, but this more difficult. Besides the stairway access into the attic, there are also holes up in the attic through the original firewall separation and the attic over the original house. (second picture is one example) In addition there is a large opening in the garage ceiling at the left front corner area that would allow the spread of flames into the attic and at least one smaller one over by the laundry area. All openings between the garage and the attic need to be sealed off as noted above or the attic over the addition needs to be sealed off and separated from the attic over the garage.

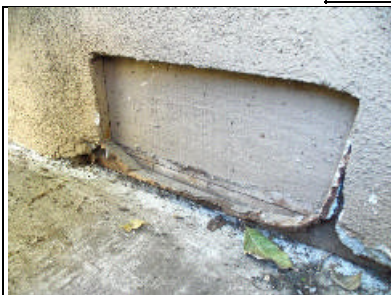
**[CR]** The combustion air vents were blocked or covered. These vents provide combustion air for the fuel burning appliances located in the garage and remove possible contaminated air from exhaust fumes. They need to be open. These vents were on the left side of the garage and were eliminated when the master bedroom closets were extended into the garage. Also see note in water heater combustion air section. Picture shows vent on left side of original garage that has been covered.

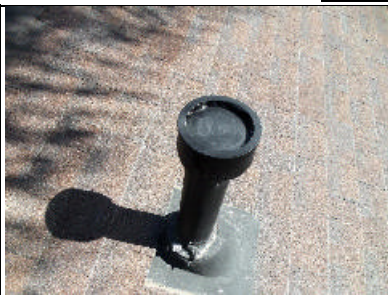
[SC] The termination used for the dryer vent is intended for a combustion gas vent and the openings are much too small for a dryer vent and it will clog up with lint. This can cause the dryer to overheat and be a serious fire risk. Also, the dryers efficiency will be very low because it will not vent properly. Install a proper termination. (When the duct terminates up through a roof, a T-top type termination or two 90 degree angles can be used to keep the rain out.)

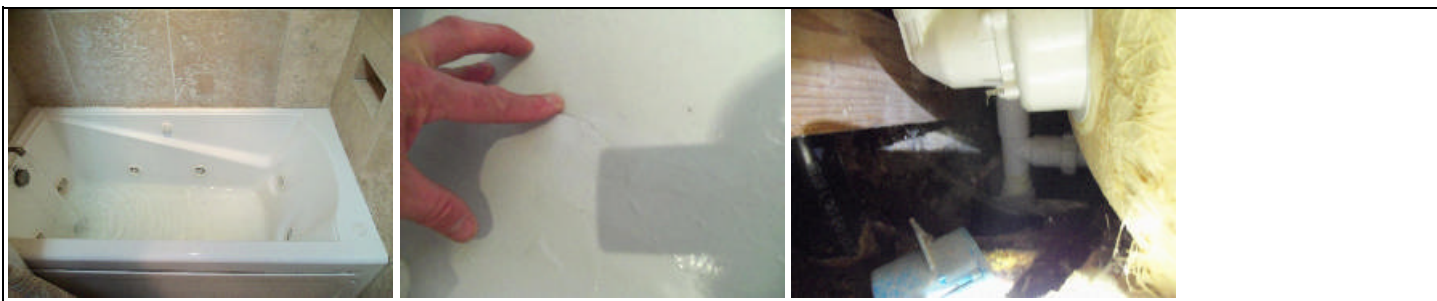
The second picture shows the crack in the fiberglass. The last picture shows the area under the tub. It may be difficult to see but it is all wet.

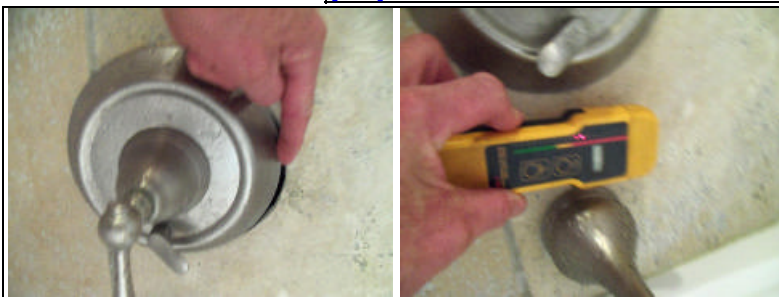
[CR] The hole in the tile wall is too large and there is no way to seal it.

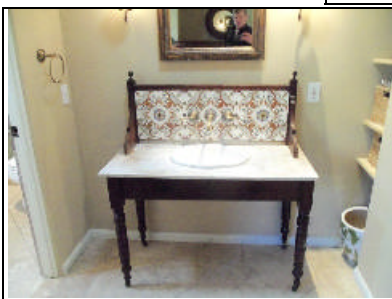
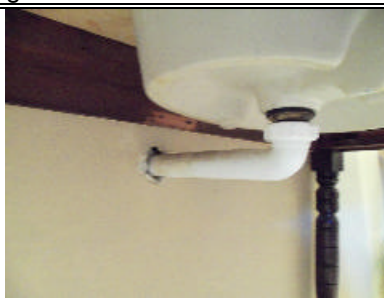
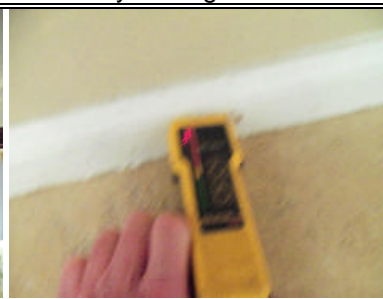
[NOTE] The moisture noted in the base of the wall below this sink is almost surely from the leaking of the tub in the other bath that is directly behind this wall.

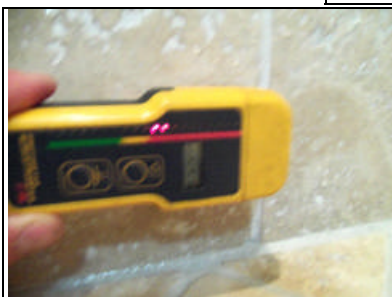
[FE] The trap for this shower was completely dried up. This could indicate that the shower hasn't been used in a long time in which case you should ask the sellers why it is not being used. If the shower is being used, then this will indicate that there is a leak in the trap which would require breaking out the base of the shower to replace the trap. In addition there is water damage to the wall directly behind this shower on the living room side which could be due to leaks in the shower pan. It is also possible that the water damage to the wall comes from the leak in the tub in the adjoining bathroom but since the water damage is outside the shower, not the tub, it makes me inclined to suspect the shower. Also, as seen the picture, there is an increase in the moisture reading on the tile inside the shower opposite the water damage on the living room wall. I did not take a picture of the wall on the other side. Clearly further evaluation is needed to determine the source of the water damage and the condition of the shower.

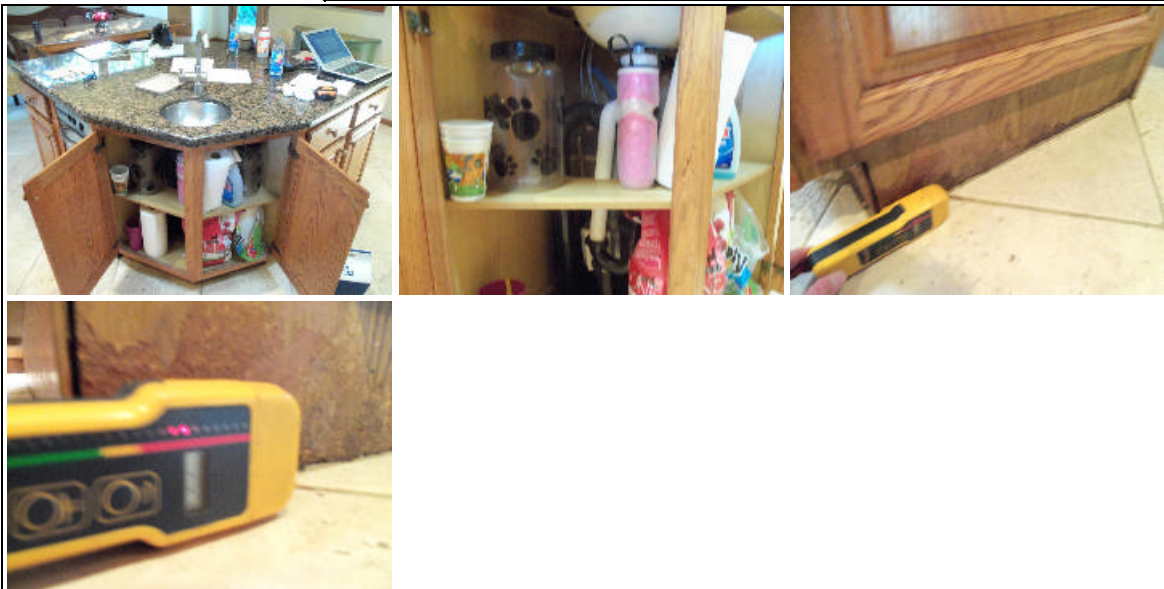
## 15.10 ISLAND SINK

[CR] I could not find any leak in the drain. However, the drain, the trap and the bent loop are not installed properly and need correction by a plumber.

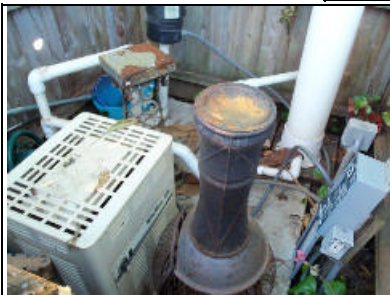
[FE] I could not test any of the spa equipment because the spa is not operational and the water level was too low. I strongly recommend further evaluation of all aspects of the spa by a pool contractor before the end of your contingency period. There could potentially be substantial problems that will not be discovered until it is made operational and tested.

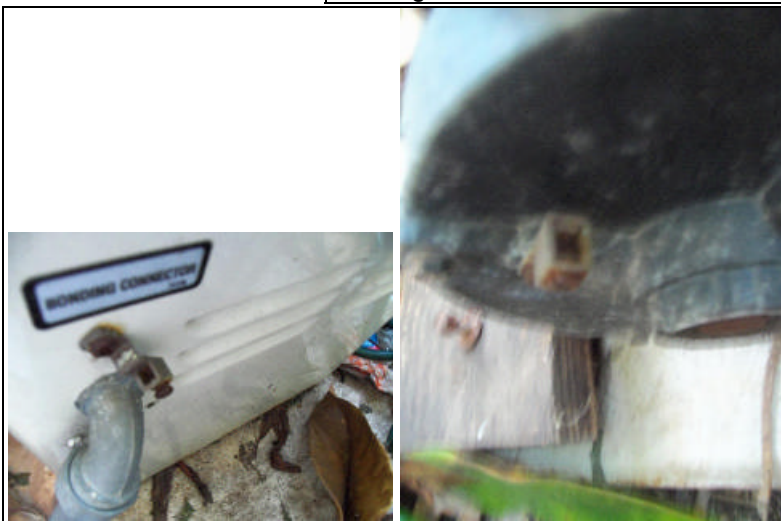
[SC] The pool equipment and metal components within 5 feet of the pool/spa lacked proper bonding. Further evaluation and correction is needed.

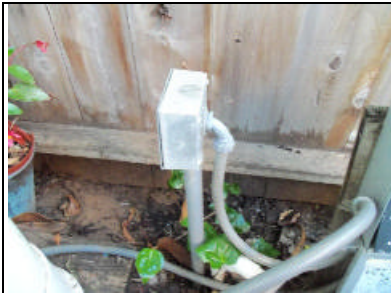
**16.7 ELECTRICAL:**

[SC] There is an electrical box that is supported only by an electrical conduit. This is not acceptable because the conduit is not strong enough and if it was to bend or break the wiring inside would be very vulnerable. The outlet is required to have a second means of support such as a post.

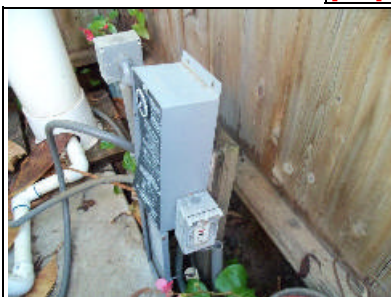
**16.8 .GFCI DEVICE:**

[SC] The waterproof cover needs to be replaced on the GFCI outlet.

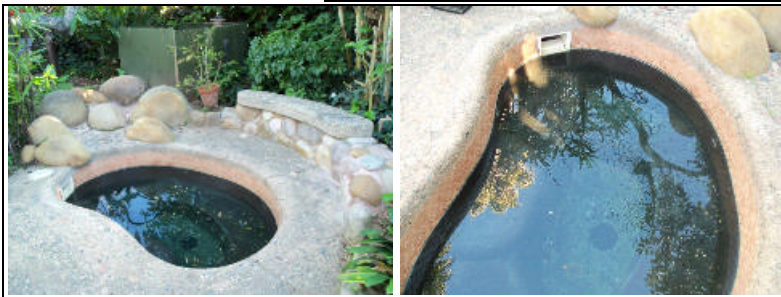
[FE] The plaster appears to be older and in the later part of its life. I recommend that you have a pool plastering contractor give you a cost estimate to replaster the spa, and an estimate of any remaining life and the risk of leaking as the plaster gets older.
