All Pro Home Inspections

STANDARD RESIDENTIAL INSPECTION AGREEMENT

Client Name:
Inspection Address: 1234 Main Street
EI Cajon, CA 92020

INSPECTION REPORT	9
STRUCTURE, FOUNDATION, CRAWL SPACE	13
EXTERIOR	28
ATTIC AREAS & ROOF FRAMING	42
ELECTRICAL SYSTEMS	47
PLUMBING	52
HEATING SYSTEMS	57
GARAGE - CARPORT	58
WATER HEATERS	59
BATHROOMS	70
INTERIOR ROOMS	81
KITCHEN	91

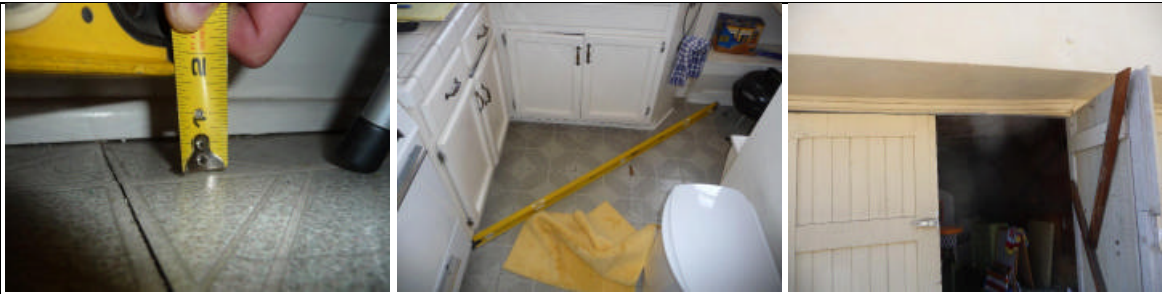
[FE] [FE] [CR] [CR] There are substantial and potentially serious structural issues with the back wall of the building with the garages and two units above the garage. The first problem is that there are no headers above the garage doors. (I was only able to see inside one garage, but assume they are all the same.) The only thing supporting the upstairs above the garage doors are a couple of top plates and some idiot even cut into part of that. This is weak and it is probably accurate to say that it is extremely weak. The floor directly above this door has a slope of about 1-5/8 inches under my 6 foot level. This is definitely substantial. Clearly something needs to be done. This will require removing and replacing all the doors and installing a proper header. There could be collateral damage to the building such as cracking and other damage when the floor is re-leveled. Because of the weakness in the overall wall structure discussed below, this repair needs to be designed by an engineer. I recommend that you have further evaluation at this time by an engineer and would be happy to provide you with names of engineers. The pictures are in the kitchen of unit 3325 1/4 which is directly above the garage door. The floor is off level in other areas as well but this shows the greatest slope.

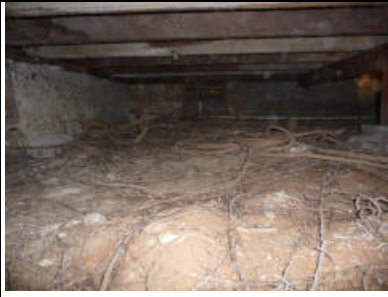
[FE] Note all the roots in the crawl space. This is a good indication that this crawl space is getting very wet in the rainy season.

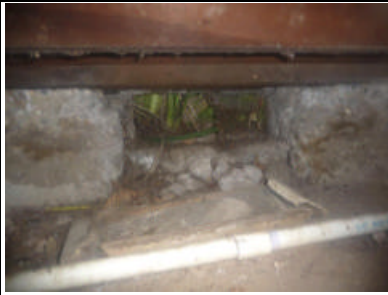
[CR] This vent is behind the planting area to the right of the entry. This is just one of several places animals can get under this unit. Also, note how high the soil level is on the outside in relation to this vent. Water in this small planting area can get into the crawl space.

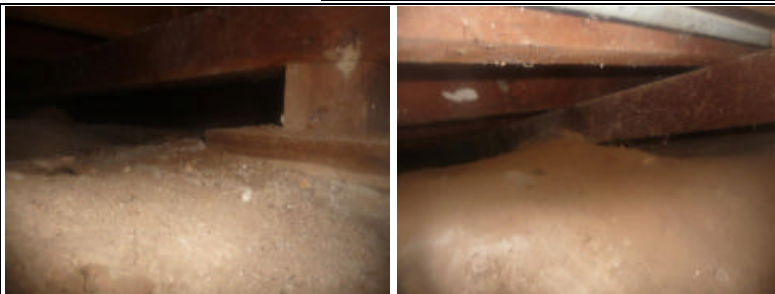
[CR] [CR] The clearance is substantially less than it should be and it will be difficult or impossible for anyone to get under some areas of the house. Soil will need to be excavated to provide adequate clearance under these areas, before any maintenance or repairs could be made. Furthermore, a lot of soil would need to be removed to comply with the standard clearance requirements stated above. Soil removal can be a substantial expense. There is only 4 to 6 inches under most of the beams with some sections having only 3 inches of clearance. One area in the picture below has soil touching the wood and this will greatly increase the potential for rot and termite activity. Judgment can be used to determine how much soil is removed, but clearly correction is recommended wherever the soil is touching or close to the wood.

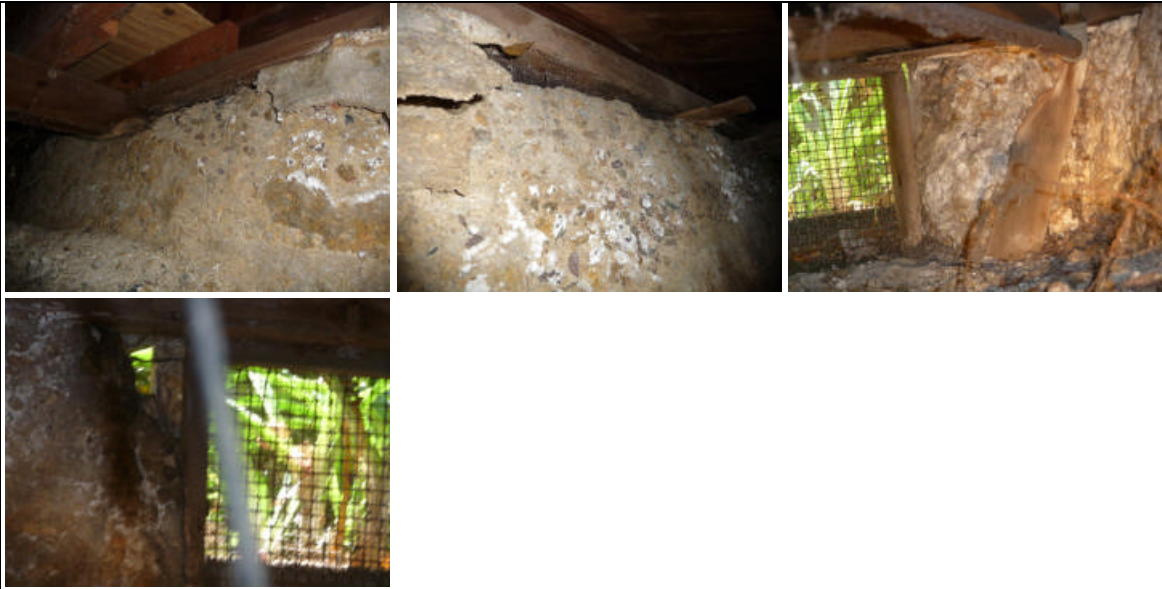
[CR] In the last two pictures, note that the deterioration next to the vent has created holes to the outside that a rodent could easily use and these need to be patched in for that reason.

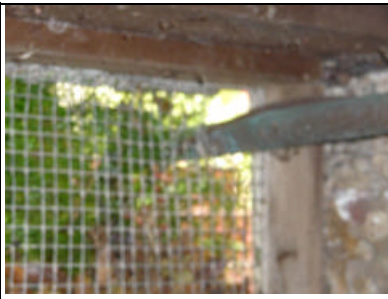
[CR] An example of a damaged screen with a gap around the pipe where a rodent can enter. Someone should check all the screens that have holes in them for pipes because several other also have holes.

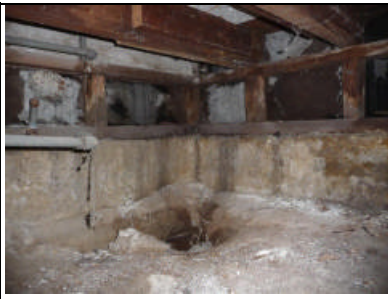
[NOTE] You can also note in this picture that there is damage to the building felt that is intended to keep water from migrating through the stucco onto the wood framing. This building felt has failed over the years due to water migration and I would assume that there are lots of other places where the building felt has failed. Most of them we just can't see. This area is visible due to the short cripple walls used in this building. Obviously any moisture penetrating through the outside wall onto the wood framing or into the wall cavity is not a good thing and increases the potential for rot, termite activity or mold. Unfortunately this is a common problem with any building this old. The only way to replace the felt to correct the problem is to remove and reinstall the stucco on the exterior of the building. This would be expensive. Most building owners for properties of this age choose to accept the risks associated with some moisture intrusion and do not replace the building felt and stucco. However, you need to understand the real risks associated with the moisture intrusion and accept those risks. One thing that can easily be done to lower the risk is to make sure that sprinklers don't hit the wall every time they come on and make sure any water running off the roof doesn't run down the face of the building or splash back onto the wall. Buildings like this without a roof overhang are more prone to this problem because more water runs down the face of the wall when it rains.

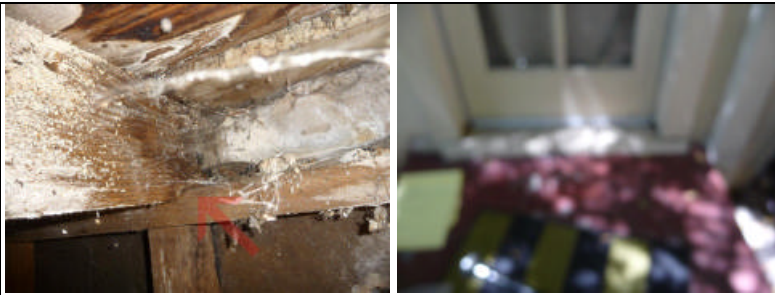
[CR] Also note that the joist below this door has crushed due to the water damage and also needs repair. This is best done by a framing contractor or foundation restoration contractor but the door installation contractor should also be able to do this if that works out better.

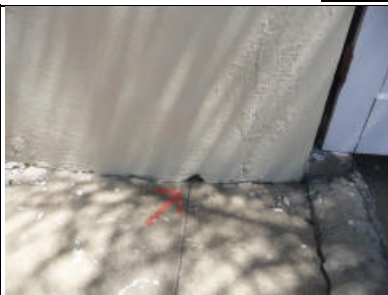
[CR] The outlet for water to escape at the S-W corner of the property in the picture is much too small. As best I can tell water runs from the back of the property to the front and a large portion of the property needs to drain out this hole. It could so easily be plugged with a little debris and back water up onto the property and under the crawl spaces. I strongly recommend that this opening be enlarged substantially.

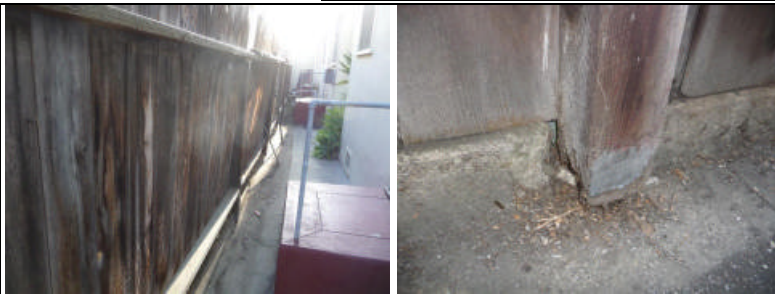
[CR] The fence at the right side is weak with a lot of deterioration in the base of the posts. The posts on the back section have been replaced but the rest of the fence is weak and leaning.

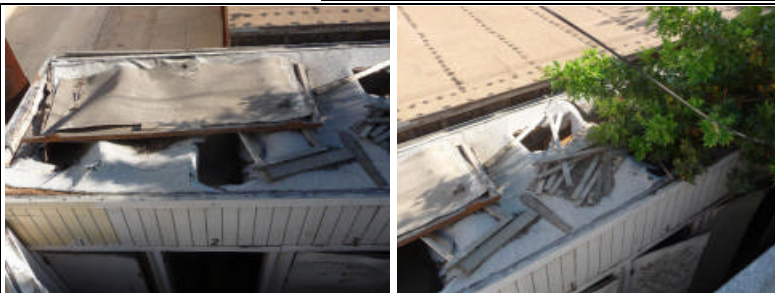
[CR] [CR] The shed at the back left of the property is trash and needs to be removed. There are huge gaping holes in the roof and lots of damage to the side walls. I consider it a hazard that needs to be removed.

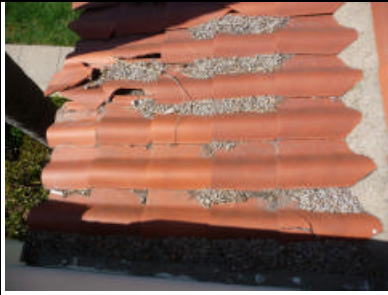
[CR] Each of the roofs has a small clay tile section over the entry porches. These are old tiles and it may be difficult to find matching tile. A couple of tiles are broken and need to be replaced on this roof. Many of these roofs have one or two broken tiles.

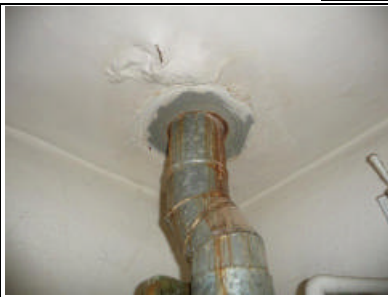
[FE] There are water stains or damage around the vent and roof leaks are suspected.

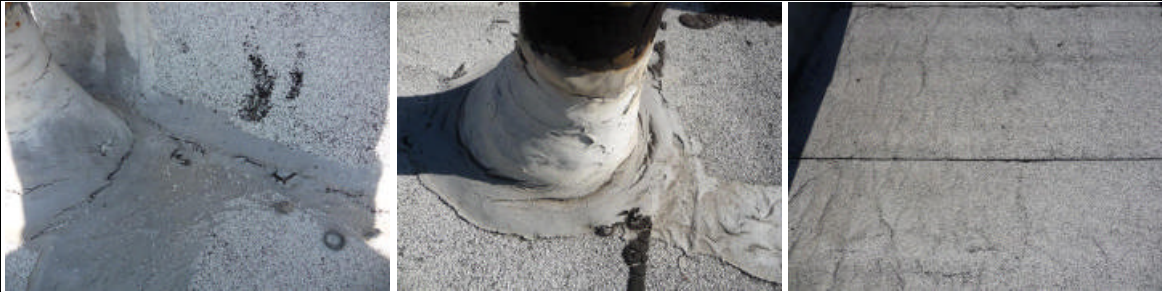
[CR] There are spots or areas with cracking or other deterioration due to aging, and maintenance or repair is recommended at this time. The entire roof should be inspected and repaired by a roofing contractor willing to certify the roof after the repairs are made. The roofing contractor should check the entire roof with special attention to the edges or any transition areas and make any needed repairs or maintenance. This is often called a roof 'tune up' and is a necessary part of maintenance to extend the life of the roof.

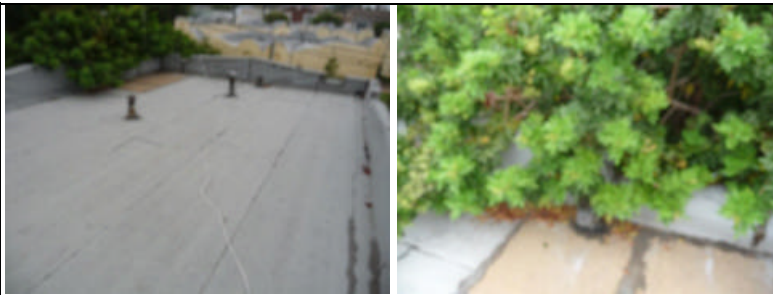
[CR] Trees or other plants need to be cut away from the roof as part of regular maintenance because they will often cause damage to the roof.

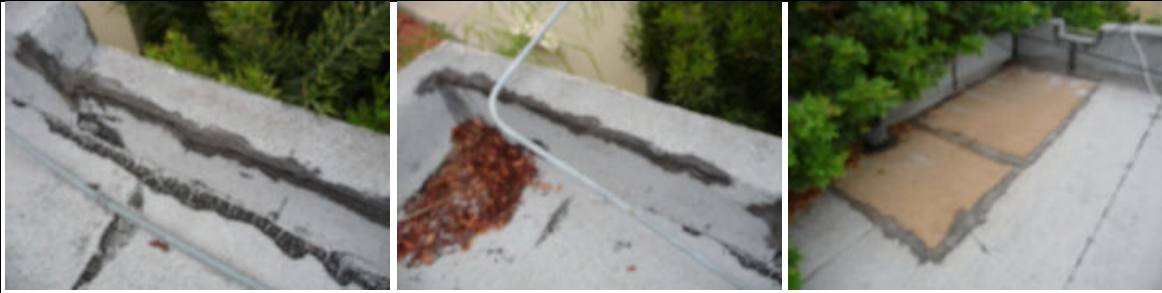
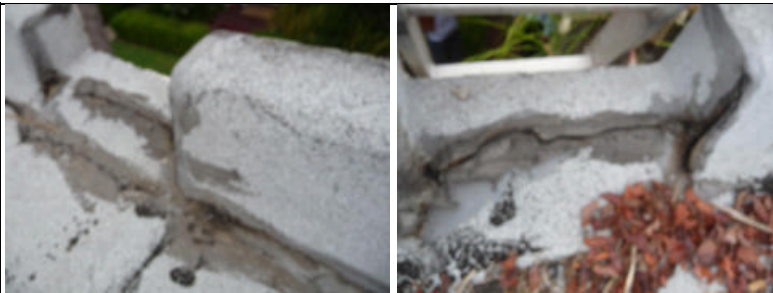
[CR] The roof has been patched close to the drain in the past and this almost certainly indicates that it has leaked in the past. The quality of this patch is weak and needs further evaluation by the roofing contractor.

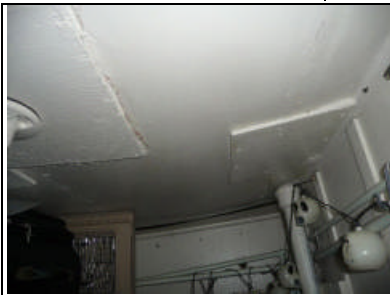
[FE] There are water stains on the ceiling of the closet below this unit and the tenet stated there had been a little leaking. I couldn't really see the roof from the top due to all the pine tree droppings.

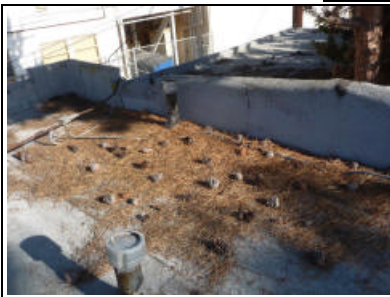
[CR] Note how difficult it will be to maintain this roof and keep the drain clear with the pine tree. Note how close the tree is to the house. Pine trees can cause substantial damage to foundations and are also substantial fire risks.

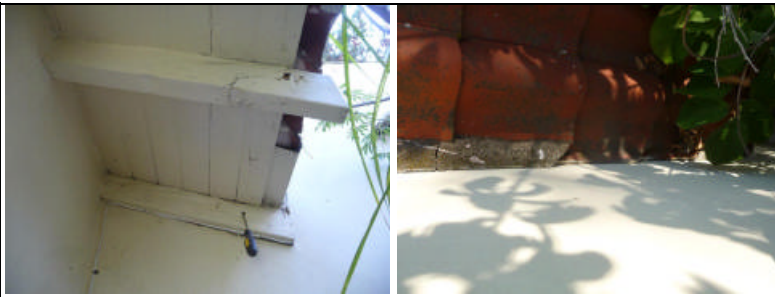
[CR] There is water damage to the wood of the eve to the right side of the entry. I am concerned about the risk of leaks from the roof above.

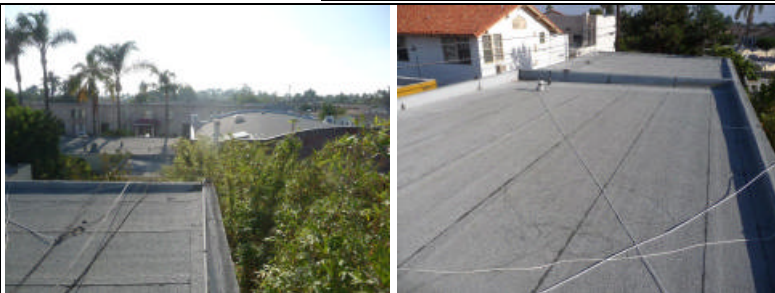
[NOTE] Siting down the edge of this building, it is clear that there is either a jog in the property line, or either this building or the neighbors building is over the property line.

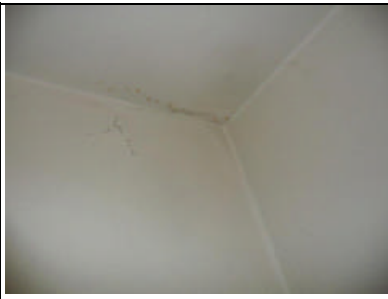
[FE] There is water damage to the wall above the tub for unit 3325 1/4 and there is also damage to the tile wall directly below this. I suspect that this is directly below the roof drain. I don't know if this damage was done before the current roof was installed or not. But, due to the problems seen with so many of the roof drains, I can't help but be worried that this one is leaking also. Both the wall and ceiling in the picture are soft and this damage was caused by a leak from above.

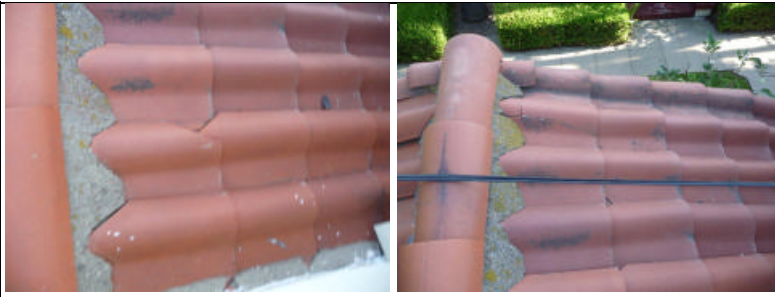
[CR] Replace broken tiles.

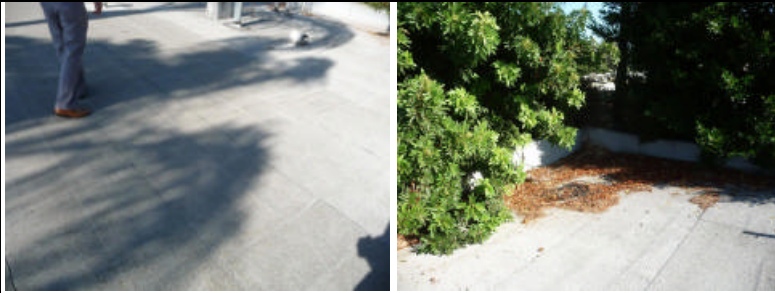
[CR] Trees or other plants need to be cut away from the roof as part of regular maintenance because they will often cause damage to the roof.

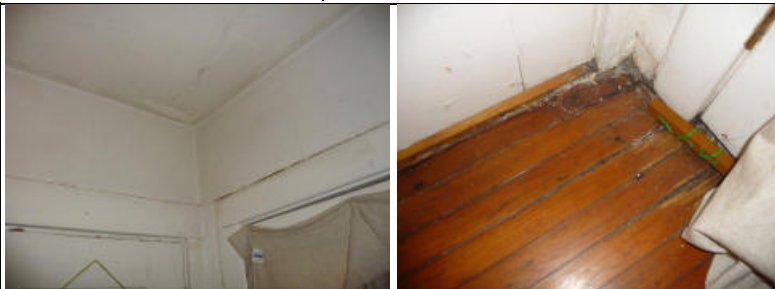
[FE] These pictures show water damage on the ceiling and floor at the back of unit 3329 that is approximately below the roof drain or scupper. I am not sure if this has been repaired but suspect it is active. This again shows the poor installation of the roof drains and how the roof drains have not been properly integrated and sealed into the newer roofs. At least three and possibly four of these roof drains have leaked on the newer roofs. I would definitely get a different roofer. Assuming that the same roofer did all the roofs, that is a very high failure rate.

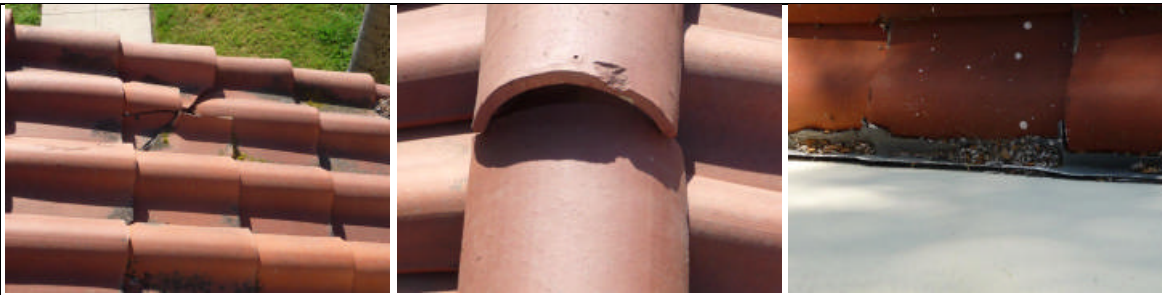
[CR] The clay tile section has broken tiles that need to be replaced. Also, the ridge tiles are all loose and need to be secured and they do not have the proper overlap.
[CR] Where the clay tile meets the wall, there is a gap that has opened up and should be sealed. This is a weakness with many of these roof sections.

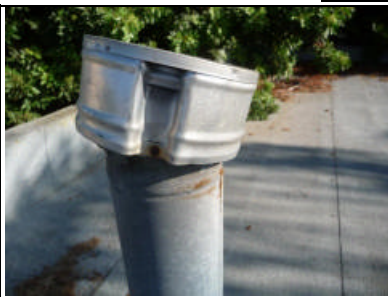
[CR] Replace the damaged vent cap.

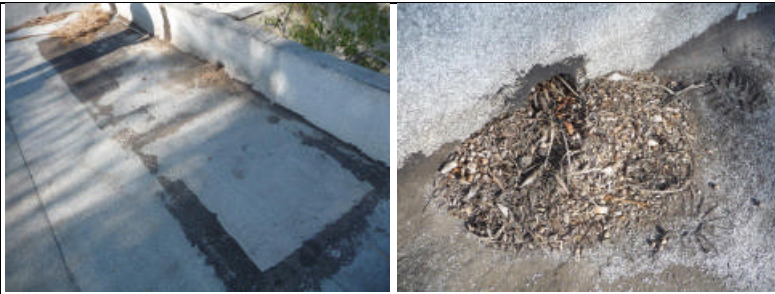
[CR] The drain is clogged with debris and too small. Keeping them clean with all the trees will require continual maintenance.

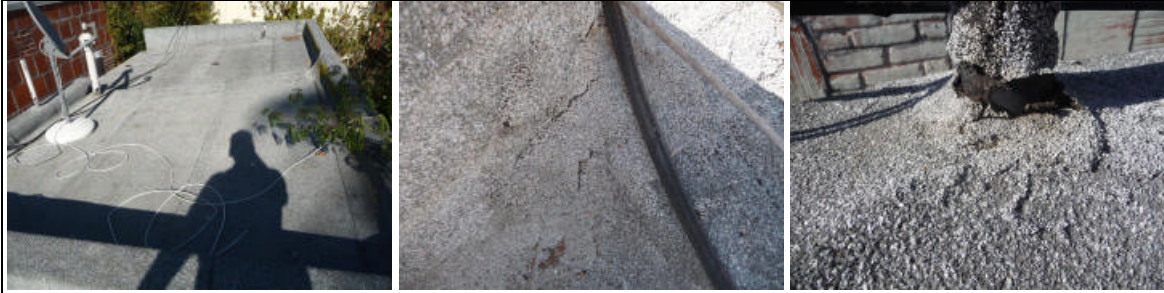
[CR] Due to the structural settlement of the back wall of this unit the roofing material is cracking in the corner. Also, this wall has settled and this is clear in the second picture where the wall has literally slid down the vent pipe. When the wall and the foundation issue is corrected, the roof will need to be checked to make sure it is sealed.

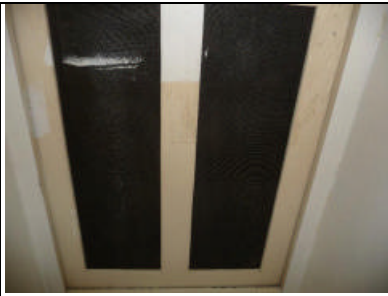
I found access into the attic at the following location(s): in bedroom closet of each unit. The picture shows a large screen that will allow a lot of air movement in unit 3331. This can allow a lot of hot attic air to enter the home.

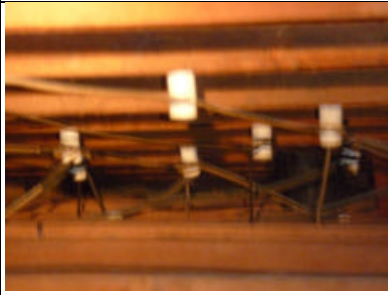
This attic is not insulated and before insulation can be added to the attic, state standards require that the knob and tube wiring be inspected and certified as safe by an electrical contractor, and that only non-conductive and non-flammable insulation can be used. That means no paper faced or foil faced batt insulation and no cellulose insulation. Loose-fill fiberglass or un-faced fiberglass insulation is accepted.

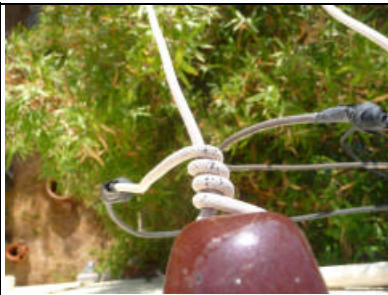
Note the cracking and deterioration with the insulation at the back edge of 3325 1/2.

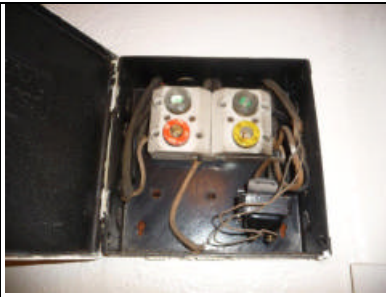
In the third picture (unit 3329) you can clearly see the fused neutral. Also, [SC] Double lugging was noted at the circuit breaker(s) in the panel. This is where two circuit wires are joined together at one breaker and is easy to fix, as long as there isn't a problem with capacity.

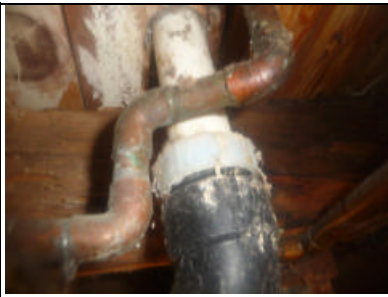
[CR] The cheap thin wall white PVC drain components are not approved for use in a crawl space. This material has inherent weaknesses and is not recommended anywhere, and should never be used in any place where a leak can go undetected for a long time. This material was used for the tub drains for many of the units and runs through the floor into the crawl space. All of the drain below the floor level needs to be thick walled ABS. This picture is for unit 3325, but all the bungalows have a similar issue.

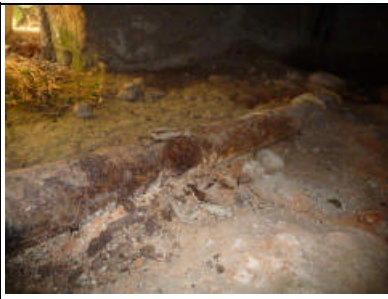
[CR] The drain line to the kitchen sink needs to be replaced.

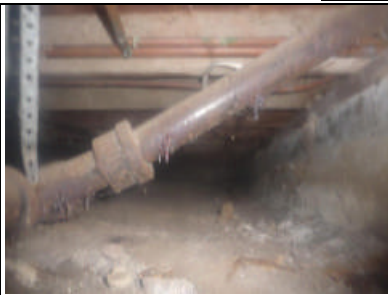
[CR] Drain lines to kitchen sink and below tub.

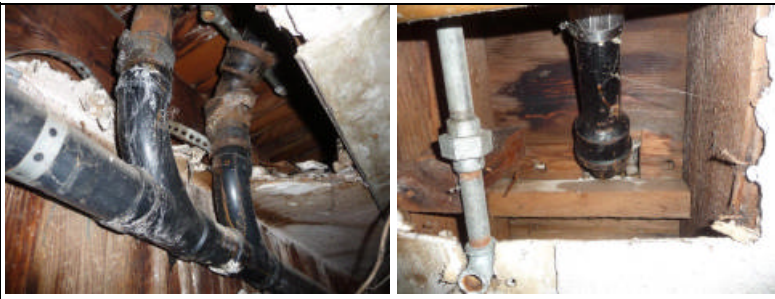
[CR] Sections of cast iron in the ceiling above the garage need to be replaced.

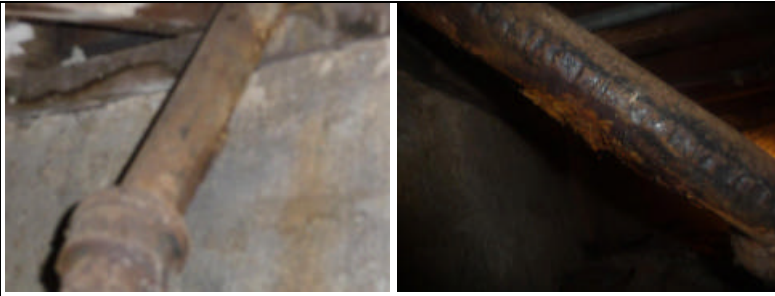
[CR] To bathroom sink.

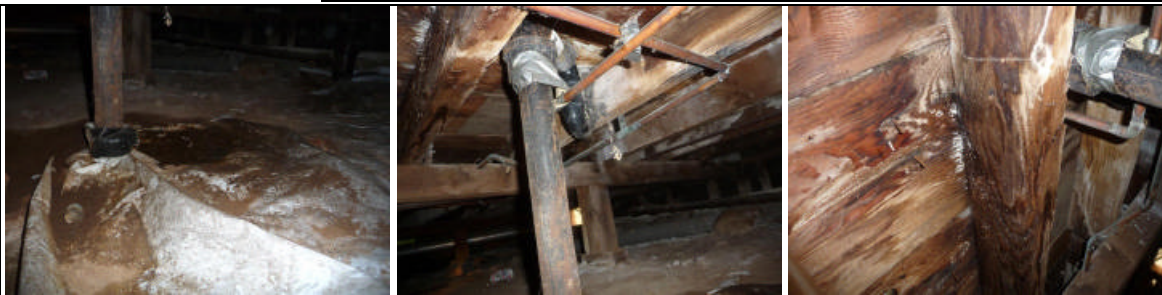
[CR] The soil has a large wet area below the tub of 3331. The wood is wet and this could just be from water splashing out of the tub because the tenants aren't being careful with the shower curtain.

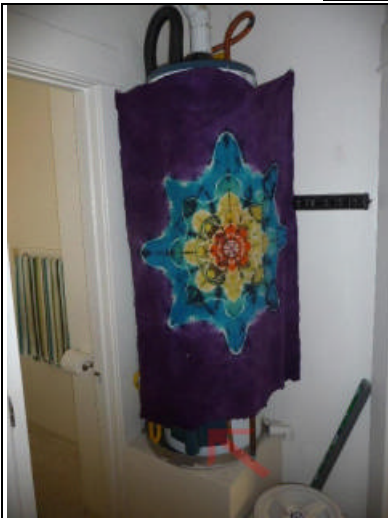
[SC] There should not be anything flammable in front of or close to the access panel to the burner assemble. This can be a fire risk. This cover needs to be kept at least 12 inches above the door panel to be safe. (See installation instructions for details.) The top is fine as long as it does not go above the top of the tank.

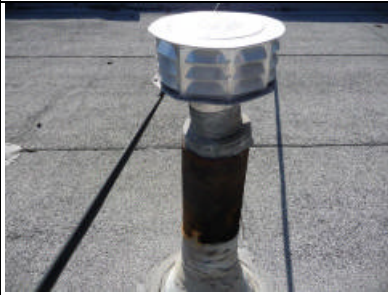
[SC] The water heater uses a piece of cast iron sewer drain pipe for a vent. I recommend that a new metal B-vent be installed for a couple of reasons. The current vent is likely original, which would make it well over 80 years old and prone to cracks. Any crack could allow dangerous amounts of heat to escape and this could be a fire risk. This material was never approved for a vent because it allows too much heat transfer. A new 3 inch B-vent will fit up inside this old larger vent and be easy to install without any alteration to the roof. Besides the potential risks with the cast iron section, there are other problems with this installaiton. The connections at both the cap on the top and the sheet metal duct on the bottom of not good. Water leaks in at the top and I am concerned about combustion gas leaking at the bottom. This same alteration is needed with several of the other vents in other units. Any unit with an original vent needs to be replaced. That's about 5 or 6 units.

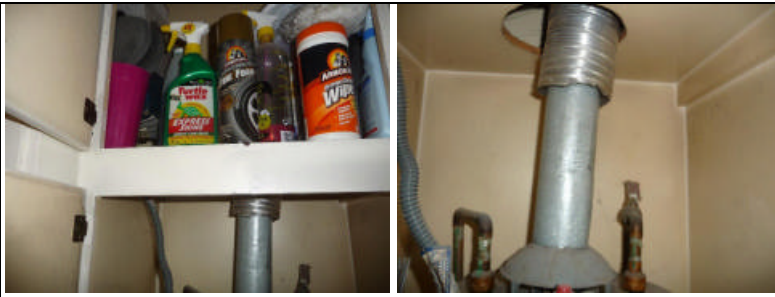
[SC] The vent was too close to or in contact with combustible materials, and this condition can be a fire hazard that needs to be corrected. There is a serious potential hazard whenever there is a shelf or storage next to, or close to, the vent that someone could place a flammable item on that could touch the vent. This is a fire risk. The shelving needs to be removed to prevent someone placing an item close to the vent.

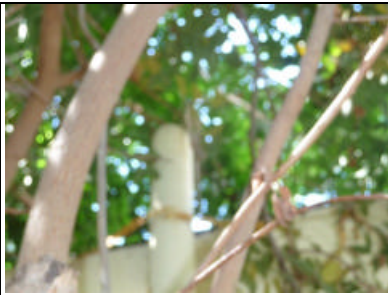
[SC] The vent cap is missing on top end of the vent and it needs to be replaced. I am also concerned about the tree branches being so close and this is another reason to remove the tree.

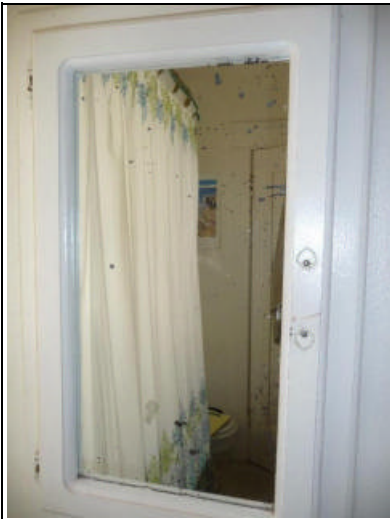
[CR] Also, note that the handle is missing. The handles were missing in a few other units as well.

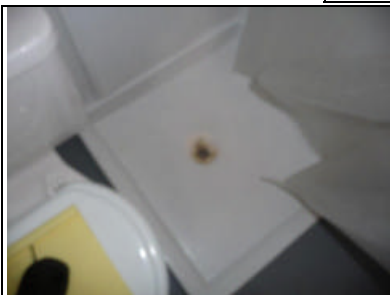
[FE] Very funky shower. Has exposed wood inside shower will be difficult to maintain. You should consider replacing it with a modular shower unit if you decide not to tear down the entire unit.

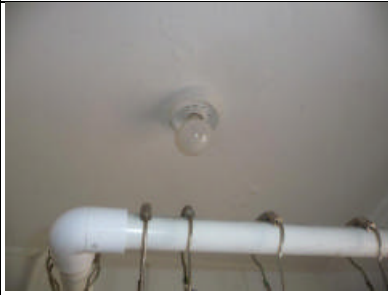
[SC] To meet current standards any light above a shower needs to have a sealed lens or cover to keep moisture out of the fixture. The light should be replaced with an approved fixture that can have a sealed lens installed or a sealed lens should be installed with this fixture to keep steam and moisture from going up into the electrical components.

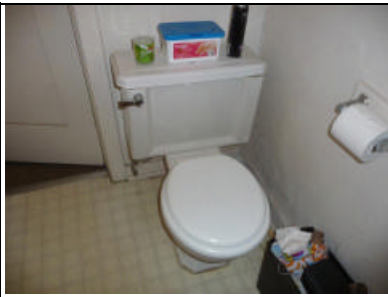
[CR] The toilet rocks or is not firm and needs to be secured properly to the floor. Any toilet that rocks is likely to start leaking at some point. A plumber should make the repair and check for leaks. It may be necessary to replace the wax ring that seals the base of the toilet. Also, the lid doesn't match the toilet tank.

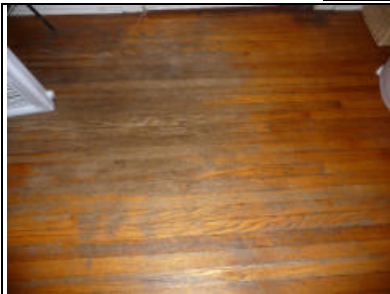
[CR] The hardwood floor has been sanded down over the years and this makes it more risky, or not possible, to sand it down again. When the floor is sanded too far the nails can become visible and the top edge on the flooring will become thin and weak. I can see places where the top lip of the flooring is cracked, loose, patched, or missing. The heads of the nails have become exposed in some places.
