All Pro Home Inspections

STANDARD RESIDENTIAL INSPECTION AGREEMENT

Client Name: John & Mary Sample
Inspection Address: 1234 Dream Street
La Jolla, CA 92037

Date: August 8, 2011
Time: 8:00 AM

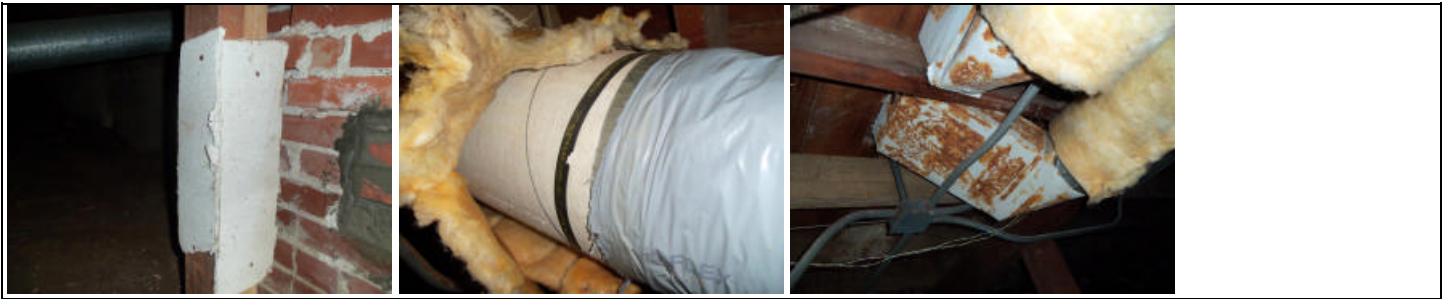
The thin grayish material on the sheet metal register casings most likely is asbestos. The asbestos material generally does not, and should not, come in contact with the air flow and when left alone should not cause problems.

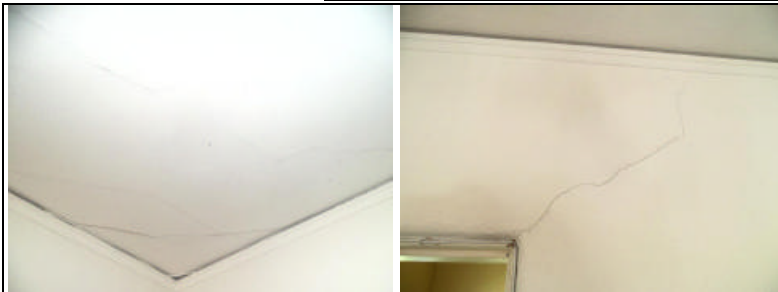
The wall above the master bedroom doorway is cracked due to settlement and is very likely due to the same thing that caused the out of level floor noted below. A couple of other similar cracks were noted above other doors.

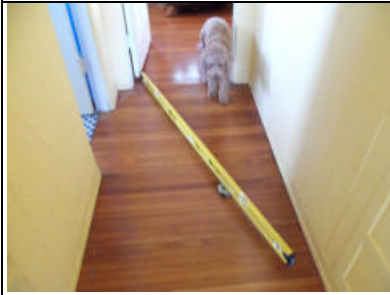
2.2 FLOOR LEVEL:

[FE] The floors throughout the house have some minor to moderate variations, most of which are not unusual for a home of this age, and are often due to differential settlement of interior piers in the crawl space. There is one area however that has a more substantial slope to the floor. This is at the end of the upstairs hall where the slope is between one and 1-1/4 inch in less than five feet. I can't be sure what caused this and recommend further evaluation. The foundation was in surprisingly good condition and the only framing issue I noted in the crawl space is discussed in that section below. It is possible that this slope is related to that framing issue but an engineer would need to do further evaluation to determine if that is true. The floor on the lower level below is also out of level but not as much as this and is spread over a wider area. There are some cracks in the plaster but not nearly as much as I would have anticipated with a floor slope like this. It is also possible, but unlikely that the floor was originally framed with some slope. There is a crack in the tile floor in the bathroom next to this area so it is clear that there has been movement since the original construction. Don't hesitate to call if you would like to discuss this further.

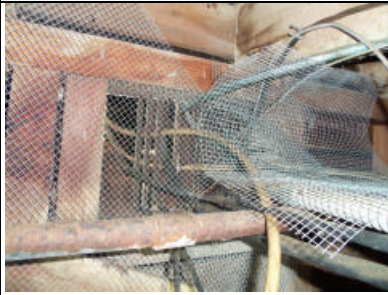
[CR] The vent at the back of the crawl space that goes to the area under the back deck has large gaps that will allow rodents to enter. The others generally look good but should be checked.

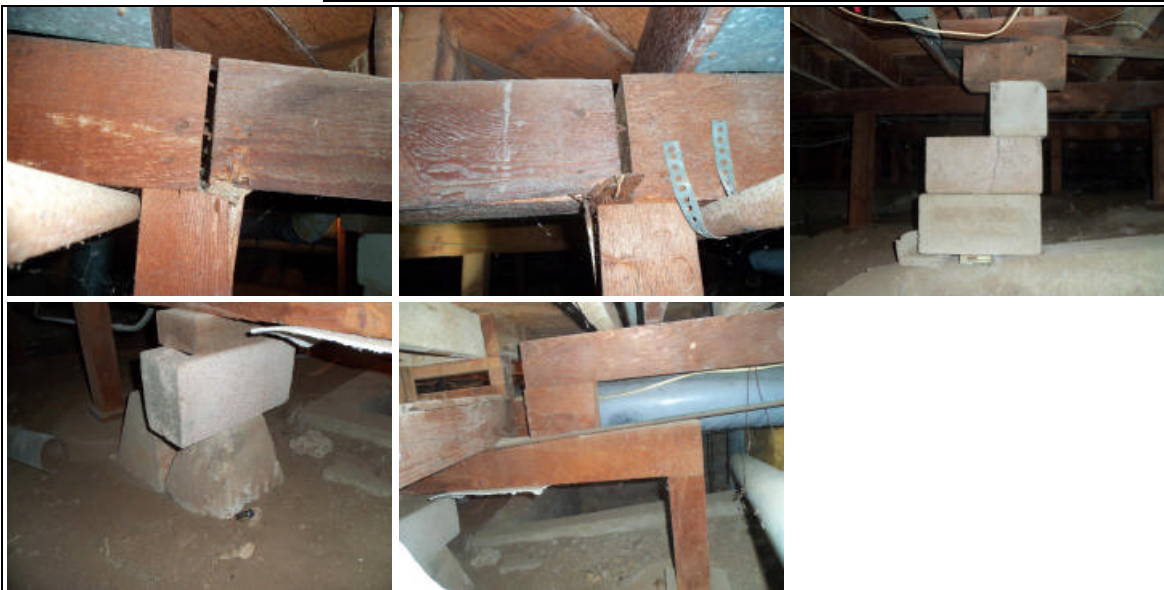
Further evaluation and upgrading the integrity of these components is definitely recommended.

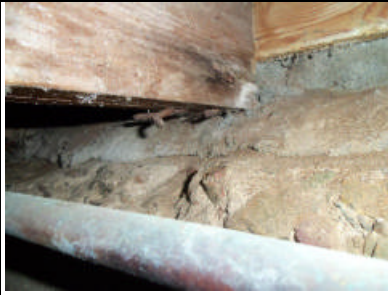
The area under the front door has the same problem with leaking but seems to be supported better.

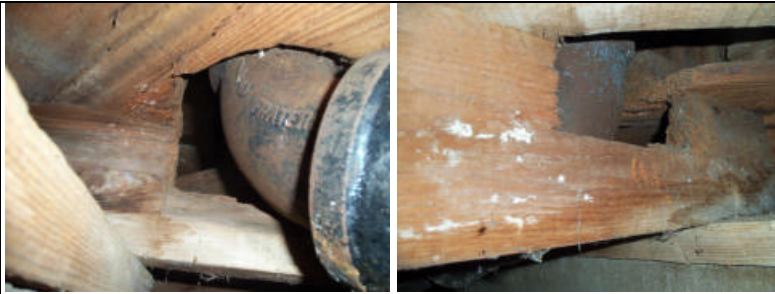
2.15 FLOOR JOIST

[CR] One of the floor joists close to the front door has been cut through to install a drain line. I recommend installing a new joist next to it to improve support.

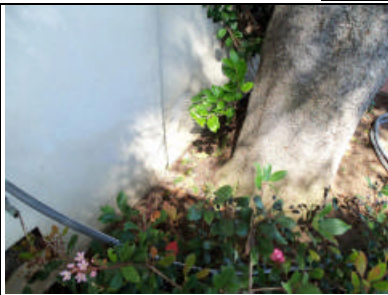
[CR] Tree(s) were planted too close to the building, and you may need to consider removal. As the trees continue to grow in size, they may damage the foundation or the roof. Consult a landscape contractor or arborist about the risks of particular trees. This tree is at the corner of the house close to the water heater and is the most likely to be potential problem. I did not see any cracking to the foundation in this area but there is still risk. The tree is large and much too close.

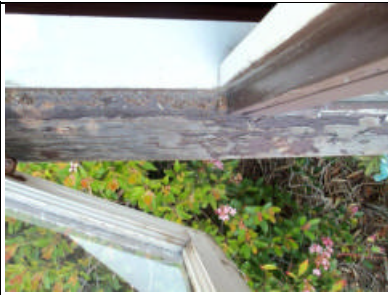
[CR] The exteriors of the windows need general maintenance such as scraping, patching and painting, particularly to the window sills on exposed windows on the south and west sides like this one. Maintaining the sills is critical to making them last and keeping water from leaking into the wall. A couple of the living room windows on the front and left side had evidence of water leaking. See interior notes.

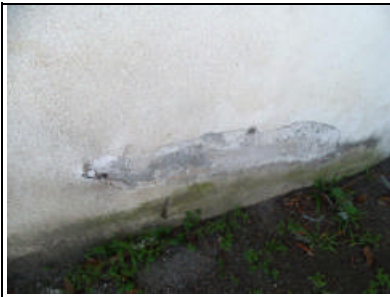
[CR] There is some spalling or deterioration noted to the stucco that needs to be patched by a stucco contractor at this time.

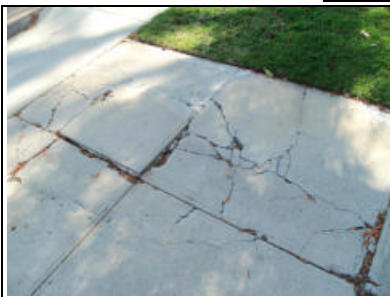
4.6 DRIVEWAY:

[CR] The front left corner area of the driveway has substantial cracks and damage.

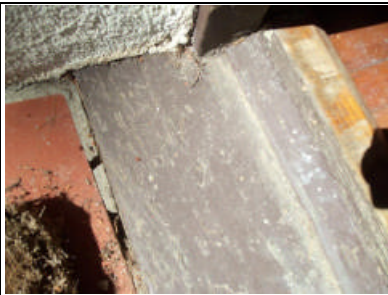
[CR] The tile at the entry porch is as high as the top of the door sill and very close to the interior floor level. This would not be allowed today because this can trap water in the sill and increase the chance of water leaking onto the floor. The exterior floor level should be under the sill. In addition there is framing lumber under the door sill that does get wet and can be vulnerable to rot. From the crawl space, I can see that this wood is getting wet but it appears to be in good condition none the less. Fortunately the wood is heart redwood which is very resistant but not impervious to rot. (If it was more modern wood, it would have rotted in a relatively short time.) I recommend that you seal any gaps to minimize the water that leaks onto the framing lumber below and then accept any remaining risk of rot.

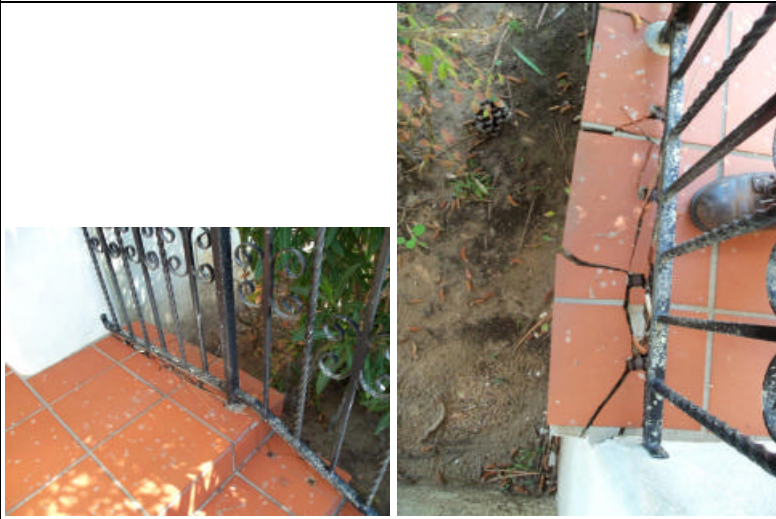
[CR] An old iron railing was cut off at the top of the tile and this old railing has cracked the concrete due to the tremendous pressure developed when steel or iron rusts and expands. This section will need to be broken out and patched back in.

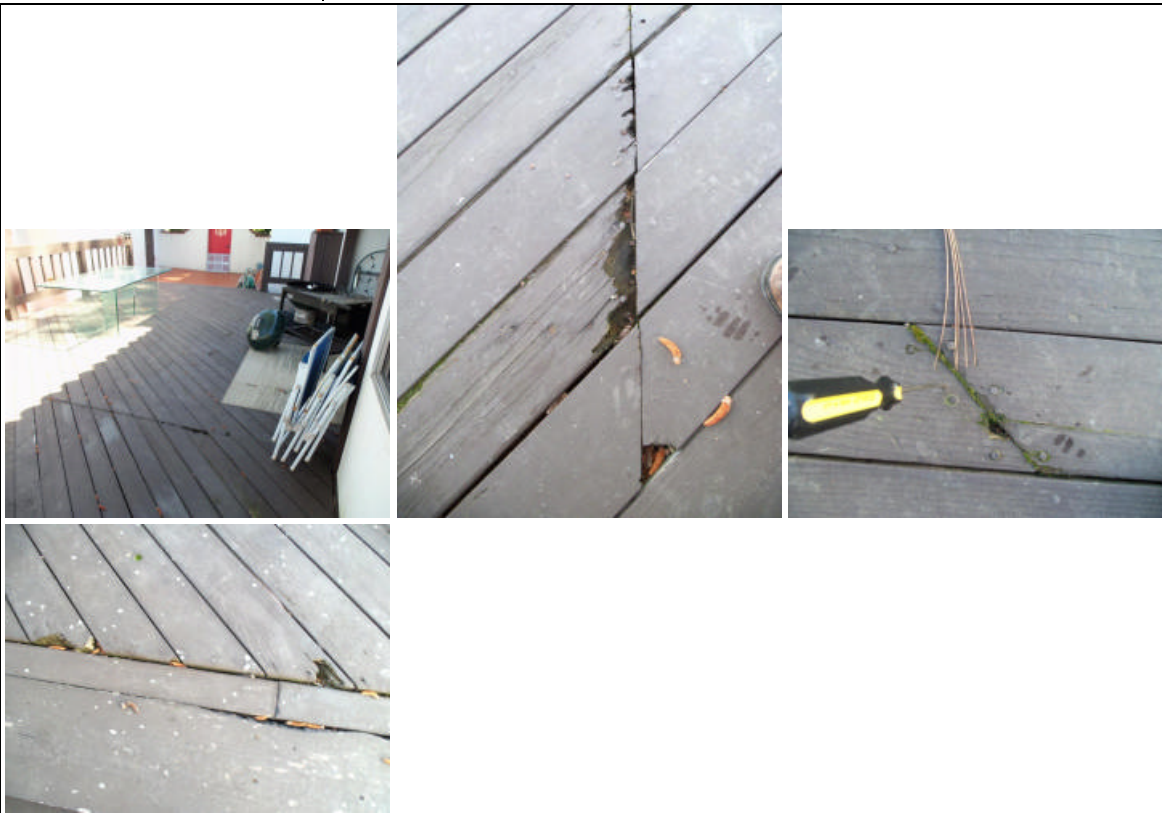
[CR] There was damaged or deteriorated wood noted in quite a few locations and the damaged wood should be replaced. See the termite report for any potential rot or termite activity. Under California law, they are responsible for any rot or termite activity or damage.

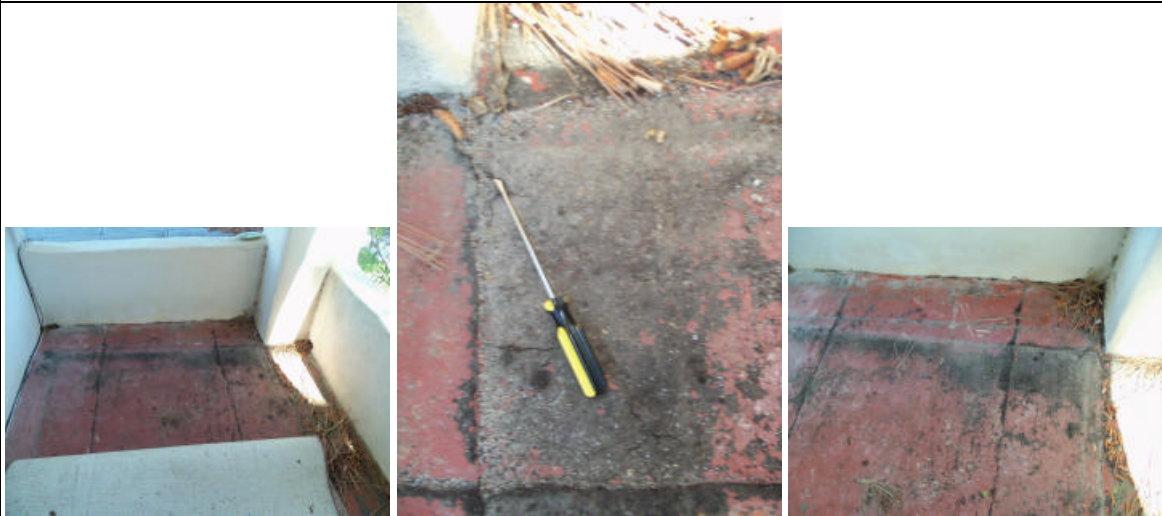
4.13 COVERED DECK OVER BREAKFAST ROOM

[CR] This decking material is completely deteriorated and I am sure that it leaks. There is just a little peeling plaster on the ceiling of the breakfast room which is likely due to leaks and the only thing that prevent larger leaks is the roof covering this deck.

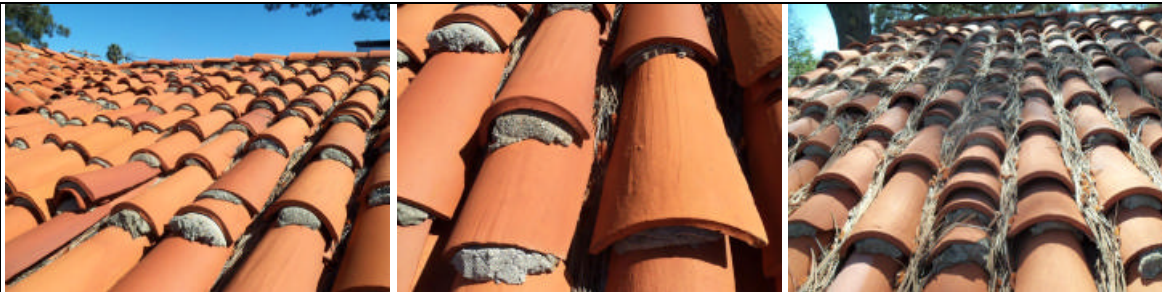
[FE] The roof is at or near the end of its economic life. Have a roofing contractor estimate the cost of re-roofing, and also give you his best estimate of any potential remaining life and the risk of leaks. Ask the roofer if it makes better economic sense to make repairs or replace the roof.

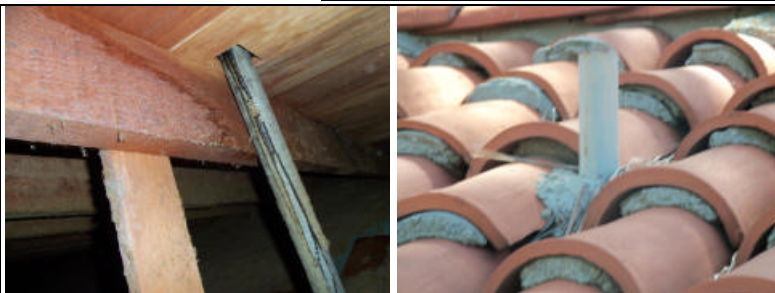
5.2 FLASHING:

[CR] There are no secondary metal flashings around the plumbing vents and the mortar is old and deteriorated and leaks are likely.

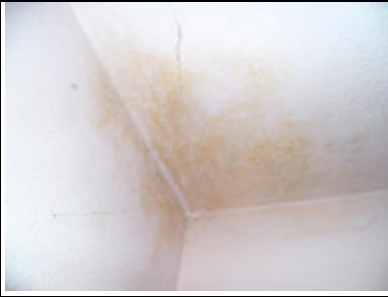
5.3 LEAKS:

[FE] This water stain is in the upstairs bedroom at the back left corner of house.

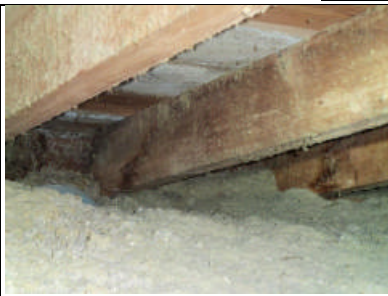
**5.4 LEAKS**

[FE] Leaks in corner of front right bedroom.

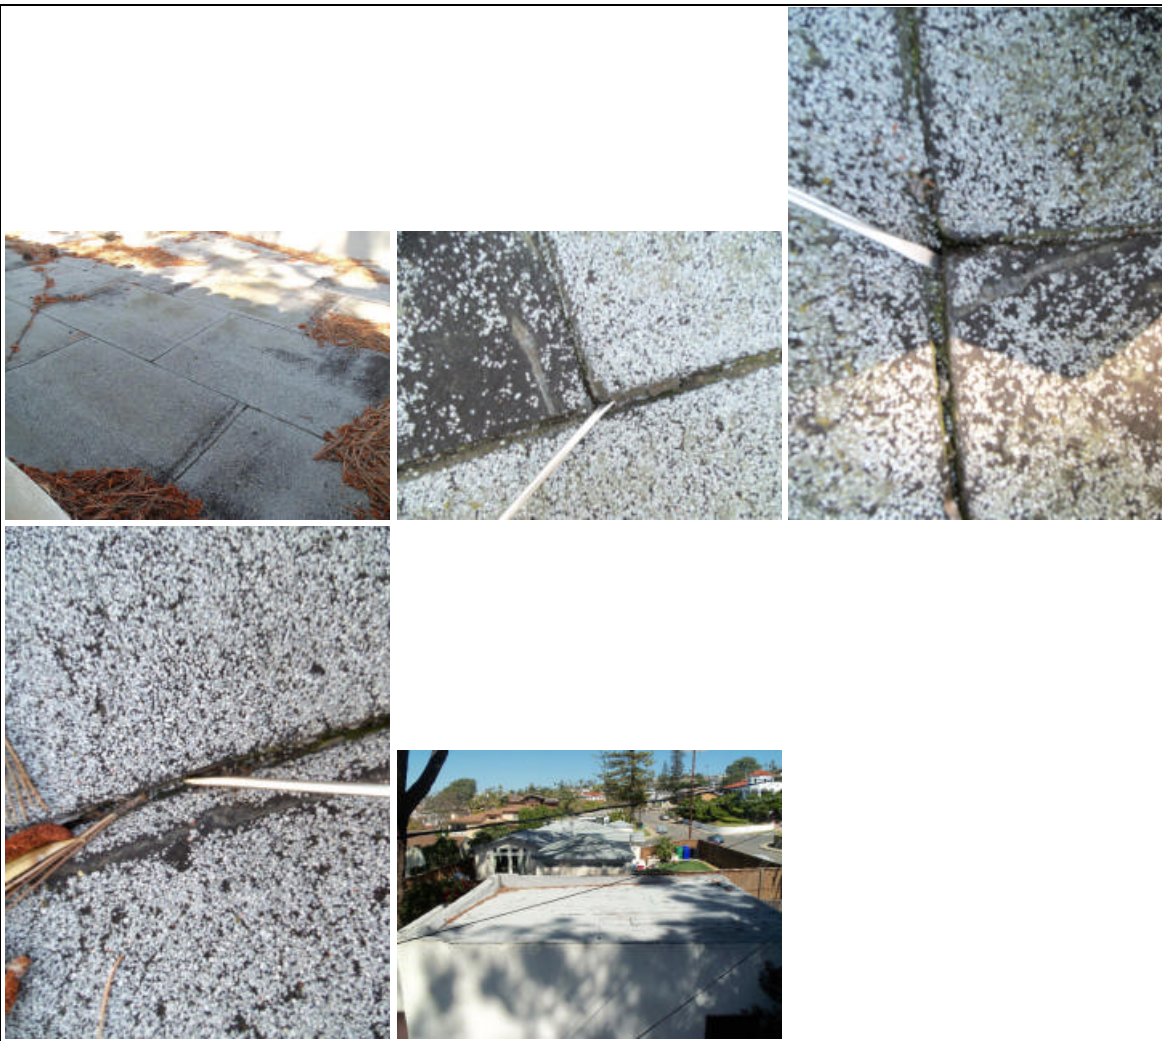
[FE] [CR] There are hot mopped roofs with a granular cap sheet over the back section of the house that is one story and over the garage. Both of these roof areas are relatively old. Both sections need further evaluation by a roofing contractor to determine if they can be patched or need to be replaced. I am most concerned about the section over the house. It is an unusual installation where the cap sheet is not overlapped. The seams are butted and they are coming loose. I doubt that this section of the roof can be salvaged and recommend further evaluation by a roofing contractor.

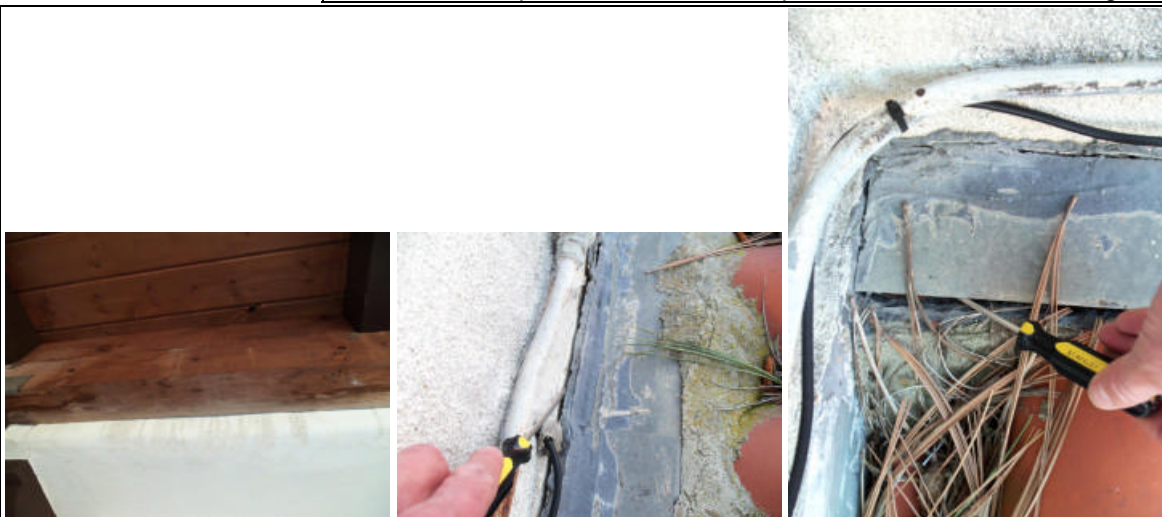
5.7 OVER PATIO

[CR] The roof to wall flashing between the patio roof and the house wall is poorly installed and has come open and it leaks. First picture shows water staining from the underside.

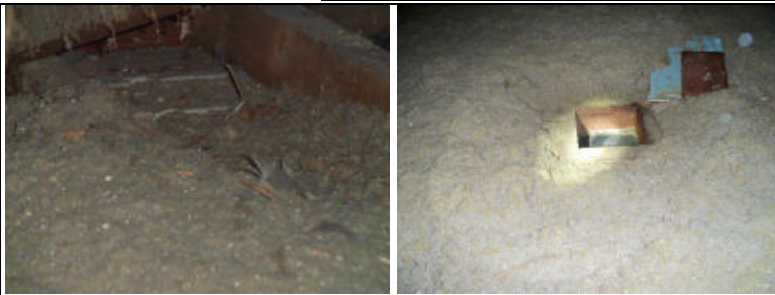
[CR] There are vent openings in the ceiling that opens directly to the attic. This is an old way of venting closets that is no longer used today because of energy conservation concerns and I recommend that it be sealed off to keep warm air from escaping in the heating season and hot attic air out of the house in the summer.

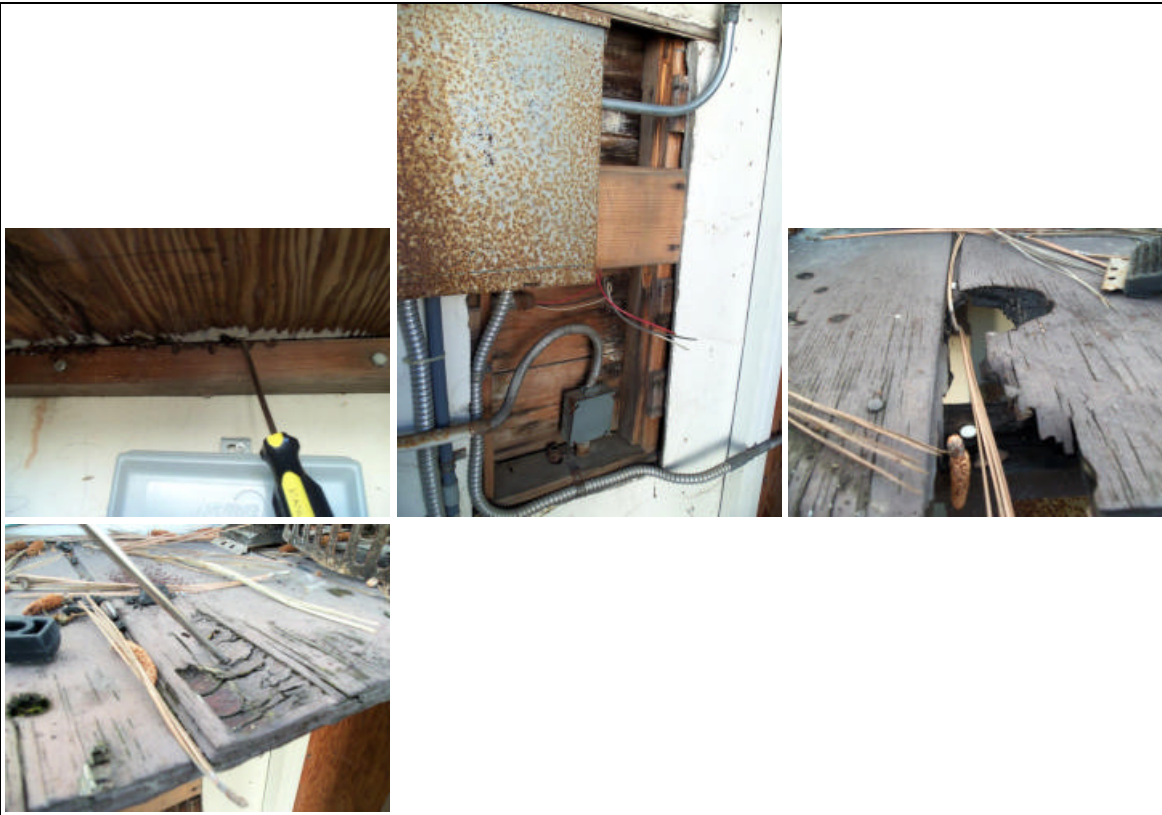
[CR] The utility closet has substantial damage and should be replaced. There is also a large hole in the house wall that needs to be patched in.

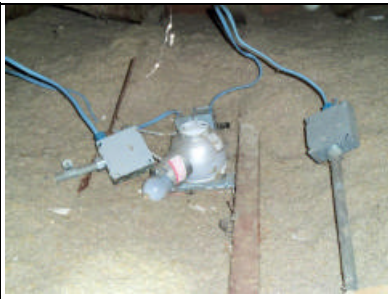
[SC] This light in the attic needs further evaluation and repair by an electrical contractor.

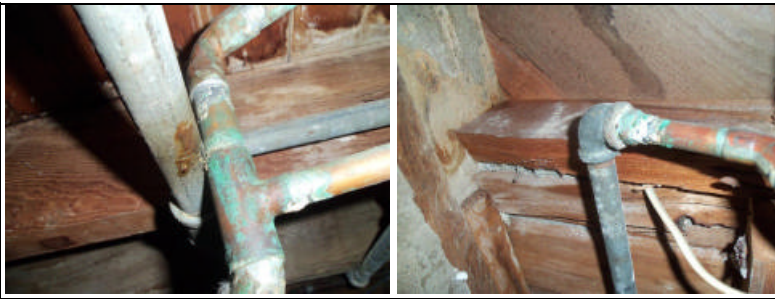
[CR] Galvanized pipe is used in at least three areas in the crawl space under the house and there could be others up inside the walls of the house that are not visible. The sections under the house appear to go the hose bibs. The pipe running up into the house from the crawl space is copper.

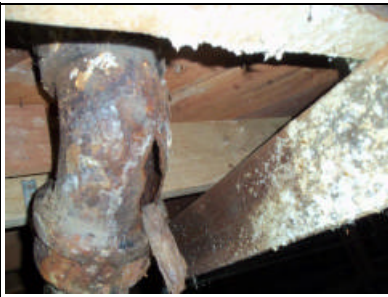
[SC] There was a large hole in the drain for the downstairs toilet that is dumping waste into the crawl space. A large area below this bathroom was wet and there was standing water. This condition is a health hazard and needs to be corrected by a plumbing contractor as soon as possible. That is toilet paper, etc. that has splashed onto the framing lumber.

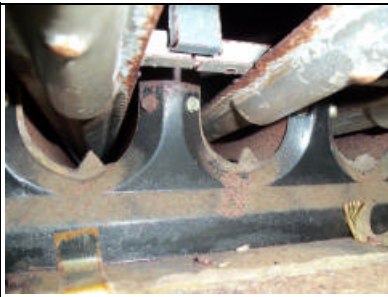
[FE] Corrosion, rust, and scale were noted in the burner chamber, or visible face of the heat exchanger and the heat exchanger could have some deterioration, and needs further evaluation by an HVAC contractor. The rust is usually caused by condensation and can be a sign of poor venting, incomplete combustion, or not enough air flow to the heater.

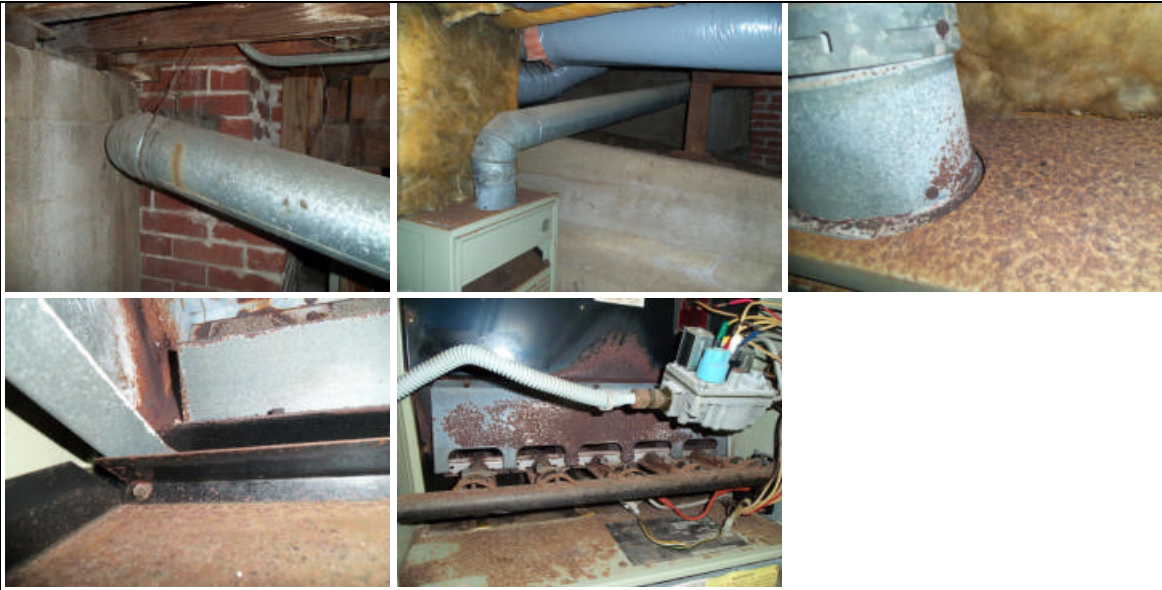
potentially serious concern which needs further evaluation and correction. There is rusting on the draft hood, discoloration on the face of the heater above the burner chamber, and rust above the burners on the visible portion of the heat exchanger.

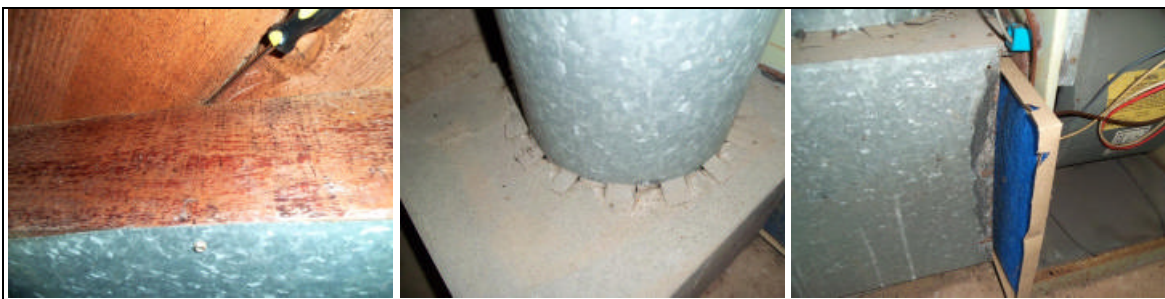
[CR] Where the filter is inserted into the return air plenum at the side of the heater, air can be drawn into the heater from the unconditioned space. This opening needs to be sealed, and generally this is done with a sheet metal cap which is missing.

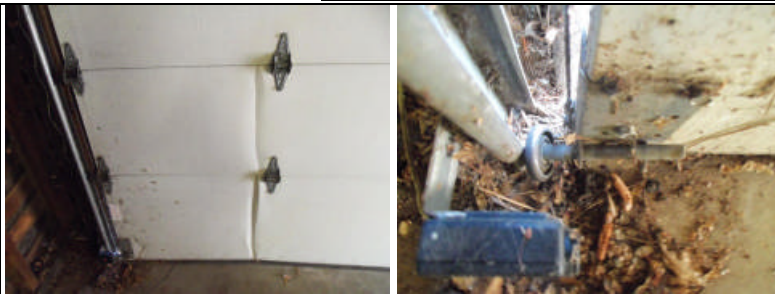
[CR] The bottom roller on the right side came out of the track and should be reset.

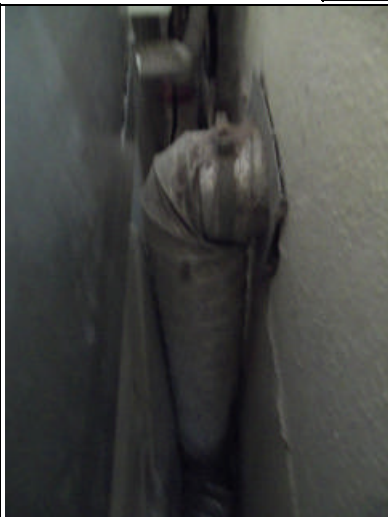
[CR] You need to be cautious not to push the dryer back too far because this will crush the duct that vents the dryer. An easy way to prevent this is to place a block of wood behind the dryers legs so that you don't inadvertently nudge the dryer back. They also make a flat sheet metal type of duct conector that would work very well here and not have the problem of becoming crushed.

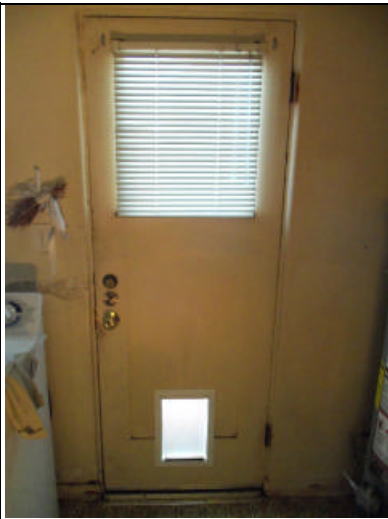
[CR] The top hinge is a bit loose and missing a screw. Try installing longer screws that will get a better bite.

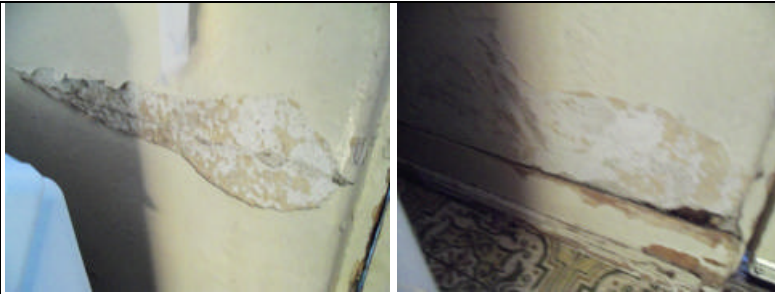
[CR] There is some damage to the plaster to the left of the door that is likely due to water intrusion. I do not know where the source of the water is and recommend further evaluation and repair to the plaster.

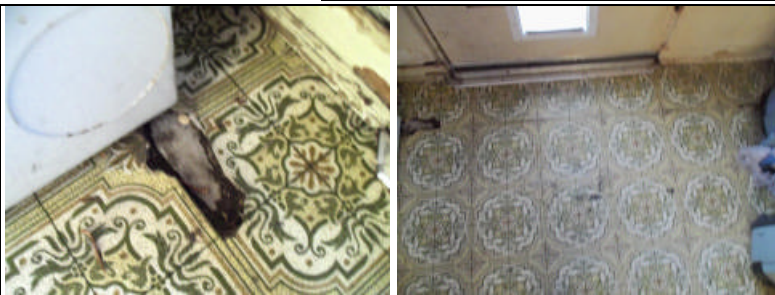
**11.11 FLOOR:**

[CR] The vinyl flooring was old, scuffed, or generally worn and had a couple of holes.

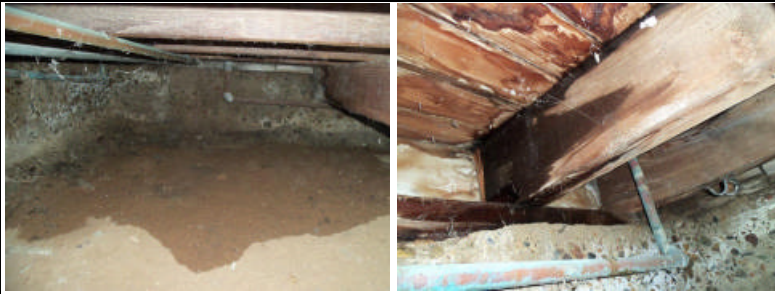
[CR] [CR] **The water heater tank was leaking, and needs to be replaced.** Water is running down below the tank and through the floor into the crawl space. This leaking is likely the cause of the damage to the laundry room floor.

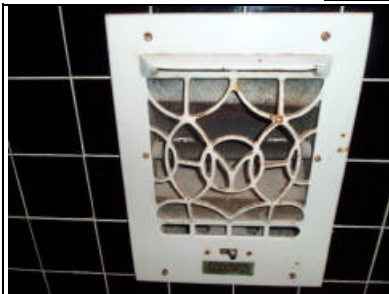
[SC] Electric wall heaters get very hot and pose a safety hazard. I recommend extreme caution be used with these heating systems. Never set anything in front of the heater and never install a towel bar above one of these heaters. These would be substantial fire risks. These heaters also get hot enough to produce third degree burns and can be a serious risk to children. Also, this heater is an old model that doesn't have any fan to cool the unit and doesn't have any safety sensors. I recommend that it be removed or at least disconnected for the sake of safety.

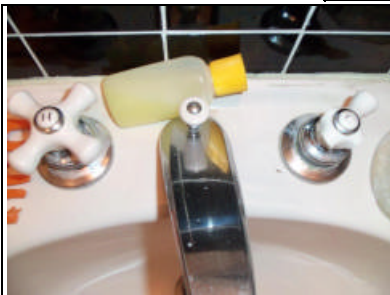
[CR] The handle is broken and needs to be replaced.

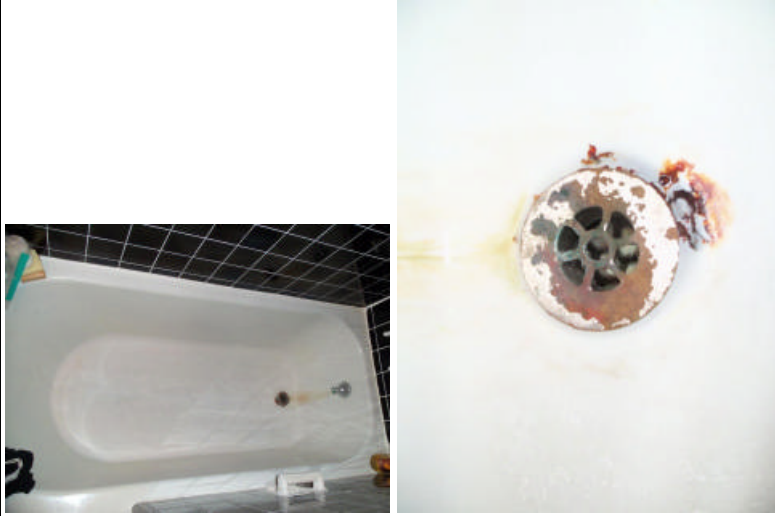
[CR] There are chips noted in the porcelain finish that need to be professionally patched to prevent rust. I see so many failures in patches in cast iron tubs that I highly recommend that they be done by a professional who will guarantee the work. See picture with chips and a little rust around tub drain.

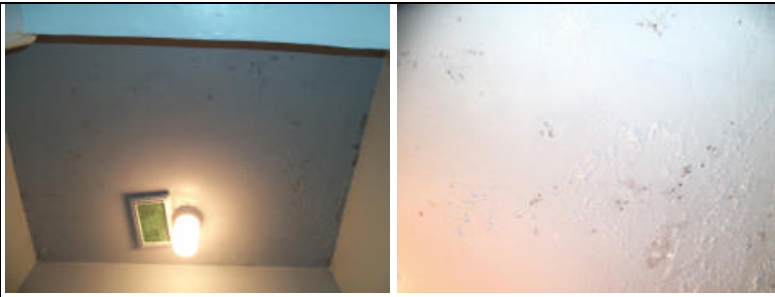
[CR] Maintenance is currently needed to the area above the shower.

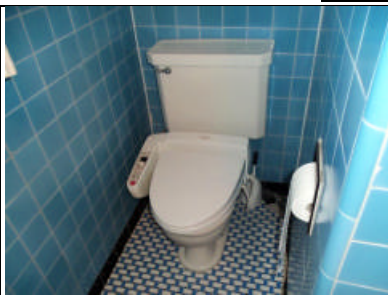
[CR] This toilet most likely uses over 3.5 gallons per flush, and I recommend changing it out to a new low-flush model to conserve water. See note in previous bath.

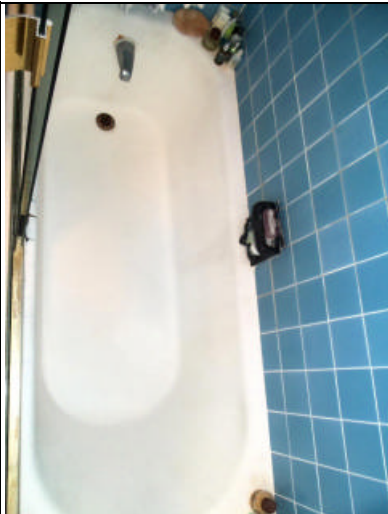
[CR] This tub has substantial damage to the enamel finish and it is questionable whether it would make sense to refinish it. Serious consideration should be given to replacing the tub entirely along with the shower walls. I suspect this damage is due to whatever has been used to clean the glass shower doors over the years.
--

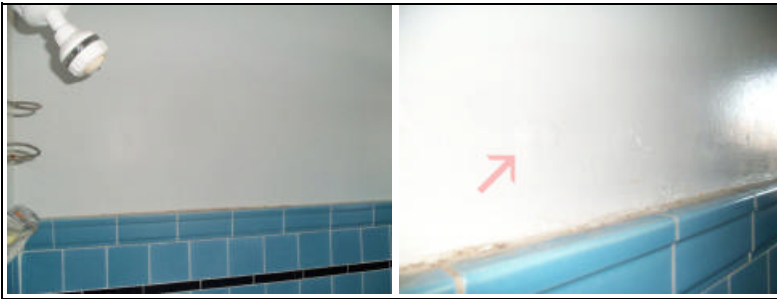
[NOTE] The top of the tile walls are low and the wall material above the tile will be vulnerable to splash from the shower and water damage. Some of the paint is blistering due to water.

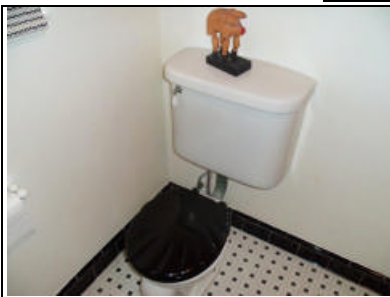
[CR] Water leaks from the tank into the bowl and wastes water. The flapper, the flush valve, or the float will need to be repaired or replaced as needed.

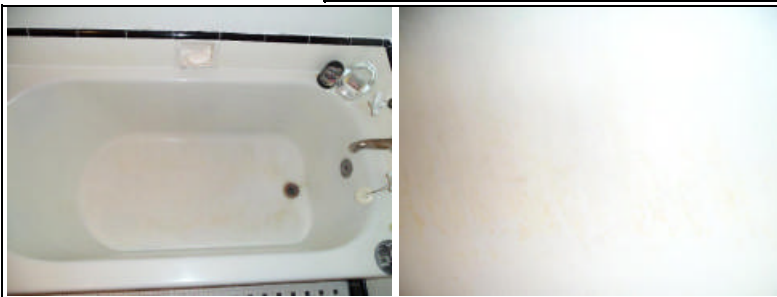
The tub is cast iron with a porcelain finish. The enamel finish is becoming thin from age. Sometimes people have the tubs refinished, but you should realize that any new coating will not be as strong as the original and typically last about 5 years or less before needing to be resurfaced again. I generally don't recommend refinishing the surface until the first sign of rust is noted. [\[CR\]](#) Rust appears to be starting and consideration should be given to resurfacing the tub at this time.

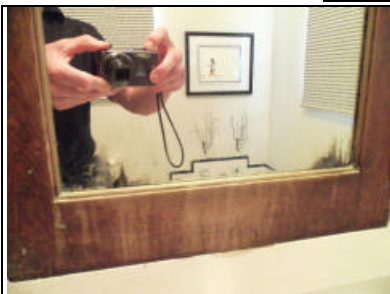
The mirror was de-silvering around the edges. This is not unusual, gets worse with age, and if it bothers you enough, it will need to be replaced.

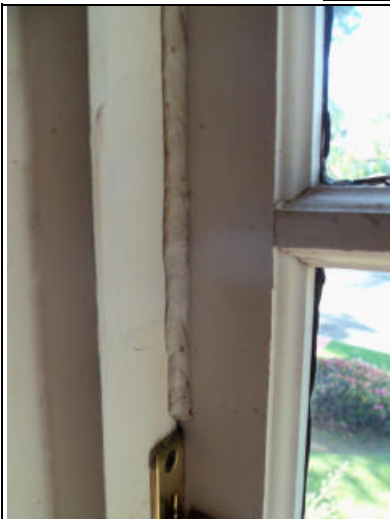
[CR] [FE] Windows throughout the house need to be serviced or repaired by a window company. Many of the windows are caulked and sealed as noted in the first picture. The tenant told me that they only use about five windows in the entire house. One common problem is that the sliding mechanisms that hold the windows in an open position all have a thin layer of rust or corrosion to the finish which makes them difficult to slide or operate. Rust is a common problem close to the beach. Rust removers and rust inhibitors should be used and consideration can be given to replacing the mechanisms. With maintenance, the mechanisms should generally be made operational.

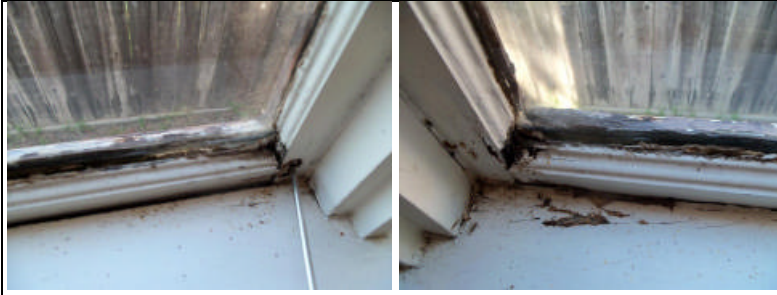
[CR] A couple of the windows worked fairly smoothly and others have been caulked shut or wouldn't open.

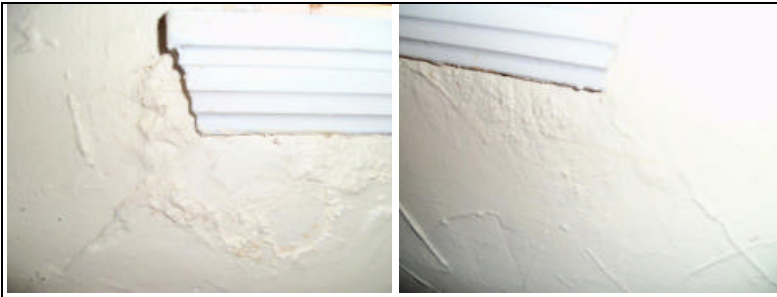
**14.10 WINDOW**

[CR] [FE] There is water damage to the wall material below the corners of the windows on two windows. This is often, but not always, from water leaking in through the corners of the window frame. This needs further evaluation from someone with experience in diagnosing and repairing leaks around windows. Occasionally these repairs can be difficult and expensive to correct.
