# All Pro Home Inspections

INSPECTION REPORT	9
STRUCTURE, FOUNDATION, CRAWL SPACE	13
EXTERIOR	18
ATTIC AREAS & ROOF FRAMING	24
ELECTRICAL SYSTEMS	25
PLUMBING	28
HEATING SYSTEMS	30
GARAGE - CARPORT	32
LAUNDRY	34
WATER HEATERS	35
BATHROOMS	36
INTERIOR ROOMS	40
KITCHEN	42

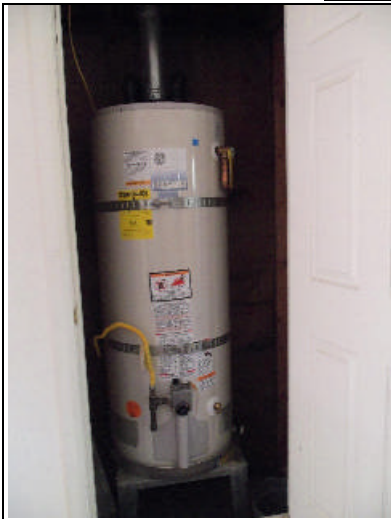
## 12.1 PICTURE

[SC] The vent was too close to or in contact with combustible materials, and this condition can be a fire hazard that needs to be corrected. The vent is too close at roof line. One inch clearance is required by code between the dual-wall vent and any wood or other flammable material. The vent is very close or even touching the wood and heat transfer is a clear risk.

[SC] The combustion air supply to the water heater appeared inadequate. The free flow of air to the water heater is critical for proper combustion and venting. Without proper air supply, incomplete combustion and carbon monoxide are common problems. This is important and correction is required. The basic requirement is to have two openings into the closet or any confined space, one opening in the upper 12 inches and the other in the lower 12 inches of the enclosure. Each vent is to have 100 square inches of clear opening into the water heater area. Putting the water heater inside this small closet is most likely choking off the supply of air and these vents are needed. It is definitely best for the vents to be through the exterior wall so the combustion gas comes from the outside.

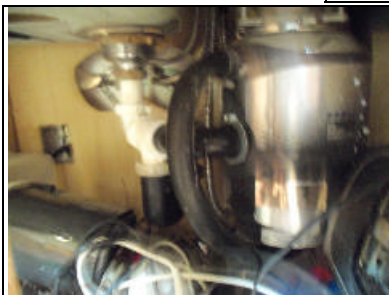
## 15.10 ISLAND SINK

[CR] [FE] There is a small sink on the island and below this sink the base of the cabinet and the concrete slab are wet. I can not find any leak in the plumbing above the concrete and I am suspicious that there could be a leak below the slab level which could be difficult to repair. With any evidence of leakage under the sink you may need to be concerned about the possibility of mold under the cabinet, inside the wall, or in other hidden areas. The potential for mold growth is high if a leak goes unnoticed or is not repaired quickly. Whenever a hidden cavity becomes wet, it needs to be opened up and dried quickly and thoroughly. Even if there is no mold on the visible surface, and even if the leak was repaired and everything is dry now, a hole should be cut in the wall and/or the base of the cabinet to check for mold growth in the hidden cavity behind these surfaces. Any mold discovered will need to be removed properly. See the Mold Statement in the Introductory Notes section at the beginning of this report.
