All Pro Home Inspections

STANDARD RESIDENTIAL INSPECTION AGREEMENT

Client Name:
Inspection Address: 1234 Main Street
EI Cajon, CA 92020

INSPECTION REPORT	9
STRUCTURE, FOUNDATION, CRAWL SPACE	13
EXTERIOR	28
ATTIC AREAS & ROOF FRAMING	42
ELECTRICAL SYSTEMS	47
PLUMBING	52
HEATING SYSTEMS	57
GARAGE - CARPORT	58
WATER HEATERS	59
BATHROOMS	70
INTERIOR ROOMS	81
KITCHEN	91

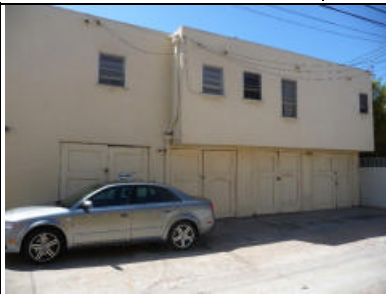
2.2 GARAGE:

[FE] [SC] When living space is built over a wall with large garage door openings with little wall space to provide structural support in the event of an earthquake, it is considered to be a soft story. The risk of failure in the structural integrity of these old wall systems in an earthquake is substantial and I recommend that you have further evaluation by an engineer. Not having shear panel reinforcing was common for the age of construction, but would be a serious weakness in the event of an earthquake. You should read "The Homeowners Guide To Earthquake Safety" provided by your agent or available at: http://www.seismic.ca.gov/pub/CSSC_2005-01_HOG.pdf for more information. Read the section "Rooms Over Garage" on page 26 and 27 which describes the problem and suggests a solution. This can be a fairly expensive upgrade but will clearly improve your earthquake safety and you should consider the upgrade for earthquake safety. Failure of the lower wall during an earthquake can be severe or even devastating.

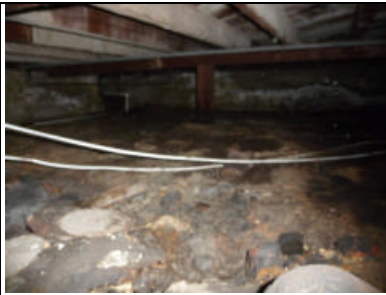
2.18 MOISTURE:

[FE] [CR] This was the only crawl space in the complex that was really wet and muddy at this time. It was wettest and very muddy towards the front or north side and continued to be wet to about 2/3rds of the way to the back. I could not determine the source of water and definitely recommend further evaluation to determine its source. There is no reason for the crawl space to be muddy like this at the end of the summer and I suspect a water line leak that is supplying a constant source of water. This has clearly been going on for a long time. I couldn't get to the front of the crawl space because it become so muddy. I didn't see any standing water. The soil and rocks were all covered with a dark stain and it could be moldy under this unit. I do not do mold testing. See the Mold Statement in the Introductory Notes section at the beginning of this report for additional important information.

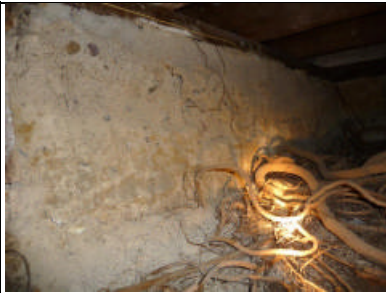
3321**2.22 DETERIORATION:**

Minor to moderate spalling or surface deterioration is noted to the face of the foundation. This deterioration is caused by water migrating through the porous concrete and leaving behind salt deposits that brake down the mortar over the years. A serious effort is recommended to minimize water saturation next to the foundation to slow further deterioration, but no effort is recommended to repair the foundation because of this spalling. This type of deterioration to the mortar also makes it difficult to see cracks because the flaking of the mortar will fill the cracks and make the entire surface rough and hide cracking.

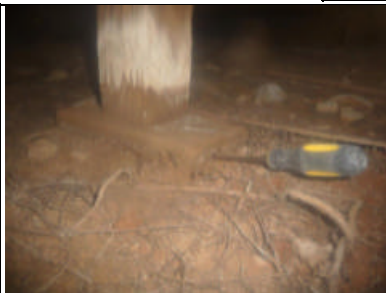
**2.23 PIERS:**

As mentioned in the common notes section for all crawl spaces, if there is soil in contact with the base of the posts and moisture in the crawl space, the potential for damage to the wood is substantial. See the termite report for any potential rot or termite activity. Under California law, they are responsible for any rot or termite activity or damage. I don't really recommend replacing even this wood, but I certainly recommend removing the soil touch the wood and keeping the water out of the crawl area to stop damage to this and all the similar post bases. I could have taken other similar pictures and this should be considered an example.

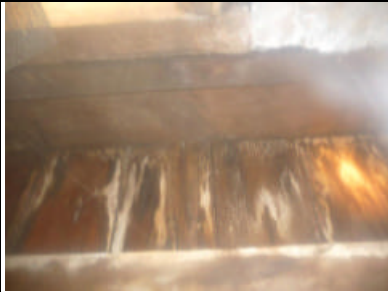
**2.25 FRAMING:**

Water damage from leaks outside tub. Not as bad as unit 3323.

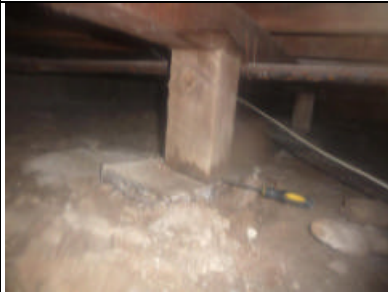
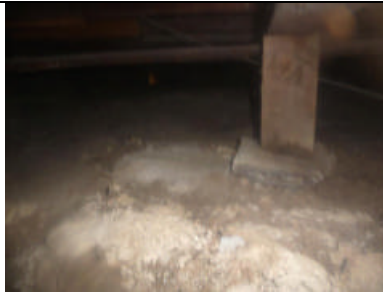
2.26 PIERS:

[CR] This pier, which is in the S-W or back left quadrant of the crawl space has substantial damage and I recommend replacing it or installing a new pier next to it. The foundation was very shallow and it cracked and settled. I suspect that many of the interior pier footings are shallow but fortunately only a few have failed and need to be replaced.

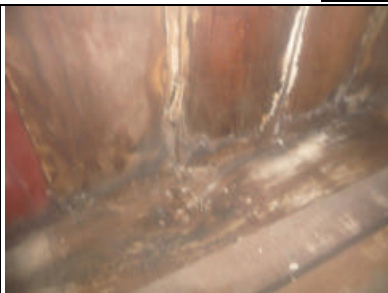
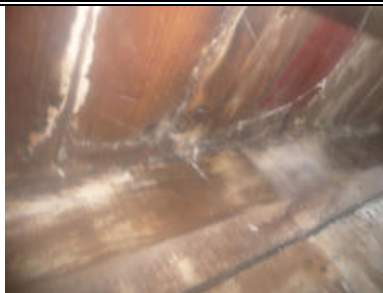
**2.27 FRAMING:**

[FE] The wood subfloor around the tub has water stains. However, the wood at the back edge behind this tub has more deterioration than most. See the termite report for any potential rot or termite activity. Under California law, they are responsible for any rot or termite activity or damage.

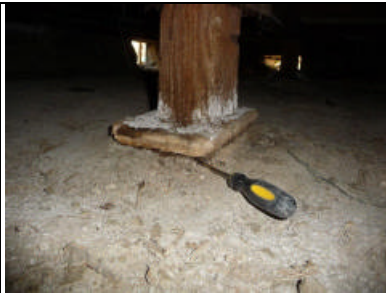
**2.39 PIERS:**

[CR] This is one of the more badly deteriorated post bases due to soil to wood contact and water intrusion into the crawl space. The soil needs to be cleared away from the wood and the moisture needs to be controlled. This is needed under most or all of the units.

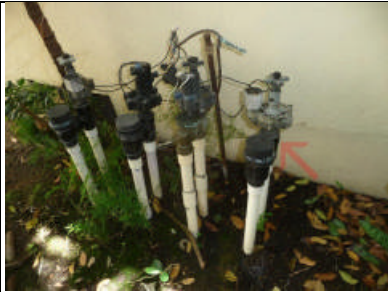
2.41 MOISTURE:

[CR] It is wet in the north west corner area. This is due to a badly leaking sprinkler valve. Actually two valves leak and need to be replaced. The bad valve has a constant steady flow of water.

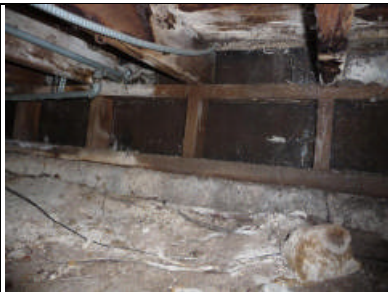
2.42 CRIPPLE WALLS:

[RU] Recommended Upgrade: These front units are the only units that have cripple walls, which are the short walls on top of the foundation that support the first floor. They lacked shear panel reinforcing. Shear panels are usually plywood panels specifically nailed to the cripple walls to resist lateral movement during seismic activity and are beneficial in helping to limit the amount of damage that may occur during an earthquake. Not having shear panel reinforcing was common for the age of construction on this house, but would be a serious weakness in the event of an earthquake. You should read "The Homeowners Guide To Earthquake Safety" provided by your agent or available at: http://www.seismic.ca.gov/pub/CSSC_2005-01_HOG.pdf for more information. Read the section "Weak Cripple Walls" starting on page 16 which describes the problem and provides a solution and additional resources. This is one of the more cost effective ways to improve your earthquake safety and you should consider adding shear panels as an upgrade for earthquake safety.

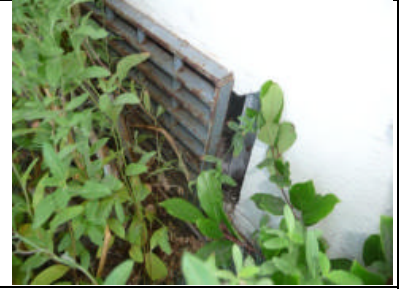
2.43 VENTILATION:

[CR] This grate doesn't work as a vent because the gaps are much too wide to keep out rodents. Also note the gap on the side of the grate.

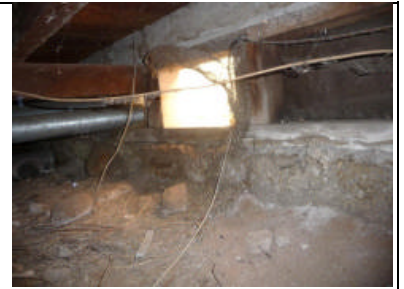
**2.44**

[CR] This shows an open vent where animals can easily go in and out.

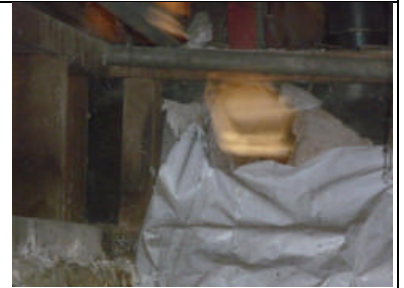
[CR] There is also a hole through the stucco at the back left corner of unit 3331 that needs to be patched to keep animals out.

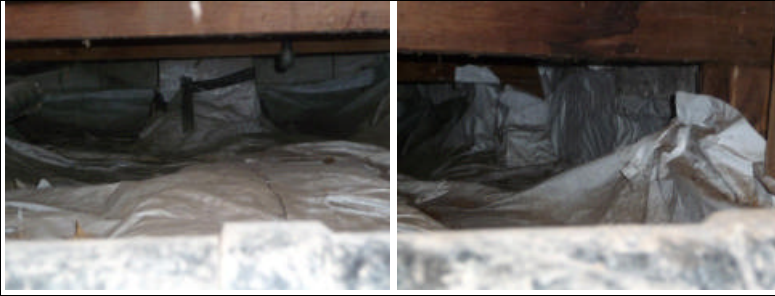
[FE] [CR] [CR] There are additional issues with the west wall of this unit. It clearly is not supported adequately and not tied into the original building. The wall has settled at least 3/4 of an inch as noted from the roof where the wall has slipped down in relation to the vent pipe. Also, a large gap has opened up in the back corner of the bathroom where this exterior wall connects to the original structure. I also have concern that this wall may encroach into the setback requirement since it is about 6 inches farther north of the line for the original structure and would expect that was placed on the set back line. I strongly suspect that this addition was done without a permit. Correcting this will require foundation and framing

repairs and drainage control and grading corrections. See grading and drainage notes in the next section.

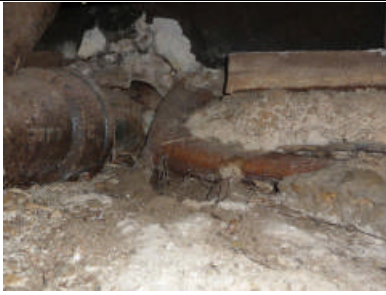
3.1 LANDSCAPING:

[CR] Tree(s) were planted too close to the building, and you need to remove several of them. As the trees continue to grow in size, they can damage the foundation or the roof. Consult a landscape contractor or arborist about the risks of particular trees. This picture shows a root from the Brazilian pepper behind 3329 running into the crawl space.

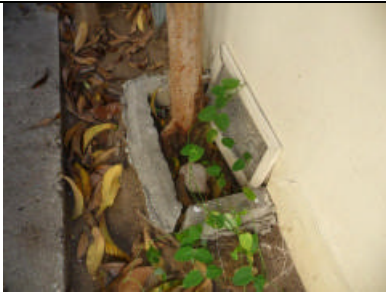
**3.2**

[CR] This picture shows a tree planted directly against 3327 at the crawl vent. This needs to be removed.

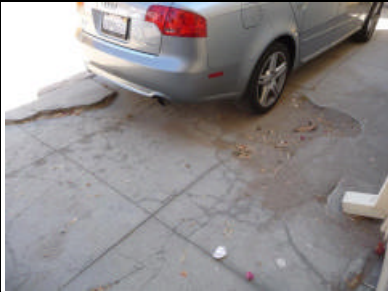
4.1 DRIVEWAY:

[CR] [CR] The concrete behind the garages in the area of the downspout needs to be broken out and replaced. Water ponds and this will just get worse.

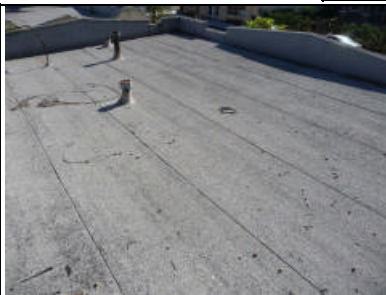
5.3 GENERAL CONDITION:

[FE] The roof is in the later part, and could be close to the end, of its economic life. You should consider the remaining life limited and budget for replacing it. You should get an estimate from a roofing contractor at this time for the cost of replacing the roof and their best estimate of remaining life. Also ask the roofer for the cost of repairs needed and how long they would be willing to certify the roof for in writing after making the repairs. This will help you to decide if it makes economic sense to make repairs or it makes better sense to replace the roof.

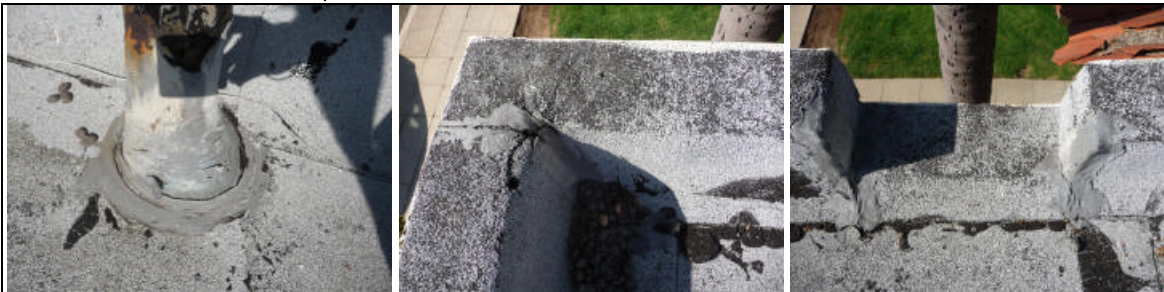
[CR] There are spots or areas with cracking or other deterioration due to aging, and maintenance or repair is recommended at this time. The entire roof should be inspected and repaired by a roofing contractor willing to certify the roof after the repairs are made. The roofing contractor should check the entire roof with special attention to the edges or any transition areas and make any needed repairs or maintenance. This is often called a roof 'tune up' and is a necessary part of maintenance to extend the level of the roof.

The pictures are intended to provide examples of areas that need repair or show the level of wear. The pictures are not intended to and do not show all the defects.

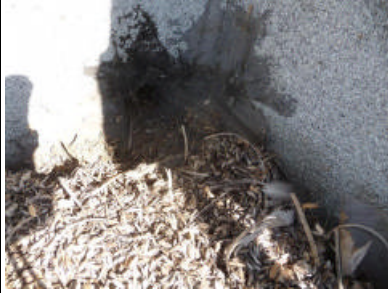
[Defect] The number one defect that see with every roof that has been replaced with modified bitumen is that the scupper or drain opening is much too small. This will make the drain prone to clogging and greatly increase the potential for damage from leaks. These scuppers were likely salvaged from the previous roof. They should have all been replaced with a properly sized scupper.

[CR] There is clearly a leak from around this drain. I can see water damage on the ceiling in the back corner of the breakfast room directly below this drain. The tenant told me that it only leaks when the drain is clogged. Chances are it leaks every time it rains but only leaks badly enough for the tenant to notice when the drain is clogged which is likely often.

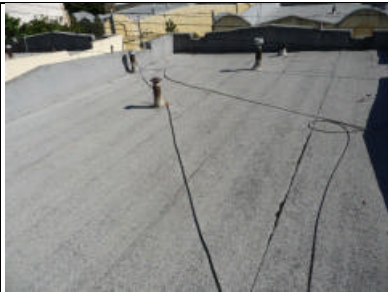
5.15 GENERAL CONDITION:

[FE] The roof is in the later part of its economic life. You should consider the remaining life limited and budget for replacing it. You should consider getting an estimate from a roofing contractor at this time for the cost of replacing the roof and there best estimate of remaining life.

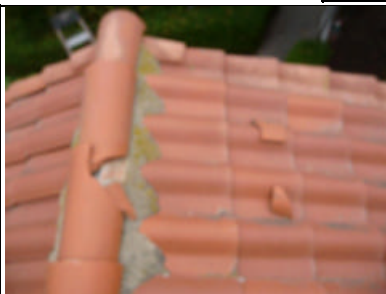
5.20 CLAY TILE:

[CR] A couple of tiles are broken on the small roof section over the entry that need to be replaced.

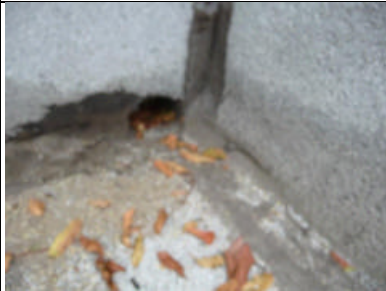
5.22 ROOF DRAINAGE:

[CR] The drains are too small and I recommend replacing them with something more adequate the next time the roof is replaced. until then, you will need to clean the drains and downspouts as part of regular maintenance.

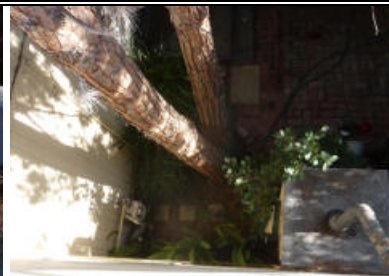
5.26 GENERAL CONDITION:

[CR] Note how difficult it will be to maintain this roof and keep the drain clear with the pine tree. Note how close the tree is to the house. Pine trees can cause substantial damage to foundations and are also substantial fire risks.

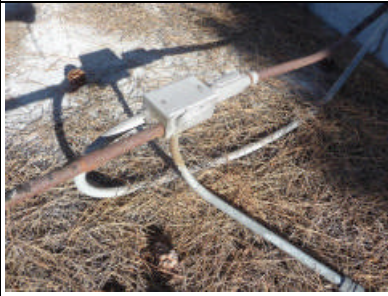
**5.28 COMMENTS:**

[CR] The electrical lines are not properly supported on this roof.

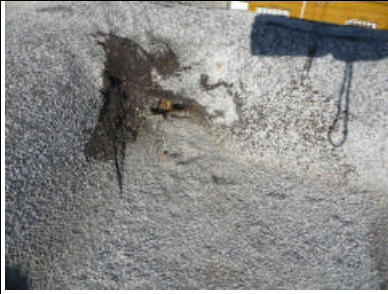
5.32 ROOF DRAINAGE:

[Defect] Small drain.

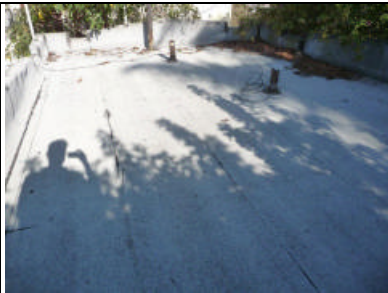
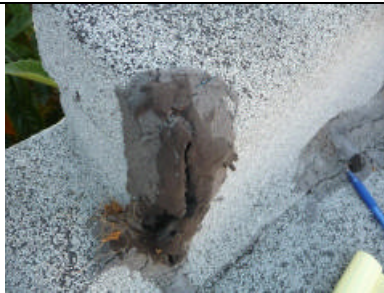
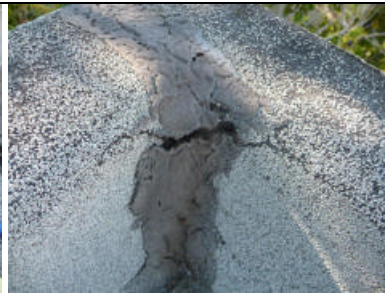
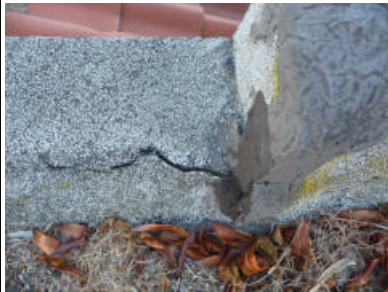
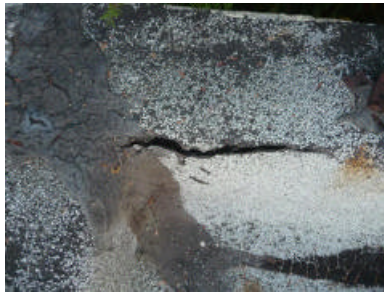
5.34 GENERAL CONDITION:

[FE] The roof is at or near the end of its economic life. Have a roofing contractor estimate the cost of re-roofing, and give you his best estimate of any potential remaining life and the risk of leaks. Ask the roofer if it makes economic sense to make repairs, and how long he would be willing to certify the roof for in writing after making the repairs.

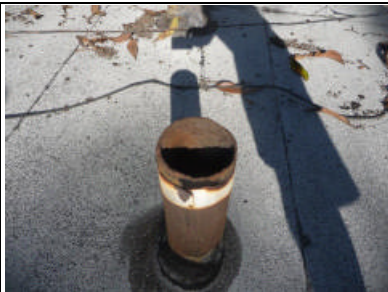
**5.36 FLUE VENTS & CAPS**

[CR] Check for vents missing caps. This may be an abandoned vent but it still needs a cap.

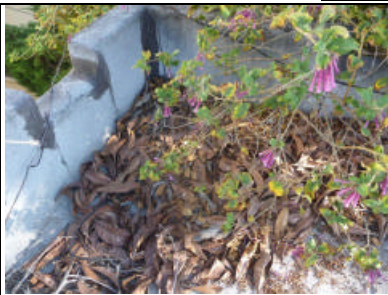
**5.37 ROOF DRAINAGE:**

[CR] Don't see any reason why this drain would get clogged - do you?

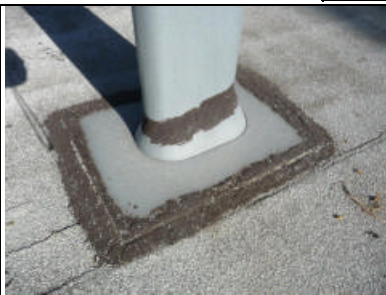
**5.40 FLASHING:**

[CR] This flashing is not sealed and needs maintenance. This flashing should be sealed properly like the other heater vent is sealed. The roofer will need to check the entire roof for any other maintenance.

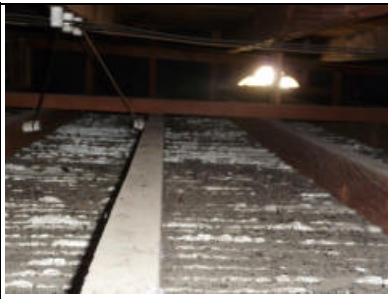
[RU] Recommended Upgrade: There is no insulation in the attic and you should seriously consider adding some to improve energy efficiency and comfort. Through a state mandated program, SDG&E is currently offering a rebate for adding insulation to older homes. You need to call SDG&E before you install the insulation for more information.

Since you have old knob and tube wiring that is still being used in the attic, you will need to have the wiring inspected and certified by an electrical contractor for safety before it is covered with insulation. This is a California law. Also, you need to use non-flammable insulation such as blown-in fiberglass or un-faced fiberglass batts. Do not use cellulose.

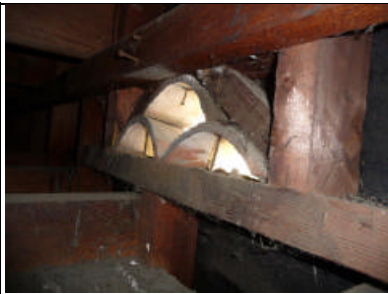
6.3 VENTILATION:

[CR] There were vents that do not have screens. This is not unusual for old homes but would not meet our standards today and may allow insects, birds or animals to enter the attic space. 1/4 inch galvanized steel screen material should be used to seal off any open vents.

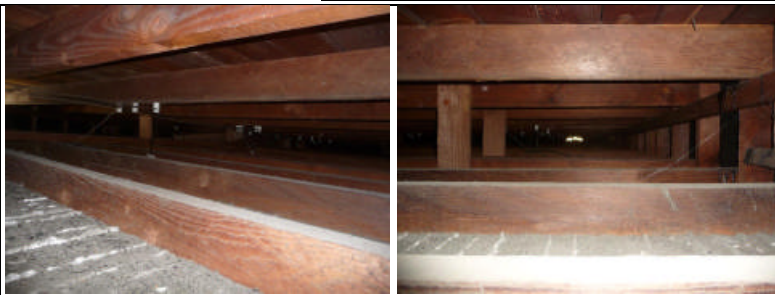
6.4 FRAMING:

The roof framing for this structure is predominantly conventional framing built in place. The original framing was noted to be in serviceable condition. Although the framing does not conform to present standards, no adverse conditions were noted and no action is necessary.

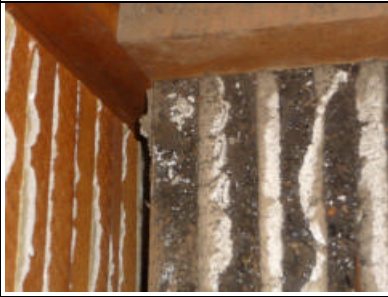
6.5 FIRE STOPS:

[SC] There are draft stops or fire stops missing in the attic. Their purpose is to slow down and hopefully stop the spread of fire from below from using the space in the wall cavity as a chimney to spread a fire up into the attic. They are required at each floor or ceiling level so that a fire from below can not rush up into the attic. You should never be able to look down from the attic into a vertical cavity. A contractor who understands the requirements needs to inspect the attic and install the proper draft or fire stops. The space can be blocked off by a wood block, piece of sheet metal or even drywall.

[NOTE] Draft stops are missing in every attic that I was able to enter and this note will not be repeated for any of the other units. This requirement was in the original 1927 code. Most buildings built before that time also followed this rule but clearly these homes do not. Since most of the attic areas are inaccessible, you will probably have to accept this and any increased risk. The value of adding draft stops to the accessible attic areas would be

[NOTE] This note is common to every attic and will not be repeated. This picture is from 3331 but all of them are the same. You can look right down into the wall cavity.

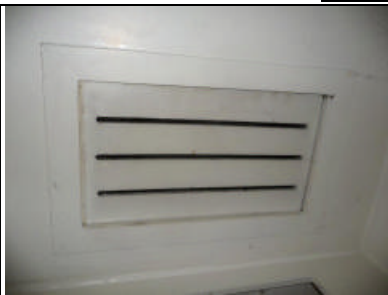
6.9 ATTIC ACCESS:

I found access into the attic at the following location(s): bedroom closet. This picture shows the vent slots in the access panel that will allow air movement between the attic and the house.

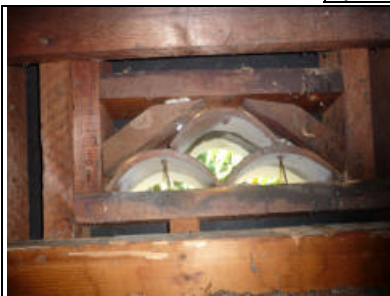
**6.17 VENTILATION:**

[CR] There were vents that do not have screens. This is not unusual for old homes but would not meet our standards today and may allow insects, birds or animals to enter the attic space. 1/4 inch galvanized steel screen material should be used to seal off any open vents.

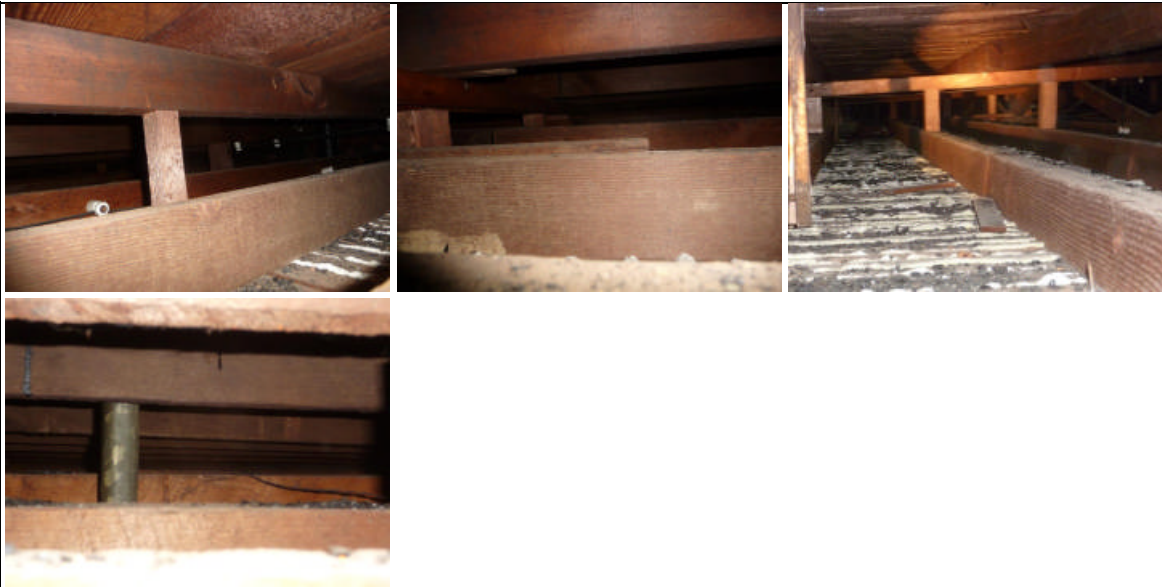
**6.20 FRAMING:**

The framing appears functional. The clearance was very tight.

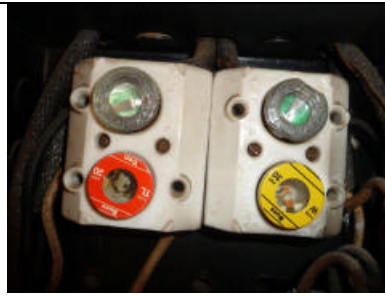
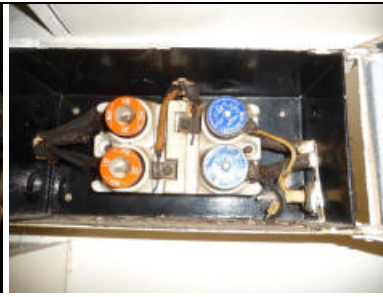
[SC] Also the 30 amp fuses will likely allow twice as much power to flow on the wires than it should and this can be a clear fire risk. Keep in mind, we lose over a billion dollars a year in property due to electrical fires.

In the third picture (unit 3329) you can clearly see the fused neutral. Also, [SC] Double lugging was noted at the circuit breaker(s) in the panel. This is where two circuit wires are joined together at one breaker and is easy to fix, as long as there isn't a problem with capacity.

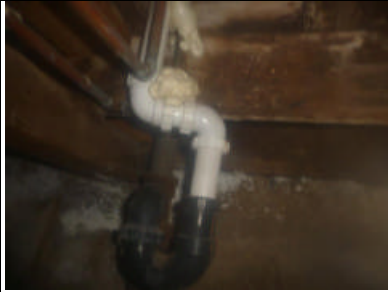
8.6

This one is for 3321 and is one of worst offenders because of the number of elbows that use compression fittings.

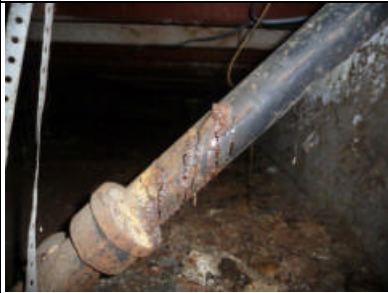
8.7 3317

[CR] The drain line to the kitchen sink is leaking and needs to be replaced. The rest of the cast iron in this unit was better than most other units.

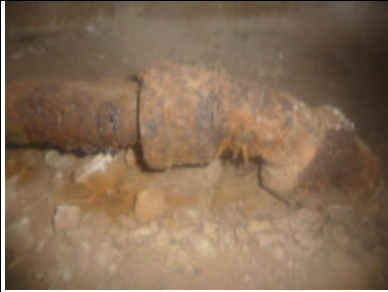
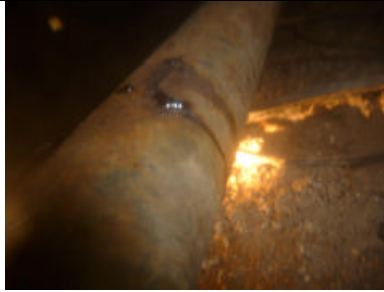
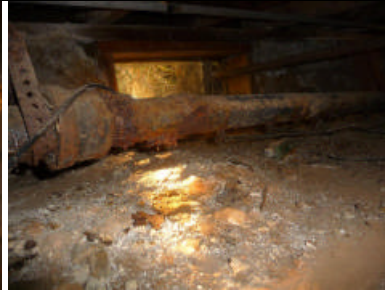
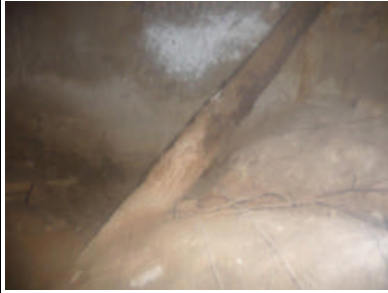
8.10 3321

[CR] Drain line to kitchen sink and portions under the bathroom.

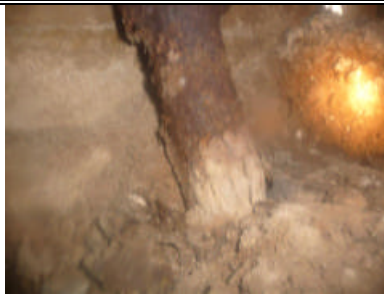
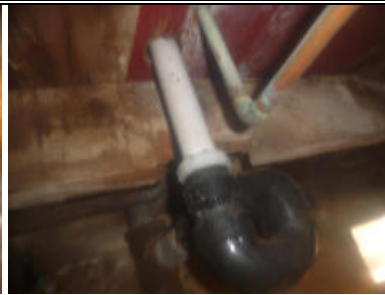
8.11 3323

[CR] Drain lines to kitchen sink and below tub.

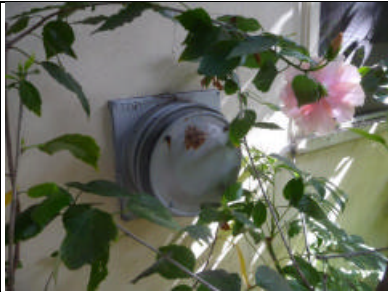
9.1 VENT:

[SC] Keep any plants cut 12 inches away from the direct vents for the heaters. This picture is at 3325 but check and maintain them all.

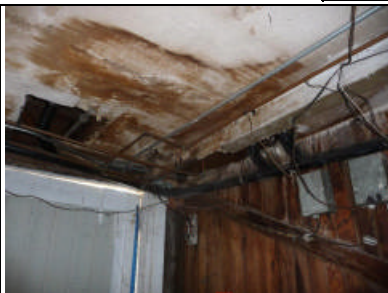
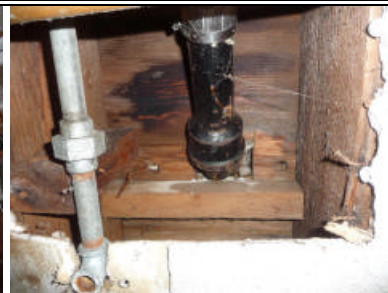
[SC] [CR] [CR] Repair the damage or holes in the fire resistive wall between the garage and living space.

The manager told me that there are also a lot of holes in the ceiling of the other garage that we were not able to get into so this is clearly a common issue to all the garages. She told me that the northern most garage was the worst because the water heater from above failed dumping water down onto the ceiling.

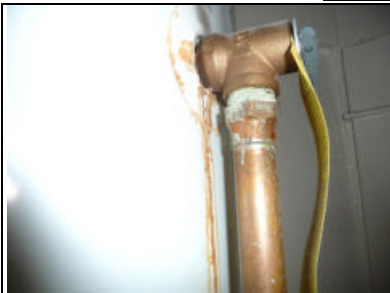
11.21 T&P VALVE:

[CR] Have plumber check seal at valve.

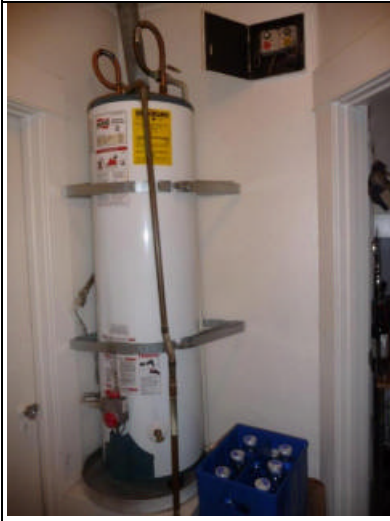
11.23 PICTURE

Small room behind kitchen.

[CR] The temperature & pressure relief valve's discharge line should not drain into the crawl space because you will not know it is leaking. Also, it could cause water related problems in the crawl space.

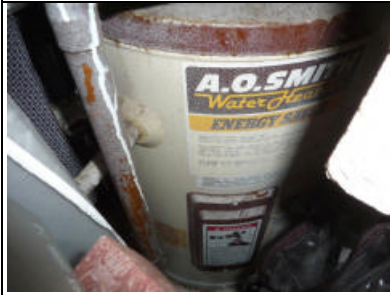
3323-1/2.**11.31 PICTURE**

In the closet for this unit.

[CR] The temperature & pressure relief valve's discharge line was missing. The discharge line needs to be 3/4 inch copper, or other approved material. PVC is not acceptable. The line needs to extend to the exterior and terminate no more than 24 inches above the ground facing downward.

[SC] The water heater needs to have one or both of the straps installed.

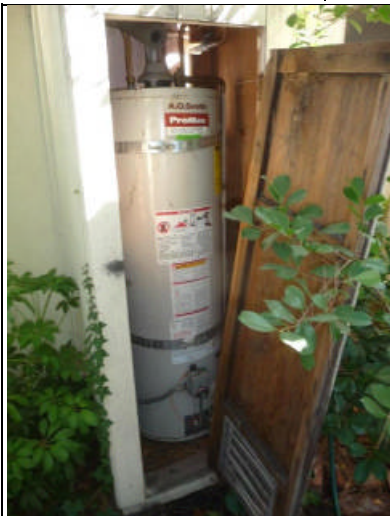
3325.**11.39 PICTURE**

In an exterior closet .

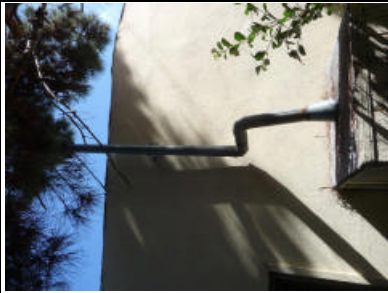
[SC] Single wall vent is not allowed to run through any ceiling, or any partition, or inside any concealed space, or in the open air on the outside of the building. It is only permitted for the section from the water heater to where the vent exits the room or enclosure. All other sections need dual-wall vent installed to replace any single wall sections. I am also concerned about the pine tree branches being too close to the vent.

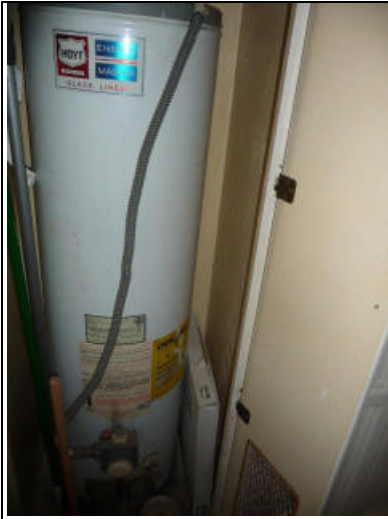
11.48 PICTURE

20 gallon.

[SC] The vent needs to be replaced to improve safety. This can be done by a heating or plumbing contractor. [SC] The flue vent pipe sections were out of alignment, weak, or not properly connected, and this needs to be corrected. A proper transition fitting is needed between different sections. [SC] Flexible corrugated vent connectors are only allowed to connect the appliance exhaust to the first section of vent and must be completely exposed in the space above the appliance exhaust. Replace all other sections with ridged dual-wall vent ducting. They can never run through any partition, can not be connected to a second section of flexible vent, can not be used exposed outside, etc.

[SC] The vent was too close to or in contact with combustible materials, and this condition can be a fire hazard that needs to be corrected. There is a serious potential hazard whenever there is a shelf or storage next to, or close to, the vent that someone could place a flammable item on that could touch the vent. This is a fire risk. The shelving needs to be removed to prevent someone placing an item close to the vent.

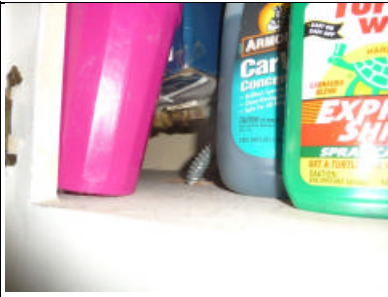
[SC] The code requires one fresh air intake vent, that measures 100 square inches, to be located in the upper 12 inches of the room or enclosure that contains the water heater. This room or enclosure does not meet that requirement. The gas valve can't be inside the cabinet area.

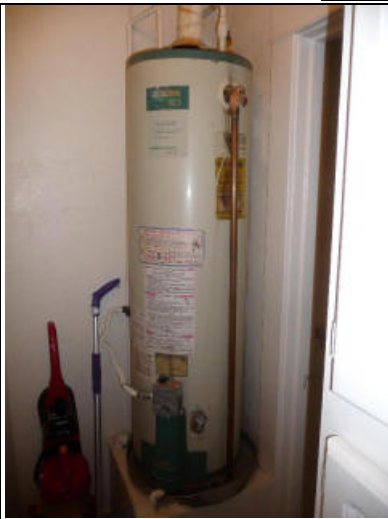
**3325 1/2.****3327.****11.56 PICTURE**

30 gallon.

[SC] The combustion air supply has no upper vent. The basic requirement is to have two openings into the closet, one opening in the upper 12 inches and the other in the lower 12 inches of the enclosure. Each vent is to have 100 square inches of clear opening into the water heater area.

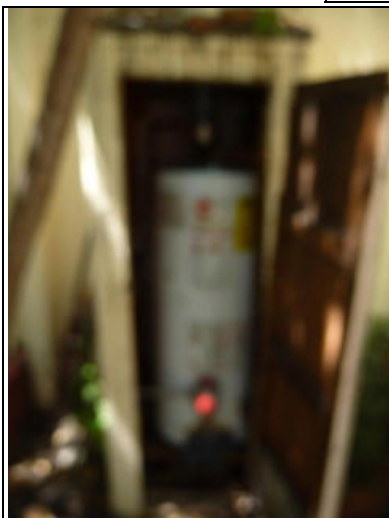
3329.**11.65 PICTURE**

In an exterior closet .

[SC] The vent cap is missing on top end of the vent and it needs to be replaced. I am also concerned about the tree branches being so close and this is another reason to remove the tree.

[CR] This enclosure is in bad condition and needs to be replaced.

[CR] The water heater should be considered in the latter part of its life and any remaining life may be very limited. I recommend that it be replaced now.

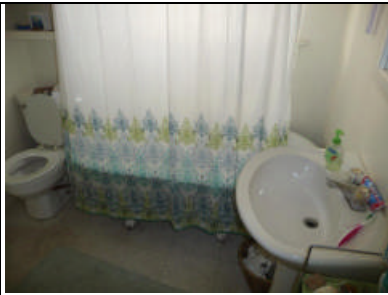
12.1 OVERVIEW

This bathroom is very typical of most of the other units and the notes here are intended to be standard notes for all of the units. The notes in the other units will be reserved for uncommon problems only.

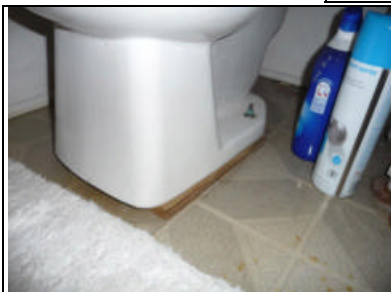
[CR] The toilet rocks or is not firm and needs to be secured properly to the floor. Any toilet that rocks is likely to start leaking at some point. A plumber should make the repair and check for leaks. The toilet is currently sitting on top of the piece of plywood so I suspect there is damage to the floor or framing below the toilet that will also need to be repaired.

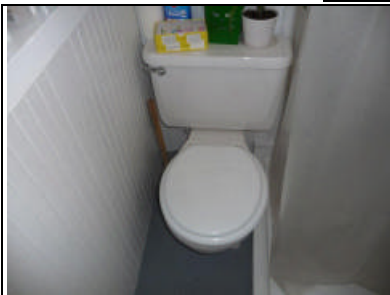
[CR] The clearance around the toilet was less than it should be. From the center of toilet there should be 15 inches of clear space on each side.
80's vintage toilet. This toilet is most likely designed to use 3.5 gallon per flush [gpf] and you should seriously consider replacing it to conserve water.

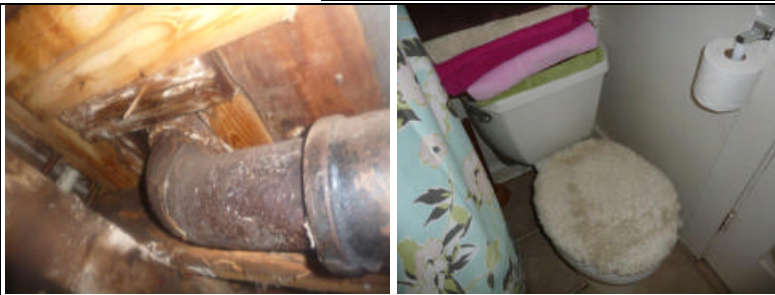
**12.34 FLOOR**

cracked tile by toilet.

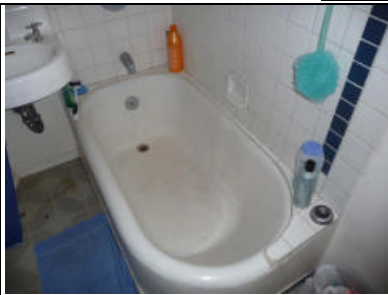
[CR] [CR] This tile is in bad shape and needs to be completely replaced. Even when there may appear to be little damage on the surface, there can be substantial deterioration to the backing material behind the tile or possible mold or rot development inside the wall. There are offsets in the plane of adjacent tiles. This is a substantial sign of a problem in the system and generally a fatal flaw. There are cracks in the grout lines which is a symptom of deterioration or movement in the backing material.

[NOTE] This tub was not designed or intended to be used in a shower and there is no flange at the edge of the shower and it becomes very difficult to provide an adequate seal between the tub and the shower wall and leaks are likely.

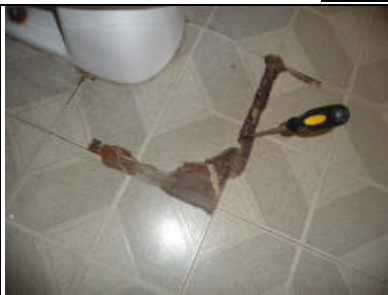
[CR] Damage is noted to both the flooring and the subfloor in front of the toilet.

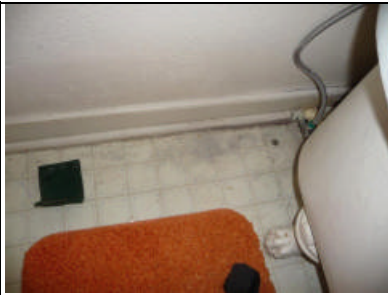
[CR] [FE] The wall corner behind the toilet has opened up and yes that is daylight visible through the gap. See the structural notes.

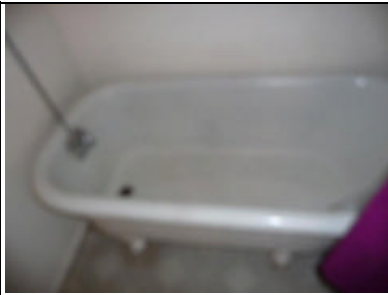
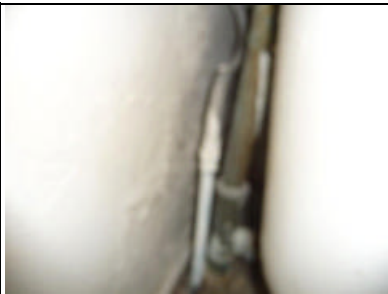
[CR] There is no curtain at the back of the shower. There is some water damage noted. Also see the crawl space notes. A curtain is needed all the way around and the tenants need to be conscientious or water will get out and cause problems.

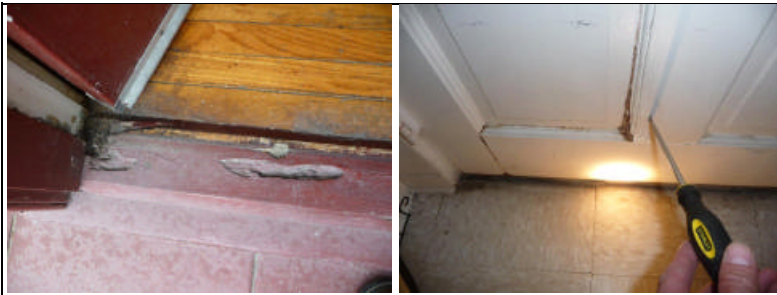
[FE] [CR] The door does not have a properly installed or maintained sill and this will increase the potential for water leaking onto the framing at the base of the door and this will increase the potential for rot in the framing or subfloor at the base of the door. Have a specialty door installation contractor evaluate the door sill further and correct as needed. There is dog damage to the front door.

[CR] Replace back door. See the termite report for any potential rot or termite activity. Under California law, they are responsible for any rot or termite activity or damage.

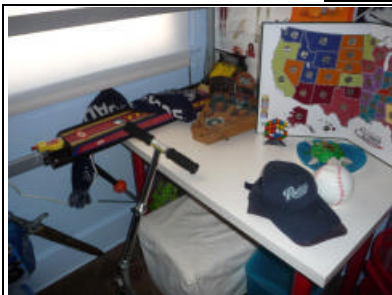
[SC] I couldn't test the emergency release on the back bedroom window due to furniture and storage. This should be accessible in case of a fire and emergency escape between necessary.

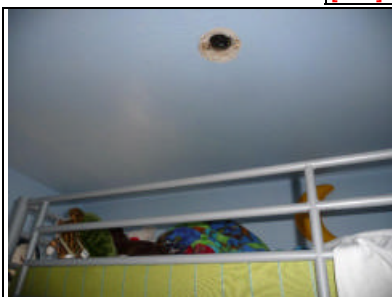
**13.16 FIXTURES:**

[SC] This fixture is above the kids bunk bed and could be touched. It needs a cover plate.

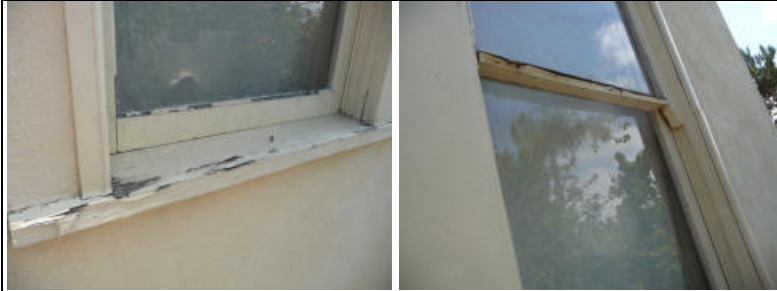
13.17 WINDOWS:

[CR] Repair may be possible to first front window.
[CR] the bad window panel will need to be replaced. There are a couple of salvage yards in town where you should be able to find replacement panels.
[CR] A few of the window screens are missing throughout.

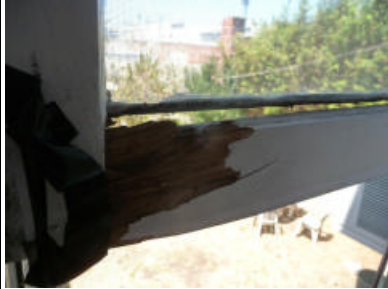
3325 1/2.**13.19 WINDOWS:**

[CR] The front window needs to be replaced. See the termite report for any potential rot or termite activity. Under California law, they are responsible for any rot or termite activity or damage.

[CR] The bedroom window has a molding missing between the panels.

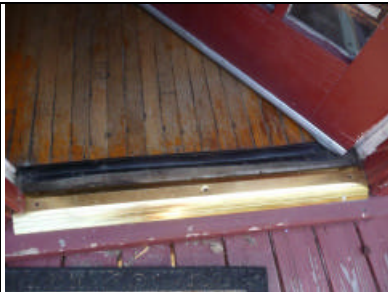
**13.20 EXT DOORS:**

[FE] [CR] The door does not have a properly installed or maintained sill and this will increase the potential for water leaking onto the framing at the base of the door and this will increase the potential for rot in the framing or subfloor at the base of the door. Have a specialty door installation contractor evaluate the door sill further and correct as needed. The door sill needs to be replaced.

Note the water damage to the floor inside the door sill.

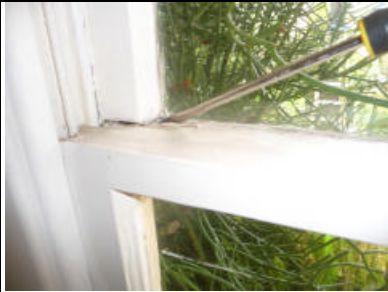
3327.**13.23 WINDOWS:**

[CR] See the termite report for any potential rot or termite activity. Under California law, they are responsible for any rot or termite activity or damage.

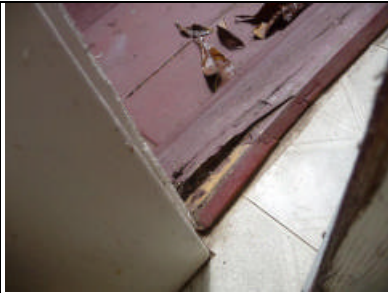
**13.24 EXT DOORS:**

[FE] [CR] The door does not have a properly installed or maintained sill and this will increase the potential for water leaking onto the framing at the base of the door and this will increase the potential for rot in the framing or subfloor at the base of the door. Have a specialty door installation contractor evaluate the door sill further and correct as needed. Also the bolt in the knob is installed backwards.

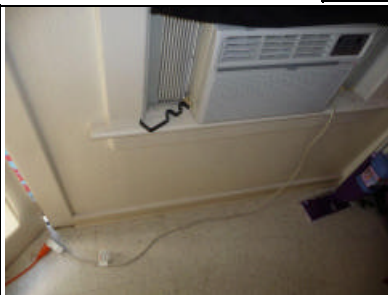
13.26 HEAT & COOL:

[SC] Every appliance need to have a permanent outlet installed within the reach of its cord. Also, I am concerned about overloading the electrical capacity of the unit with an air conditioner.

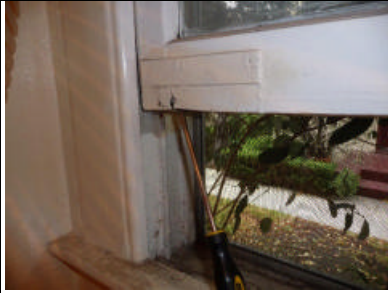
3329.**13.27 WINDOWS:**

[ICR] Damage to the frame of the front window.

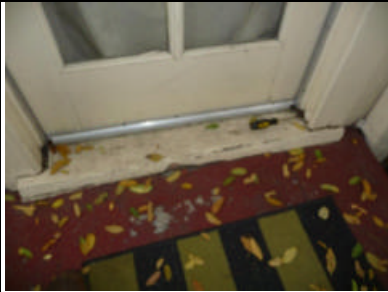
**13.28 EXT DOORS:**

[ICR] This is the back door that is leaking and causing the damage to the framing that is noted in the crawl space notes. See the termite report for any potential rot or termite activity. Under California law, they are responsible for any rot or termite activity or damage.

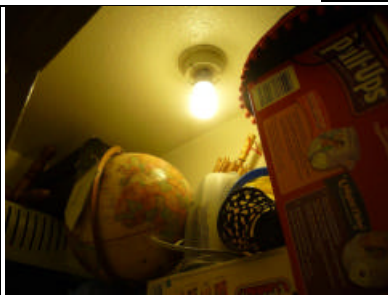
**13.29 CLOSET:**

[SC] The closet light is too close to a shelf by the standard today and can be a fire risk if something on the shelf gets too close. No fixture should be directly over the shelf. I recommend that it be moved and that the fixture be changed out to a tube type fluorescent or LED fixture, which will generate only a fraction of the heat of an incandescent light and greatly reduce any fire risk from heat build up. It will also save energy and money over the life of the fixture. The problem with a screw in base fluorescent is that someone could easily change it out to an incandescent.

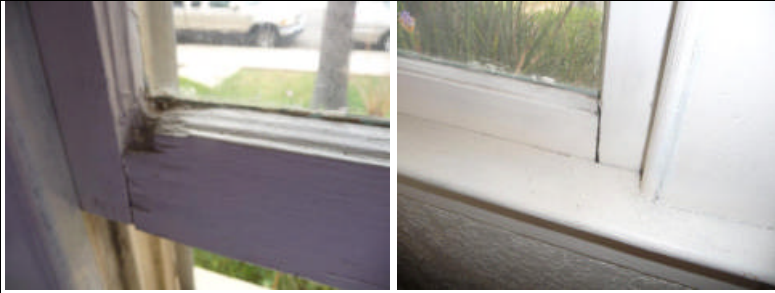
13.30 WINDOWS:

[CR] See the termite report for any potential rot or termite activity. Under California law, they are responsible for any rot or termite activity or damage.

[CR] Front bedroom window also weak.

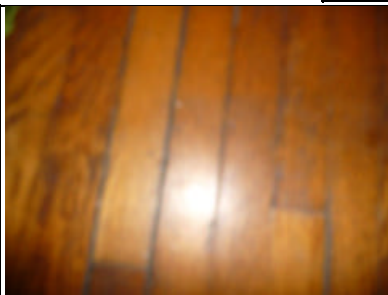
**13.32 FLOOR:**

[CR] The hardwood floor has been sanded down over the years and this makes it more risky, or not possible, to sand it down again. When the floor is sanded too far the nails can become visible and the top edge on the flooring will become thin and weak. I can see places where the top lip of the flooring is cracked, loose, patched, or missing. The heads of the nails have become exposed in some places.

This is a fairly common problem throughout the complex.

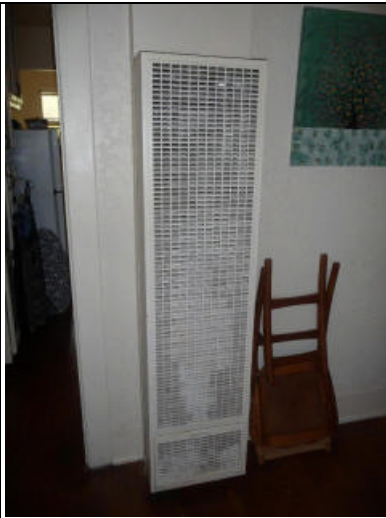
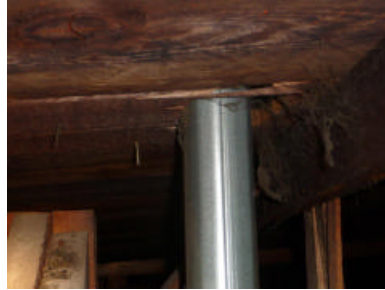
**13.33 HEAT & COOL:**

This is one of the newest heaters in the entire complex and looks good except:

[SC] The vent was too close to or in contact with combustible materials, and this condition can be a fire hazard that needs to be corrected. The vent is too close at roof line. This is almost always the responsibility of the roofing contractor who installed the roof because they failed to maintain the proper clearance and pull the vent to the wood on one side. One inch clearance is required by code between the dual-wall vent and any wood or other flammable material. The vent is very close or even touching the wood and heat transfer is a clear risk.

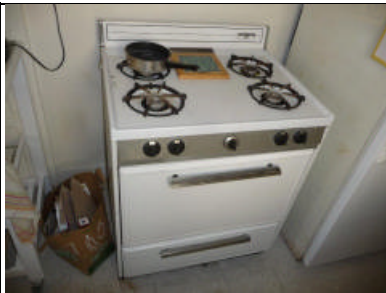
This stove is an older one with some damage to the enamel but functional.

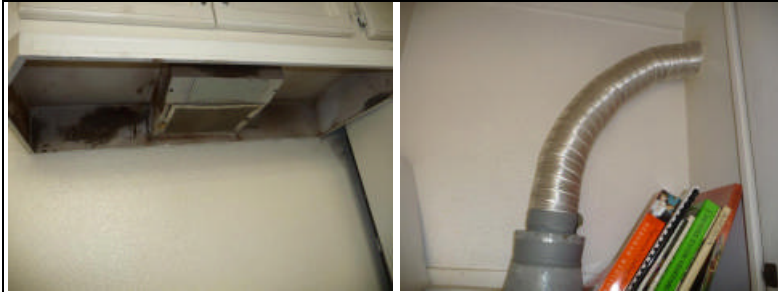
The fan is an older one with substantial damage to the finish, but it functions.

[SC] The exhaust vent ducting was a corrugated flexible material which is not approved for kitchen exhaust vents because it builds up grease which could be a fire risk. Only smooth wall sheet metal is approved. This can be an issue if the duct gets dirty which is possible for people who do much frying. The actual risk is probably low for most people.

[CR] The size of the exhaust duct is smaller than it should be and I recommend replacing it with the proper size so that the fan can operate at the efficiency that was intended. See the installation instructions for the proper size, generally 6 or 7 inches. All ducts for kitchen fans need to be smooth-wall sheet metal.

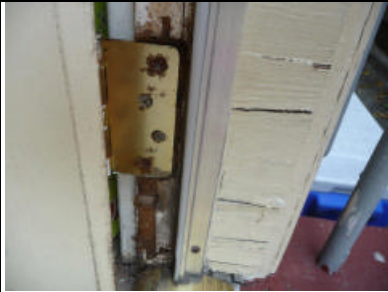
14.25 DOORS:

[CR] The back door and jam are in poor condition.

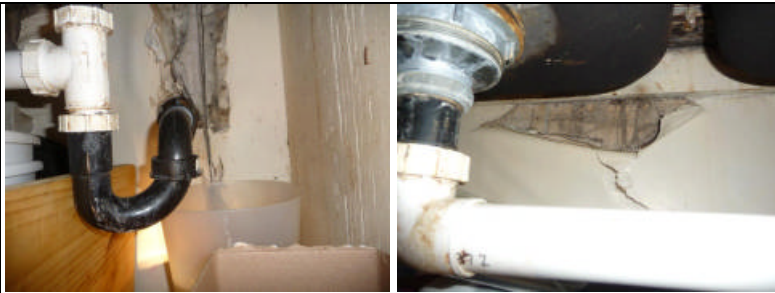
14.41 UNDER SINK:

[CR] The water damage to the back wall below the sink is due to water leaking behind the sink either at the back edge of the sink or at the back edge of the tile counter. These areas should be sealed with caulk. Use a high quality kitchen/bath silicone caulk.
