All Pro Home Inspections

STANDARD RESIDENTIAL INSPECTION AGREEMENT

Client Name: John & Mary Sample
Inspection Address: 1234 Dream Street
La Jolla, CA 92037

Date: August 8, 2011
Time: 8:00 AM

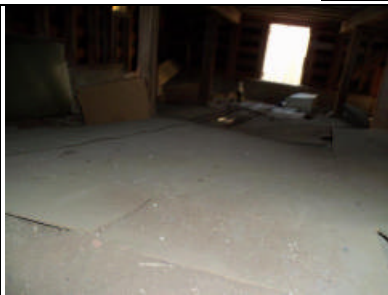
**2.10 PEST CONTROL:**

[CR] Cardboard, or other cellulose material such as particleboard or wood, or any absorbent material such as carpet, that is laying on the soil must be completely removed and cleaned out of the crawl space. Any of these materials can be a perfect medium for growing mold and can also increase the risk of attracting termites. See the Mold Statement at the beginning of the report. There is a lot of material under in the crawl space that needs to be removed in the area close to the access opening.

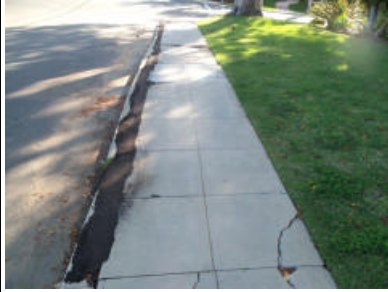
4.7 SIDEWALKS:

The city sidewalk has been patched recently.

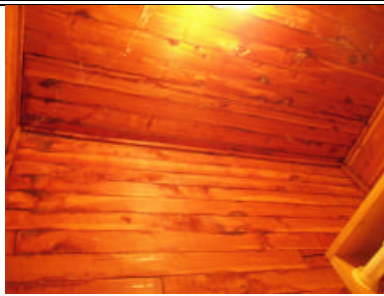
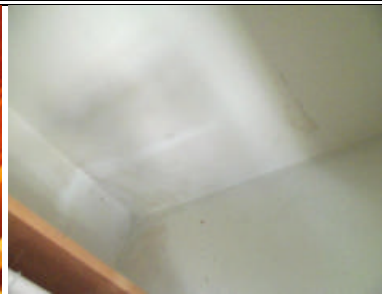
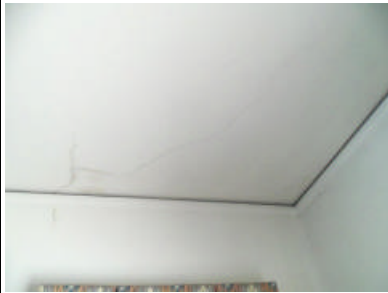
**5.4 LEAKS**

[FE] There are water stains in the attic behind the fireplace and water stains in both of the master bedroom closets below. There is no cricket and the flashing details are very weak. Also the flashing is very old. I am fairly confident the staining is due to active leaking.

[FE] Leaks in corner of front right bedroom.

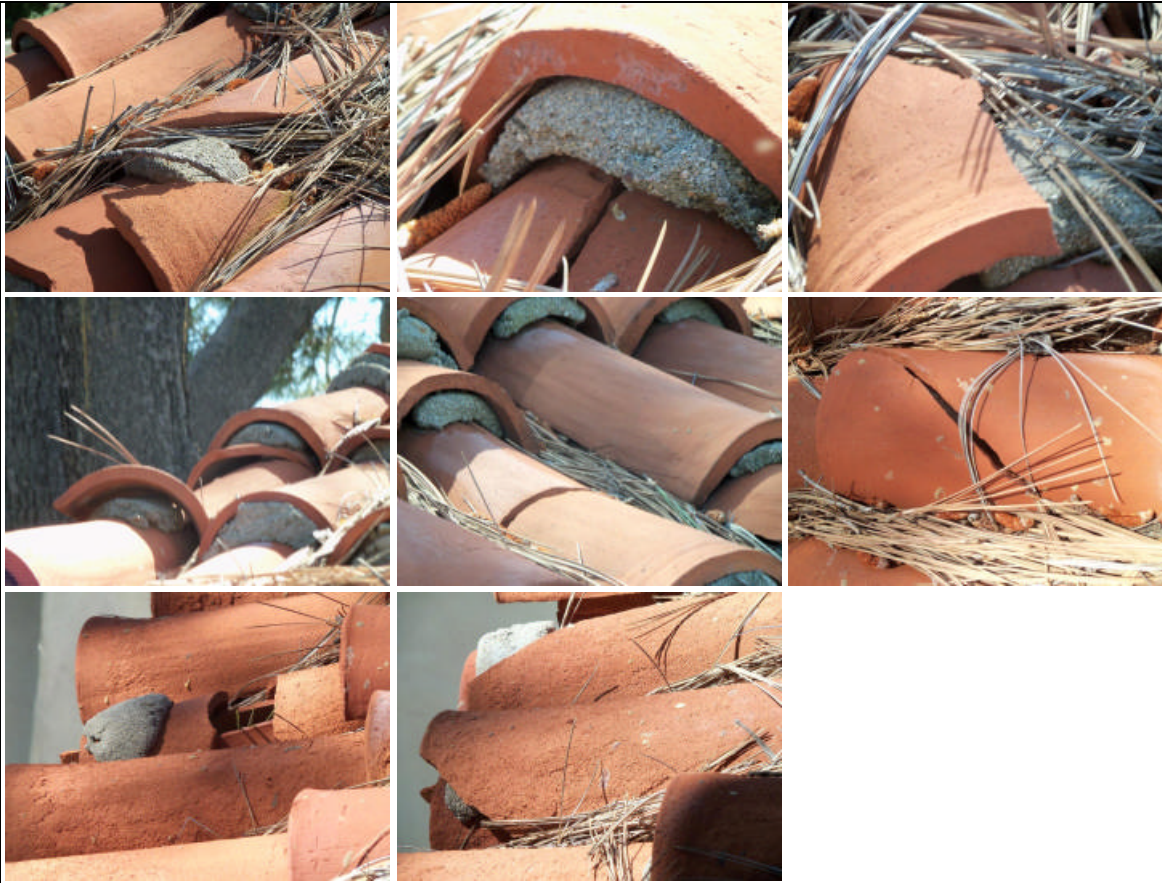
**5.5 CLAY TILE:**

[FE] There were cracked or broken tiles noted throughout the roof. I recommend that they be replaced. It doesn't make good sense to patch, mastic or glue broken tiles back together as a repair because the repairs may last 10 years if done well and a new tile should last over 50 years. Also, many repairs are poorly done and only last a few years. Broken tiles that need to be replaced are noted on all roof sections.

There are also a few tiles noted in the pictures that have just deteriorated from age.

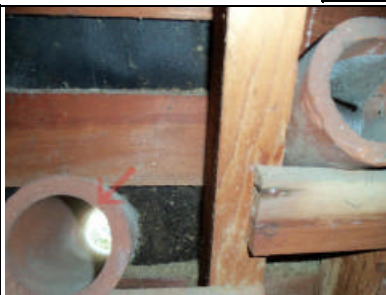
6.3 VENTILATION:

[CR] There were vents that do not have screens. This is not unusual for old homes but would not meet our standards today and may allow insects, birds or rodents to enter the attic space. 1/4 inch galvanized steel screen material should be used to seal off any open vents. Only one of the vents doesn't have a screen and this is on the south east end of the attic.

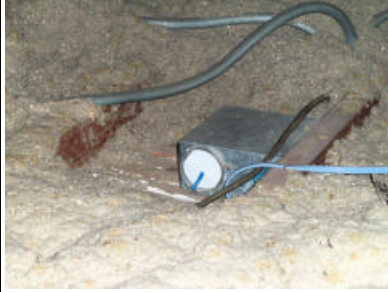
6.5 EXHAUST VENTS:

[CR] A bath vent fan is exhausting into the attic. They should extend to the exterior in order to minimize moisture being added to the attic. This can be very important in a cold climate where condensation is more of a problem, but doesn't cause as much of a problem in a mild climate like ours. However, correction is still recommended.

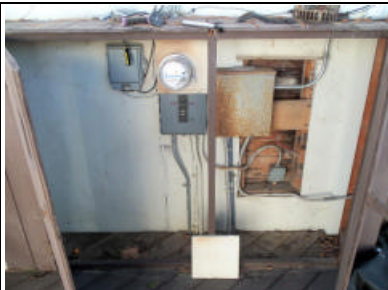
7.3 BREAKER PANEL:

[FE] The panel wiring or breakers were not installed in a clean and professional manner, or there was some other concern that did not give my an adequate comfort level and I recommend further evaluation by an electrical contractor, who can make any necessary corrections. The installation may be substandard, overly cramped, or installed in an improper or unprofessional manner. I always feel further evaluation is needed if anything in the breaker panel appears below a professional standard.

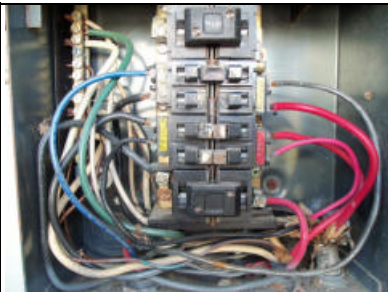
[SC] There are 220 volt circuit breakers or multi branch circuit breakers that were missing their handle tie(s). These ties are required to trip both legs of the circuit in a fault condition. This is usually an easy correction for an electrician. At least three of the 220 volt circuits are missing handle ties.

[CR] Some or all of the circuit breakers were not labeled. They should be labeled to make it easier for individual circuits to be shut off.

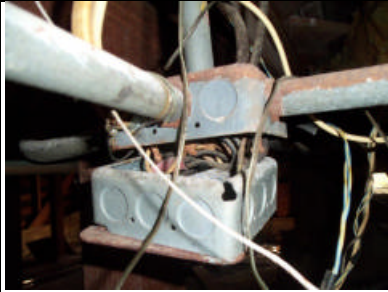
**7.11 WIRING:**

[SC] An electrician should check this junction box in the center of the crawl area under the house. It has come apart and may be overly stuffed.

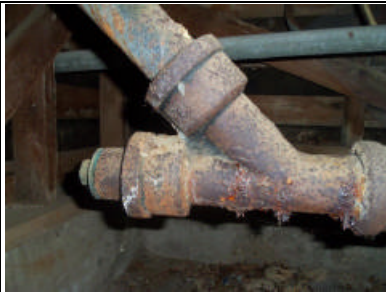
[FE] Due to the number of places that have rusted through to the outside and other damage, the drain lines need to be inspected by a plumbing contractor for further evaluation and consideration given to replacing part or all of the remaining cast iron at this time.

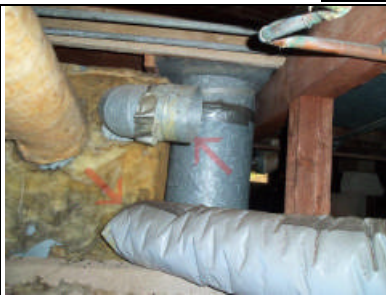
[CR] One of the ducts came apart and is blowing air out into the crawl space.

The ducts were secured with duct tape, which becomes weak with age. The quality of the duct tape used is low and failures can be expected over time. The question is not if there will be failures, but when. Air leaking out of ducts into attic, crawl spaces, or other unconditioned areas can waste a lot of energy. Large scale studies have shown that a reasonably well installed duct system using duct tape alone will lose about 20 percent of its air when it is originally installed, and after a few years the average system losses over one-third. When the ducts come completely apart, the losses are even higher. This adds substantially to the heating and air conditioning bills. Because of the huge energy losses, new standards have been implemented recently. The newer standards no longer allow duct tape alone, and a cinch-tie is required at each end of the flexible ducts, and a sealant must also be used. I highly recommend that the new standards be followed for any repairs or upgrades. I also encourage you to consider having someone inspect and redo the connections at this time to reduce the risk of leaks and improve energy efficiency.

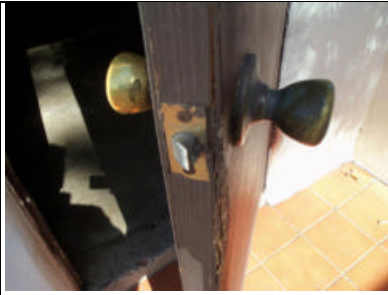
10.5 EXT DOORS:

[CR] The door is getting old and it is swelling and beginning to delaminate. It is currently still functional but you should budget for replacing it.

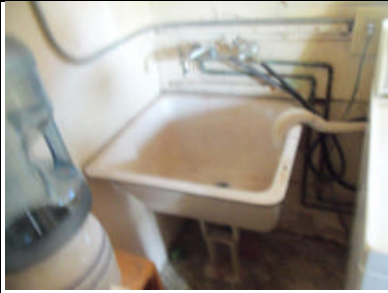
[CR] The sink was loose at the wall and should be made more secure. The left mounting screw has come loose. Unfortunately this is not easy to install since the sink is up tight to the corner. With a little caution it should be OK.

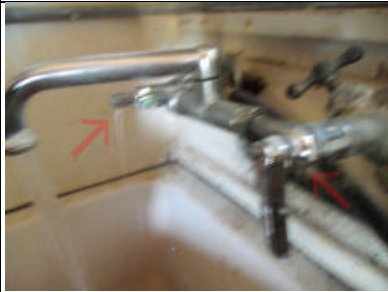
**11.5 FAUCET:**

[CR] The faucet leaked at the handles and will need new washers installed or possibly need to be replaced.

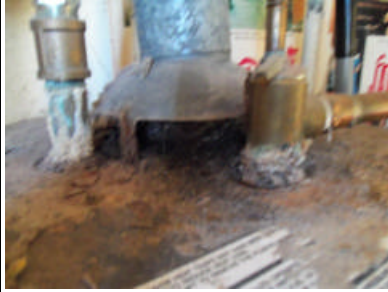
12.11 WATER LINES:

[CR] There was substantial corrosion noted to the water lines above the tank and to the pressure relief valve. See next note.

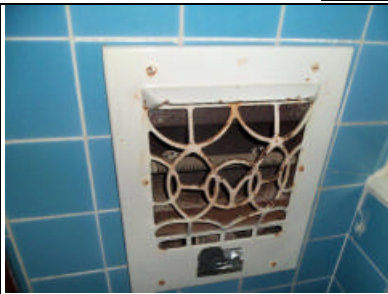
13.16 HEAT:

[SC] Electric wall heaters get very hot and pose a safety hazard. I recommend extreme caution be used with these heating systems. Never set anything in front of the heater and never install a towel bar above one of these heaters. These would be substantial fire risks. These heaters also get hot enough to produce third degree burns and can be a serious risk to children. Also, this heater is an old model that doesn't have any fan to cool the unit and doesn't have any safety sensors. I recommend that it be removed or at least disconnected. This one had tape over the switch and I did not try to turn it on.

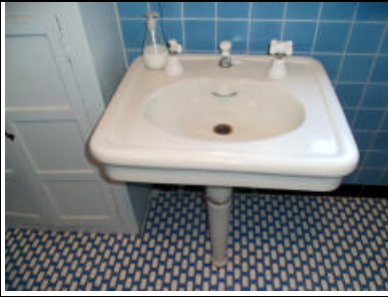
13.18 SINK:

OK.

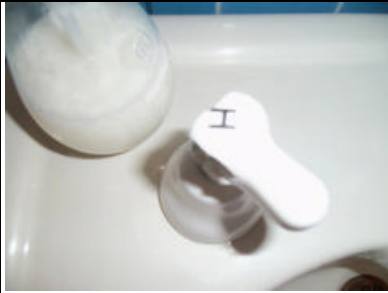
**13.19 FAUCET:**

[CR] The handle is broken and needs to be replaced.

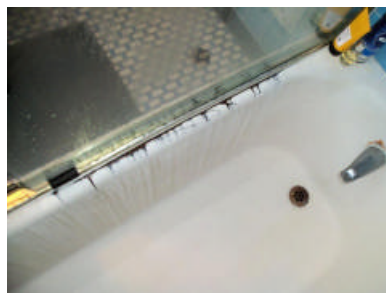
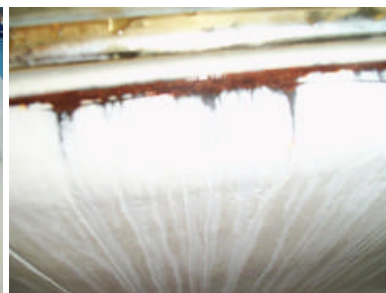
13.21 TUB:

[CR] This tub has substantial damage to the enamel finish and it is questionable whether it would make sense to refinish it. Serious consideration should be given to replacing the tub entirely along with the shower walls. I suspect this damage is due to whatever has been used to clean the glass shower doors over the years.
--

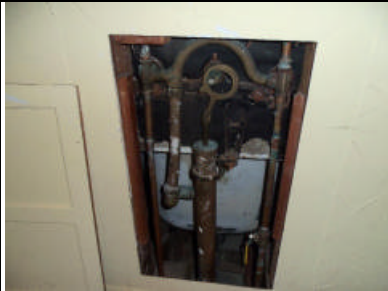
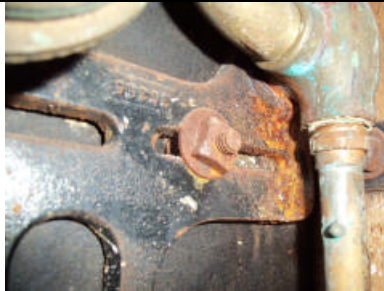
13.23 TUB/SHOWER FIXTURES:

[CR] The faucet was dripping, or leaks. It may just need a part like a washer or valve stem, but it could have a more difficult problem that will require replacing the valve behind the shower wall. See note in master bath. This is similar. The pictures are looking at the back side of the valves through an access panel in the hall wall. The master bath is similar. There was rust on one valve but no active leaking.

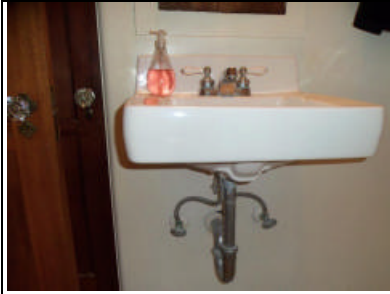
13.31 SINK:

OK.

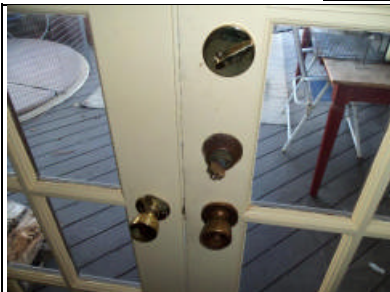
14.13 EXT DOORS:

[SC] The deadbolt lock in an exit door was key operated from both sides. This condition can be a safety hazard if an emergency exit is needed and the key is not readily available. Think of trying to find the key in house that is filling with smoke during a fire. I recommend the lock be replaced with a flip lever type on the inside to reduce this risk. Exit locks that require a key to get out are no longer approved for new construction.

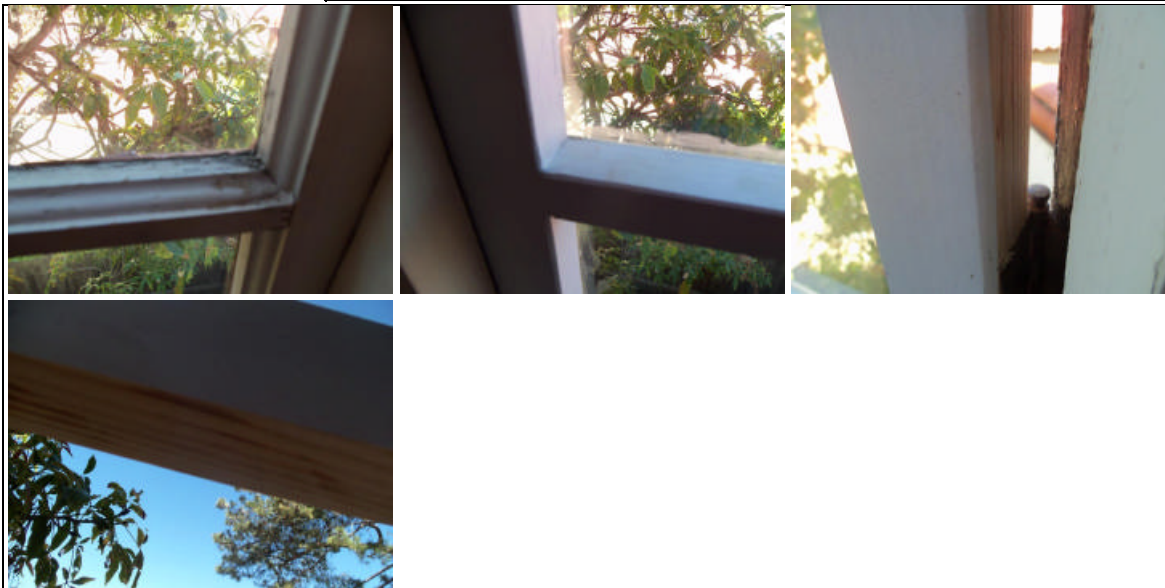
[CR] One of the window panels was replaced. (This is the only window in the house that has been replaced except the kitchen.) No effort was made to match the profile of the original window trim. The window has only been primed on its face. The bottom, top and edge of the panel has not been primed and all of it needs to be painted.

The first picture shows the molding style of the original windows. The second the new window. The other pictures show the window is not painted on the edges.

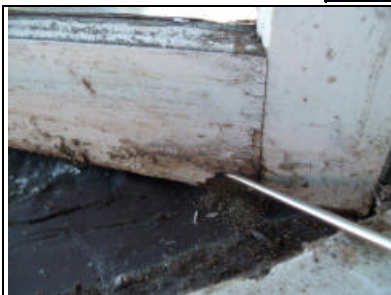
[CR] The frame on the side window also needs repair.

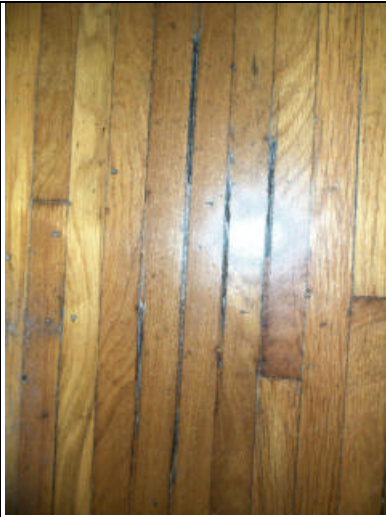
14.21 FLOOR:

[CR] The hardwood floor has been sanded down over the years and this makes it more risky, or not possible, to sand it down again. When the floor is sanded too far the nails can become visible and the top edge on the flooring will become thin and weak. I can see places where the top lip of the flooring is cracked or missing. This is noted close to the doorway from the breakfast/kitchen area into the entry.

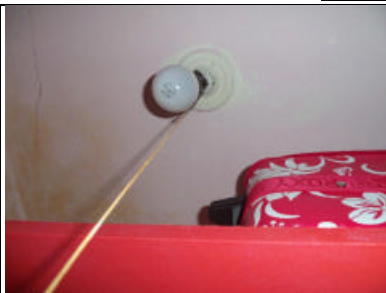
14.23 CLOSET:

[SC] The closet light is too close to a shelf by the standard today and can be a fire risk if something on the shelf gets too close. I strongly recommend that the fixture be changed out to a tube type fluorescent or LED fixture, which will generate only a fraction of the heat and greatly reduce any fire risk from heat build up. It will also save energy and money over the life of the fixture. The problem with using a screw in base fluorescent is that someone could easily change it back to an incandescent. This is noted in a couple of other closets but this is where the bare bulb is closest to the shelf.

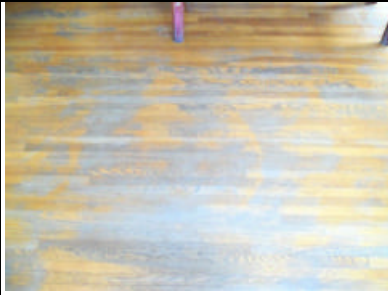
14.24 FLOOR:

[CR] The finish on the wood flooring is thin, scuffed, or damaged, and you may want to ask a flooring company for advice on refinishing the floor. The floors in other visible areas had some scuffing but were generally much better than this area.

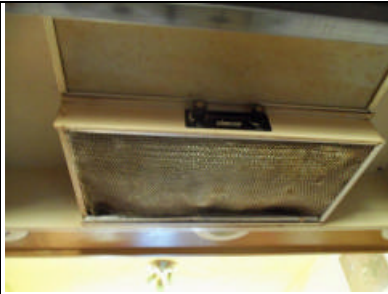
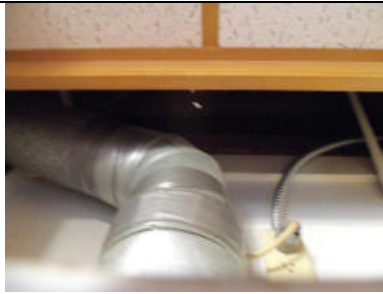
[CR] The filter was damaged and consideration should be given to having it replaced.

[CR] Inside the cabinet above the fan, there is no ceiling and this area is open to the attic space above. This is a bad idea because it will allow the hot or cold attic air to come down into the house. I recommend sealing this at the ceiling level.

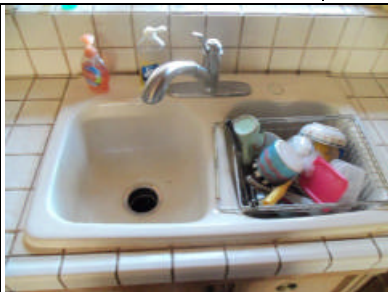
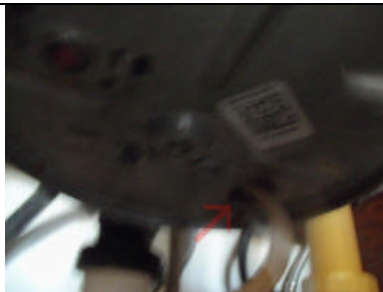
The garbage disposal functioned.

[SC] The electrical cord or pig tale was not secure or was missing the clamp at the base of the disposal. This is easy to correct, but is a substantial safety concern, because the loose electrical line could be snagged or tugged and potentially cause a short. It needs to be corrected.

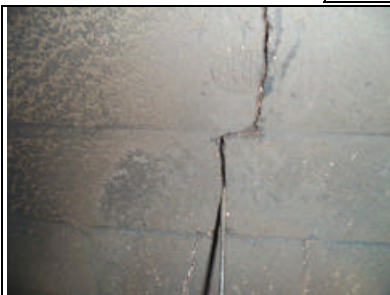
16.5 FIREBOX:

[FE] There are cracks between 1/16 and 1/8th inch in the brick walls or through the grout lines inside the firebox that could be caused by overheating, poor installation, or some movement in the fireplace. The fireplace needs further evaluation by a fireplace contractor or certified chimney sweep who specializes in fireplace repair. The cracks may just need to be sealed or patched with special heat-resistant mortar or caulk, but they could be a symptom of a larger problem. (If patching is all that is needed, you should ask the contractor about the advantages of installing a heat shield to minimize risk of further damage.)

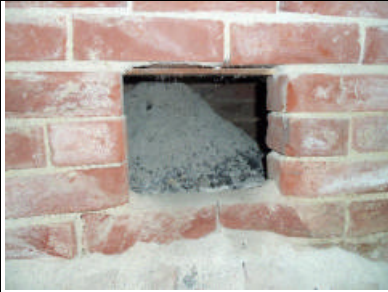
16.8 EXTERIOR:

[SC] The ash dump door was missing and needs to be replaced in the crawl space below the fireplace.

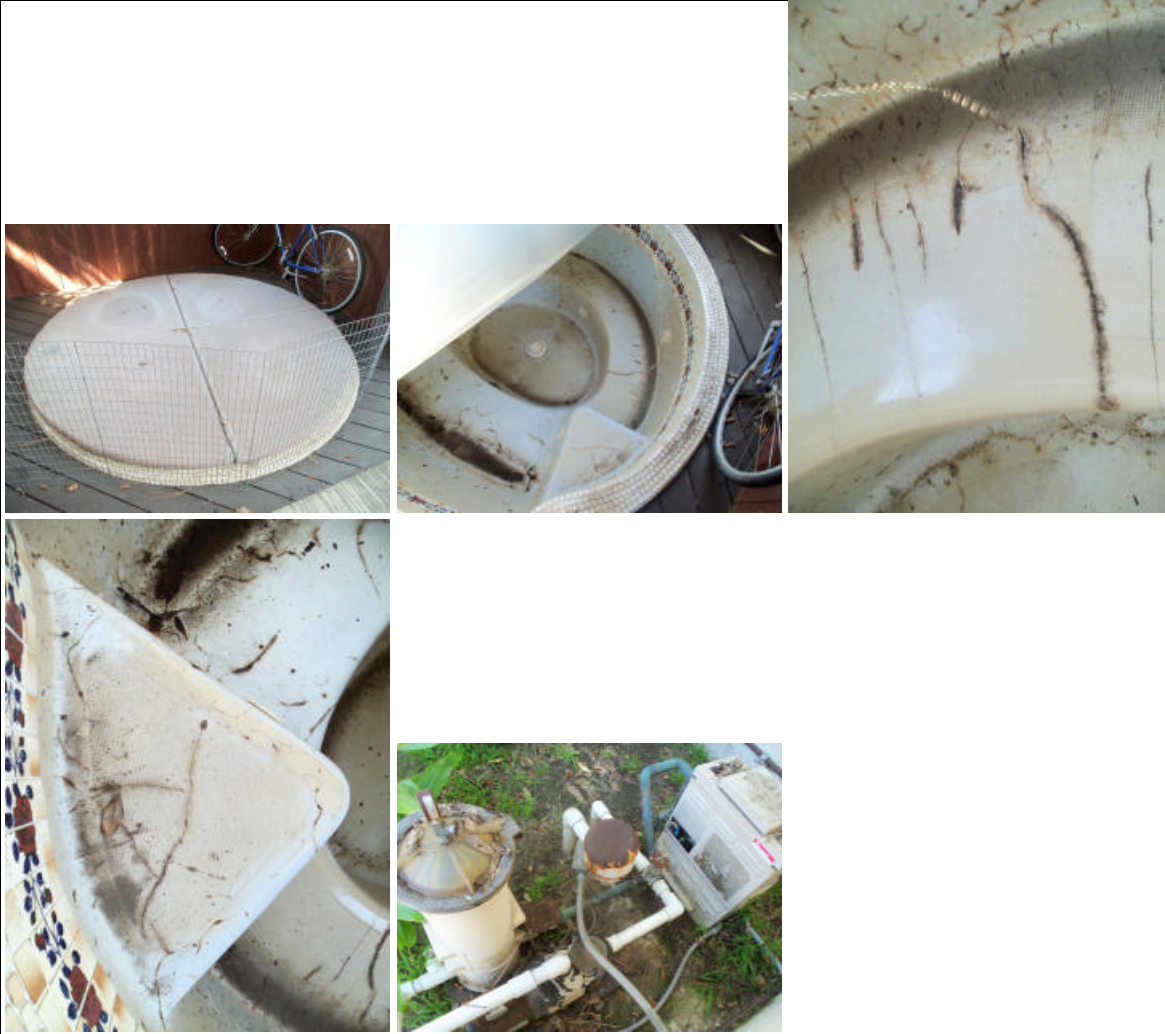
17.1 GENERAL CONDITION:

[NOTE] The spa was old I doubt there is any salvage value. The fiberglass lining is old and very cracked and deteriorated. The spa was empty and I could not test the equipment.
